## UC Santa Cruz building seismic ratings

### Cowell Library, University of California Santa Cruz

CAAN #7131

DATE: 2018-12-31

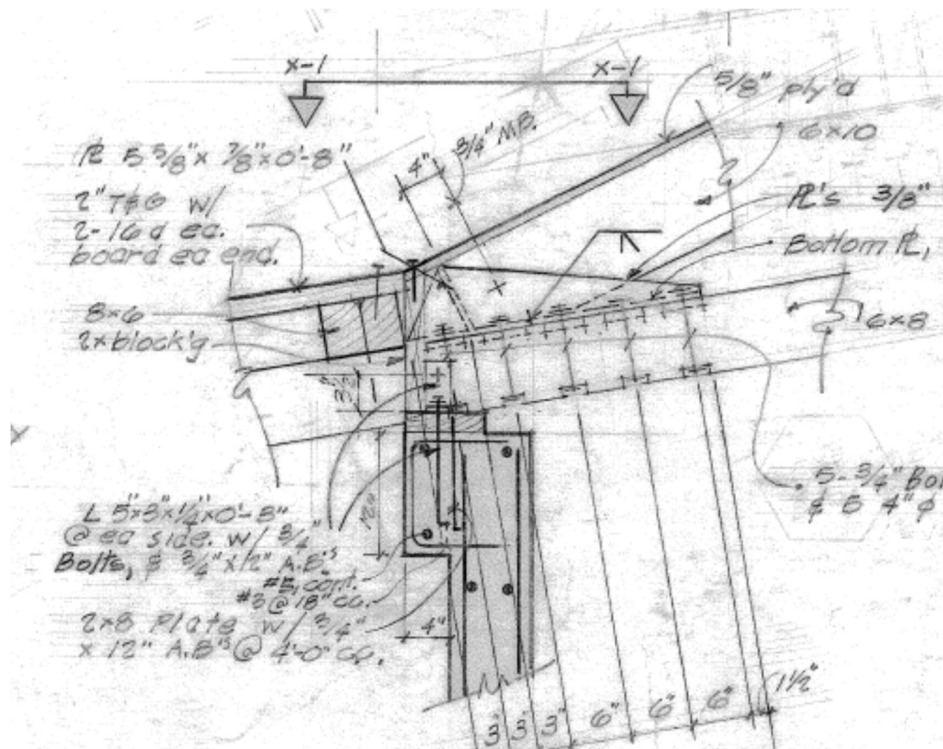
Figure: Detail of roof to wall connection

- Concrete walls are connected to the roof diaphragm at each roof truss with 2-3/4" diameter anchor bolts attaching the roof truss to the concrete wall. Preliminary calculations show that these bolts do not have adequate strength for the specified out-of-plane demands of the wall.
- At the hipped section of the roof, no straps are provided at the hips to provide continuous ties between the roof diaphragm chords.

Our initial calculations for the anchor bolts connecting the roof trusses to the walls show that the bolts may be inadequate for out-of-plane loads from the concrete walls. In addition, the anchorage of the roof tiles and the tall book shelves should be investigated further. We recommend a rating of V (Poor). We recommend further study to determine the severity of the potential deficiencies.

We recommend that the University perform a more detailed seismic evaluation to determine whether retrofitting is required. A Tier 2 linear static analysis may be appropriate. Applicable retrofit measures may include providing straps or additional anchor bolts to attach the tops of the walls to the roof diaphragm, providing additional

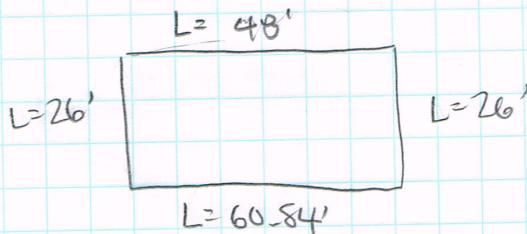
CORrigidity

$$\bar{y}_{cor} = \frac{48(0) + 60.84(26)}{48 + 60.84} = 14.5'$$

$$(y_{cor} - y_{con}) = 1.5' < 26(.20) = 5.2' \quad \checkmark \text{OK}$$

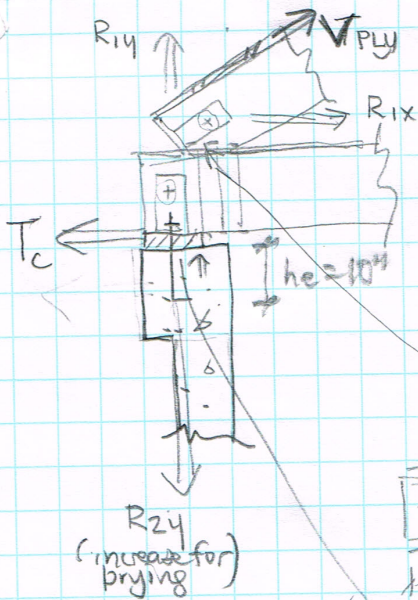
For max spacing of 8'-6",  $T_c = 946(8.5') = 8041\#$

Check  $3/4'' \phi$  bolt in 6x member w/  $1/4''$  side plates -  $R_n = 7736\# < 8990\#$

$\frac{(12060)}{(17746)} + \frac{(4020)}{(8542)} = 1.82 > 1.2 \underline{NG}$   
 $\times 0.8 \text{ open } \underline{1.5}$
