UC Santa Cruz building seismic ratings Stevenson College House 6

CAAN #7140

University of California, Santa Cruz
ASCE 41-17 Tier 1 Seismic Evaluation
7140 - Stevenson College House 6

Appendix A
ASCE 41-17 Checklists

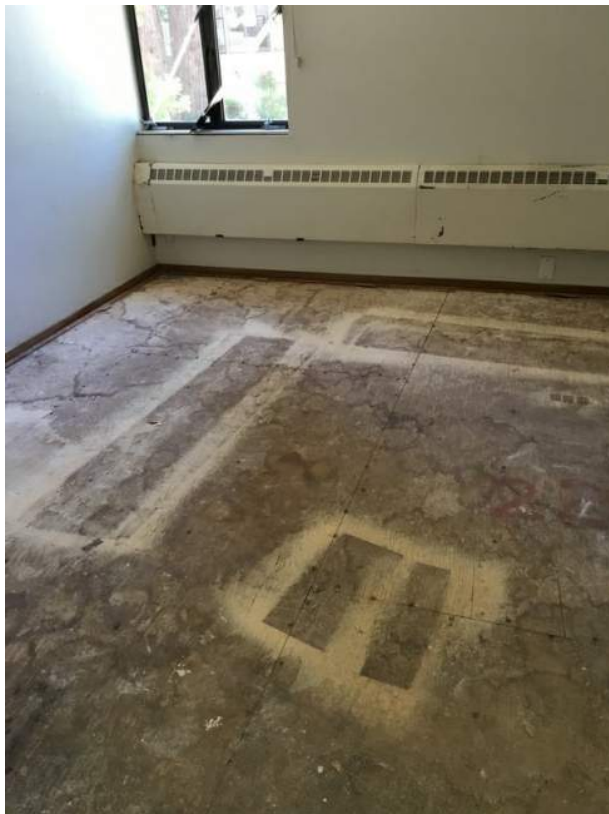
Typical plywood sheathing on building floors

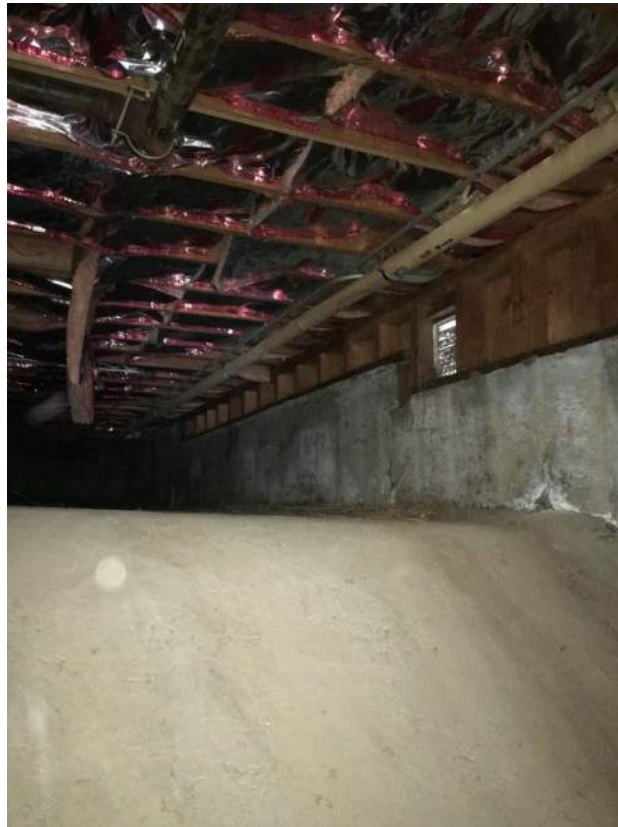
Framing in crawl spaced supported on perimeter retaining walls.

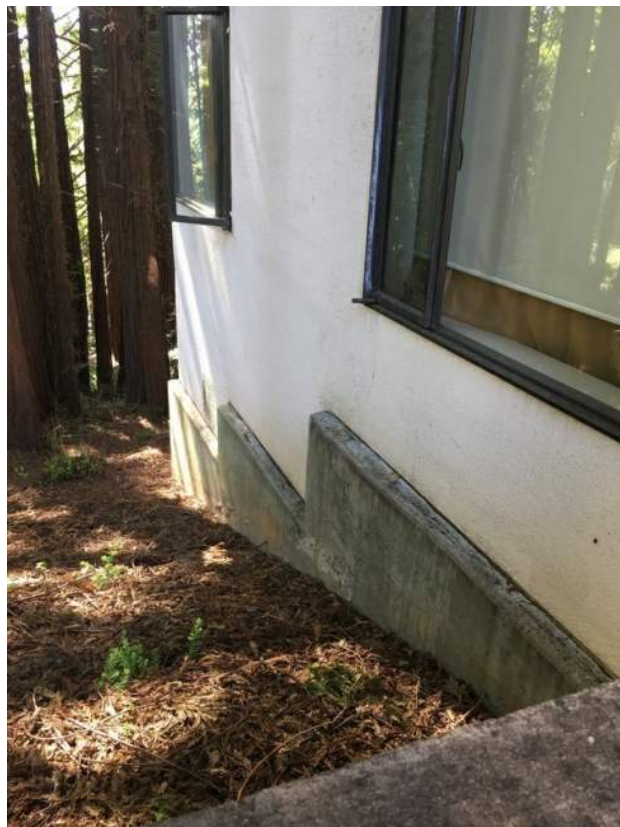
Stepped footing at crawl space
