UC Santa Cruz building seismic ratings
Crown College Gatehouse

CAAN #7158

628 Crown Road, Santa Cruz, CA 95064

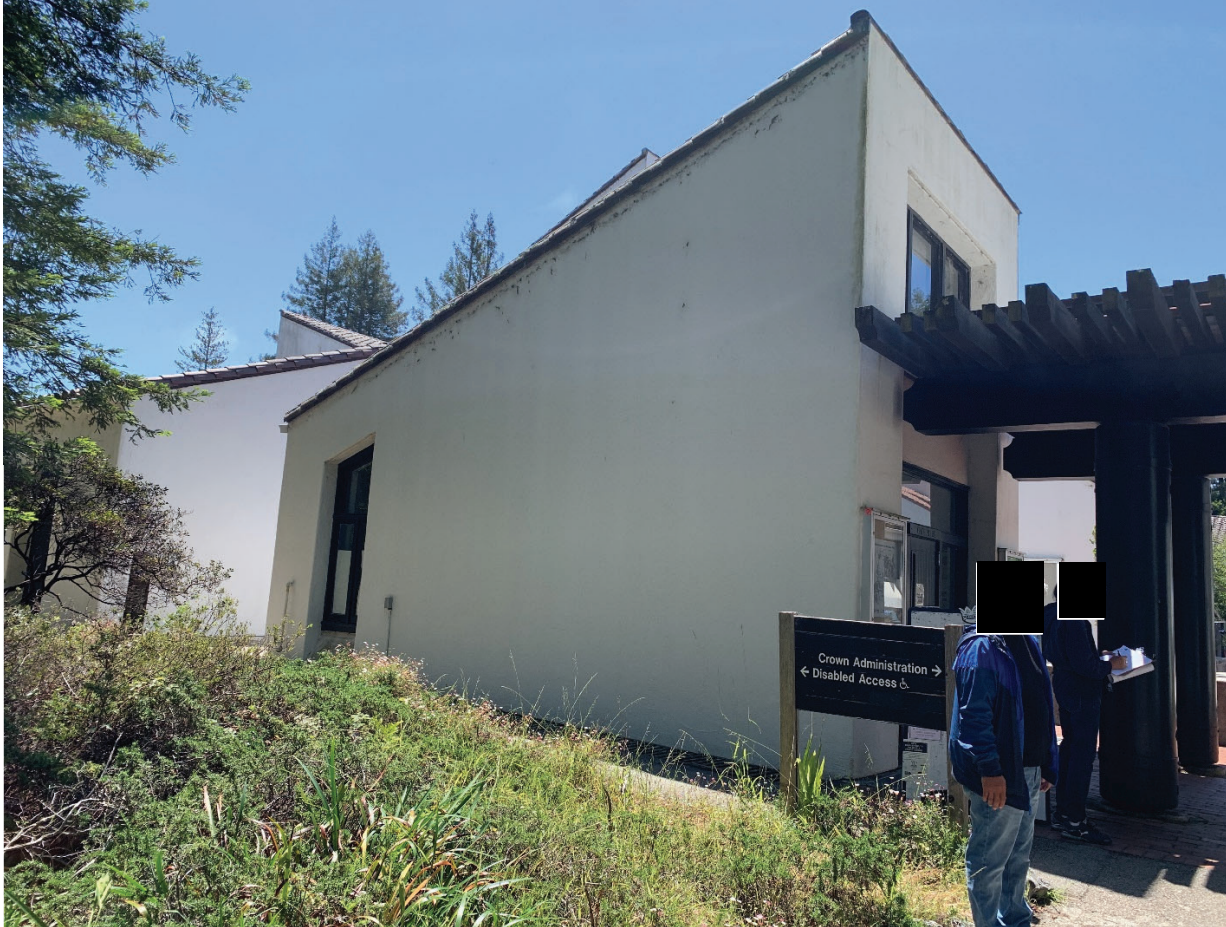
Northwest Corner of Gatehouse (Looking Southeast)

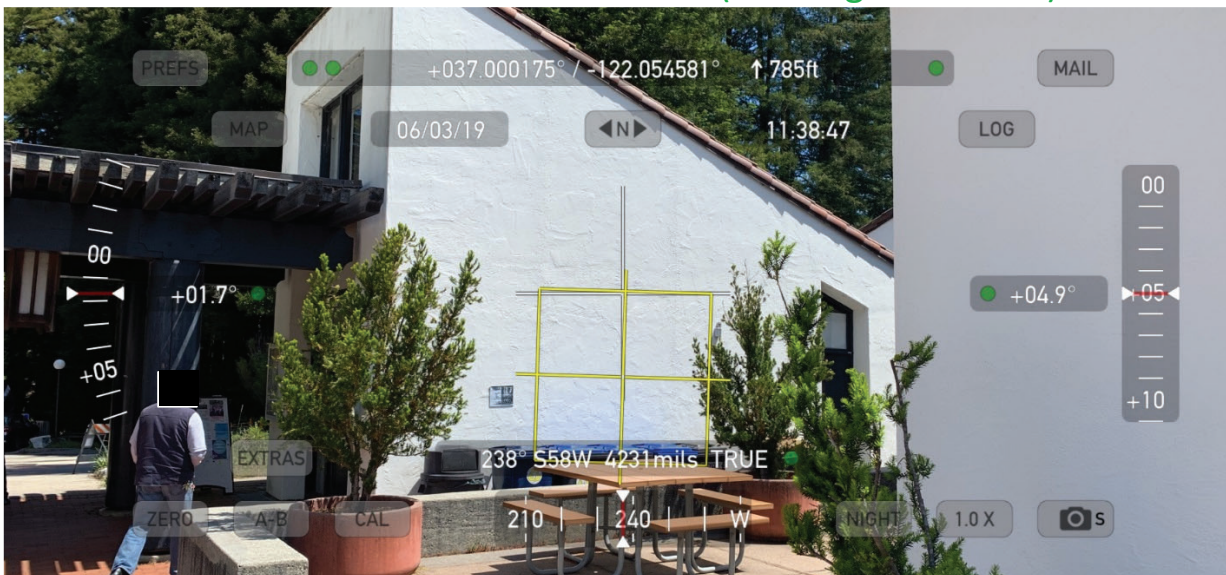
South Elevation (Looking North)

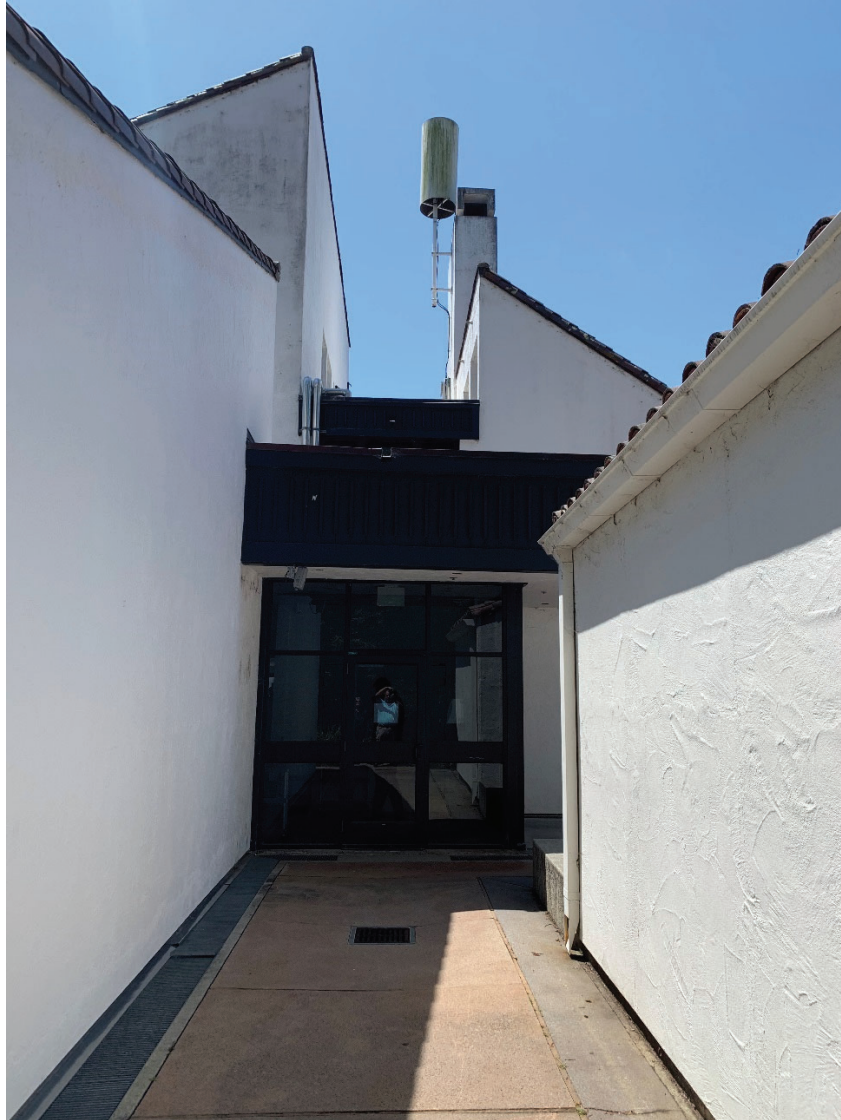
East Elevation Gatehouse at Far Right (Looking South)

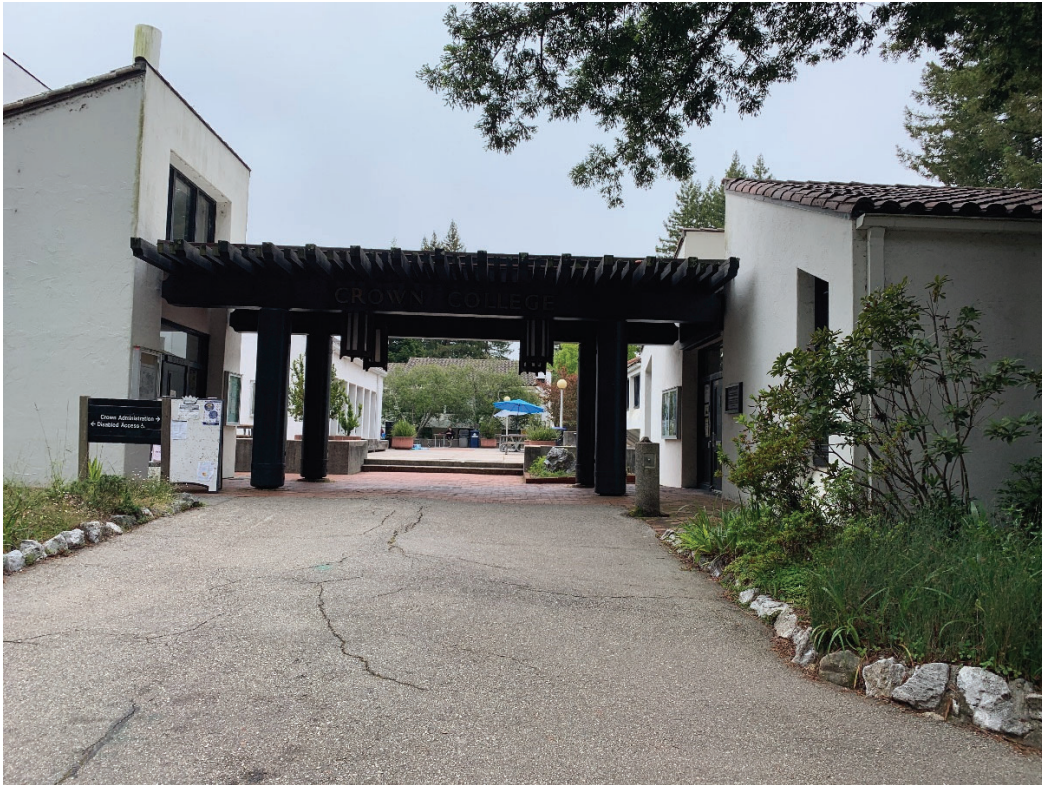
Crown College Entry Pergola, Gatehouse at Left (Looking South)
