Rating form
completed by:**RUTHERFORD + CHEKENE**
ruthchek.com

DATE: 2019-06-28

UC Santa Cruz Building Seismic Ratings
Crown Administration Building

CAAN #7159

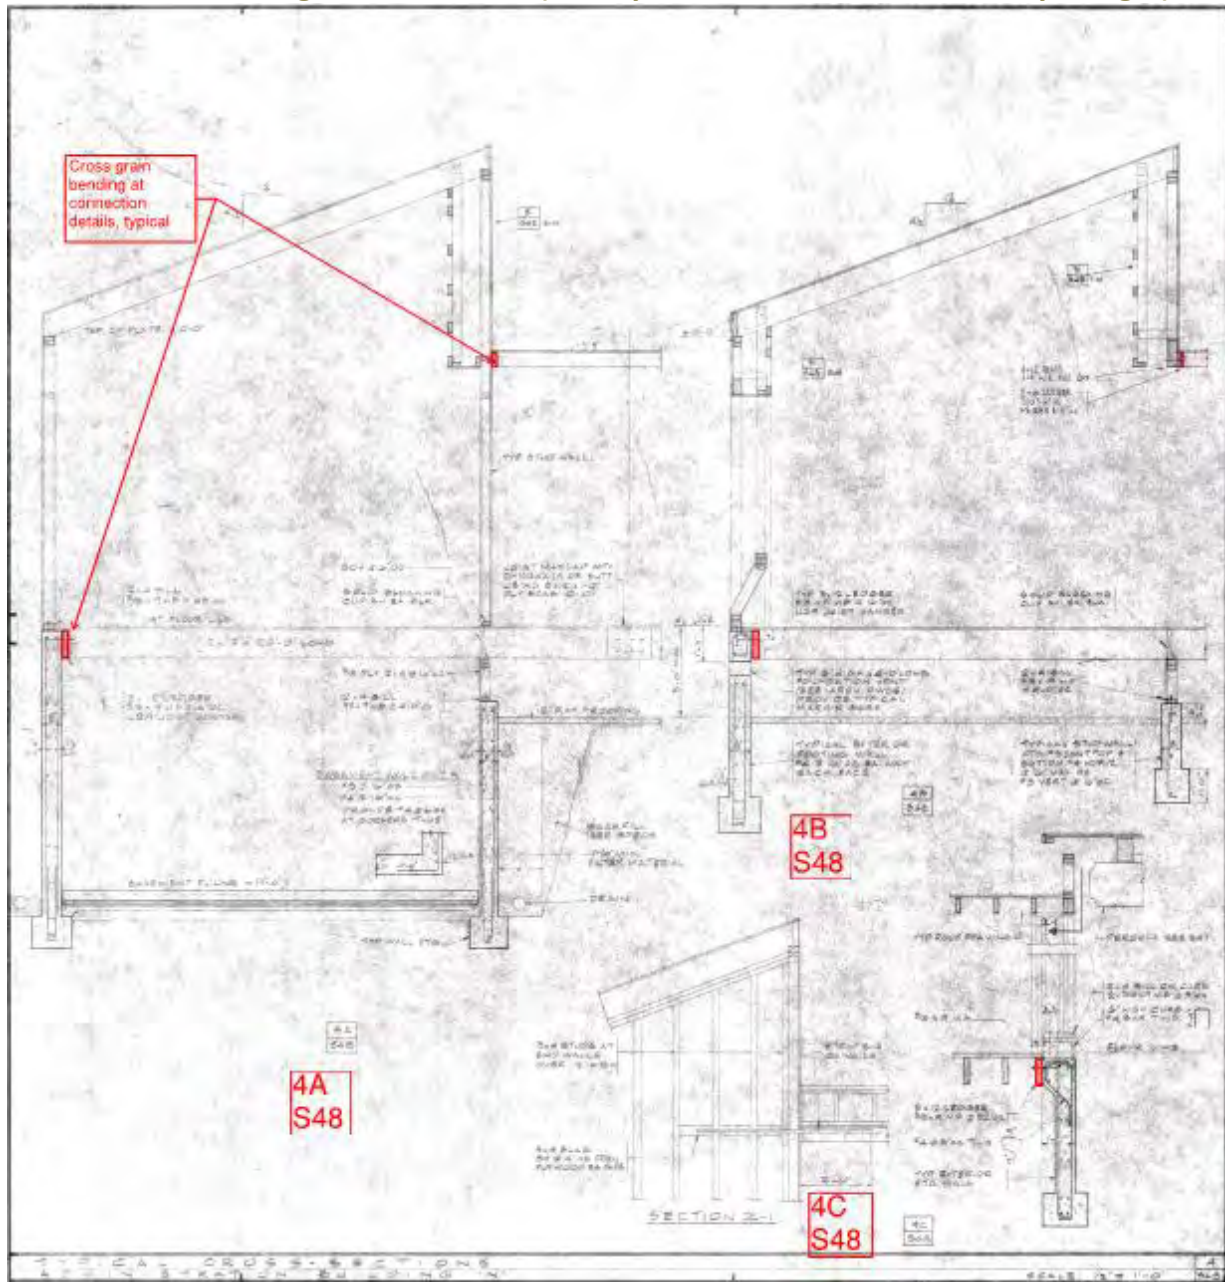
Foundation system: The perimeter and basement walls bear on a continuous 8" thick concrete stem wall on an 18" wide footing. The perimeter stem walls typically come up to the underside of the first floor framing but are set several feet below the framing at the west end at the 1972 addition. The interior bearing walls consist of wood cripple walls with 3/8" plywood sheathing on both sides supported on a shorter 8" stem wall on a 14" wide footing.

Partial Sections Through 1967 Structure (1-Story with Basement at Left, 1-story at Right)

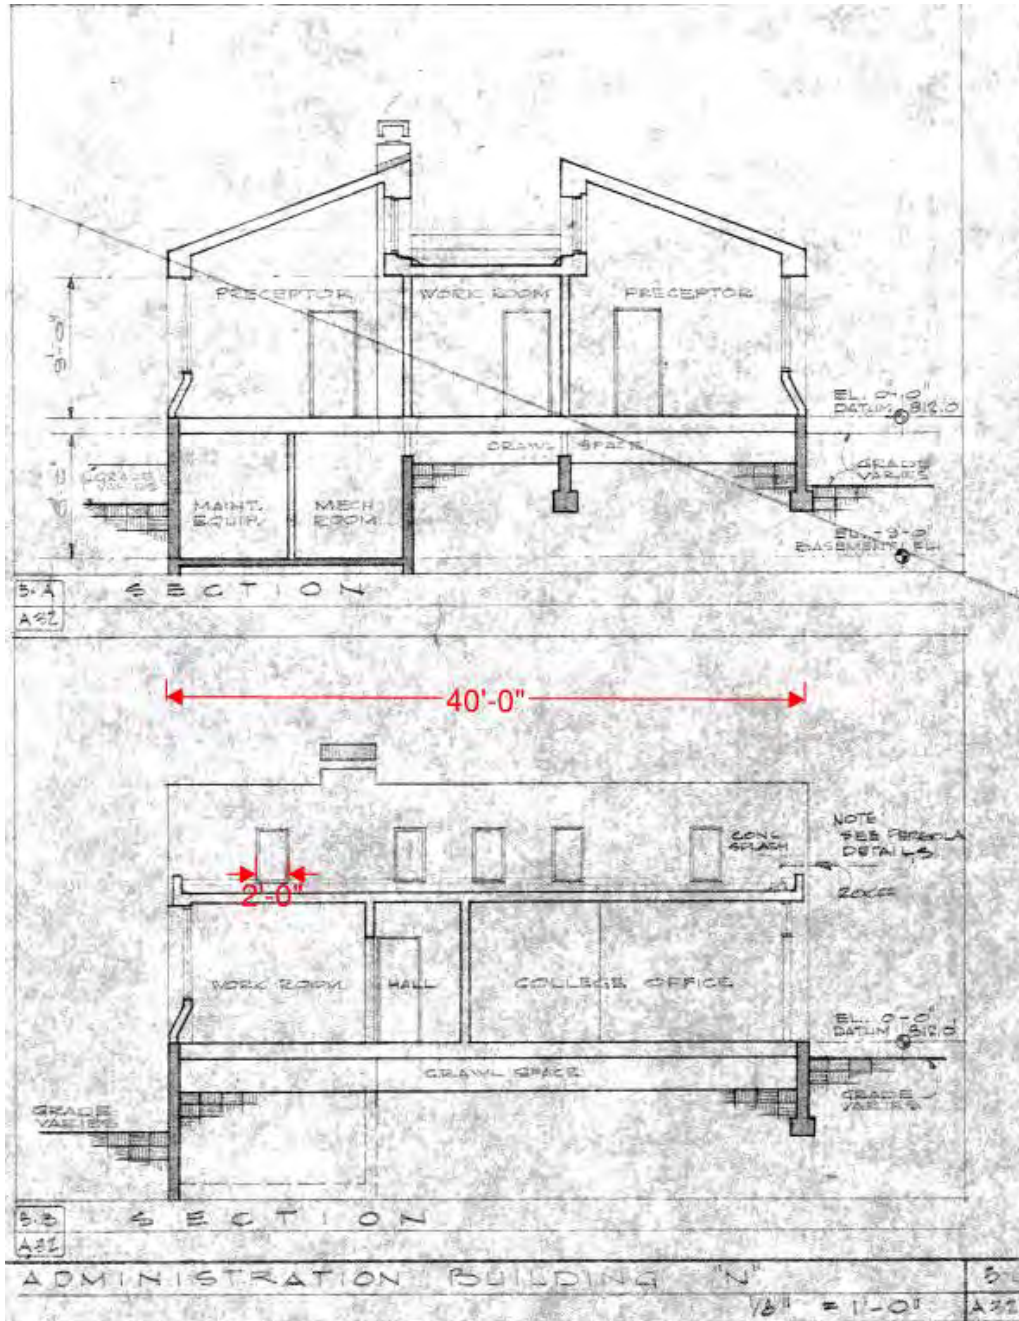
Structural system for lateral forces: Lateral forces are resisted by the corridor walls and the transverse end walls with plywood sheathing. The roof diaphragm consists of separate flat and sloped planes that must transfer loads to the corridor walls and perimeter walls. Lateral forces in the transverse (N-S) direction are resisted by the end walls of the original structure and the west end wall of the addition. Lateral forces in the longitudinal (E-W) direction are transferred from the plywood roof diaphragm through blocking and around clerestory windows to the corridor walls at the center of the building and to perimeter walls. Forces are transferred from the plywood roof diaphragms through blocking at the top of the transverse walls which are sheathed with 3/8" plywood. Plywood nailing is specified in the sheet notes on S1 as 8d@6" at margins and 8d@12" intermediate. Some details show additional nailing at eaves or connections and horizontal straps at the edges of the flat roof connection to the end walls. The walls typically have a 2x4 mud sill with 5/8" x 9" long anchor bolt spaced at 48" on centers. The first floor connection details have cross-grain bending in the ledgers at the perimeter walls both in the 1967 and 1972 drawings. Transverse sections show the corridor walls have some Simpson A-1 clips at the bottom of the first floor. Shear walls are not clearly marked on the 1967 drawings, and it is not clear which walls have single- or double-sided plywood; the cripple walls below the corridors only show one sided plywood sheathing. The load path from the split roof diaphragm to the foundation has a circuitous path and very few straps or clips and no hold downs in the short wall sections. The 1972 addition has improved wood details but still shows cross-grain bending in the connection details.

Architectural Sections 5A & 5B/A32 Showing Corridor Walls with Doors and Clerestory Windows Above, Small Basement at West End

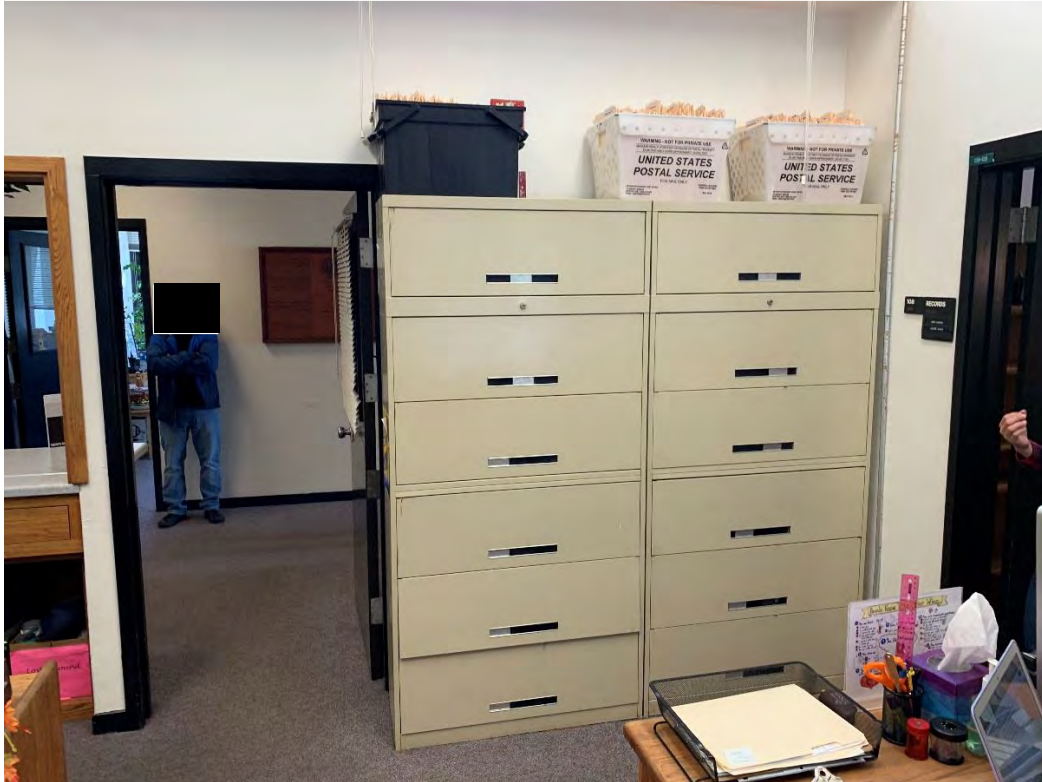
One Wall Anchor Visible at Tall Cabinet

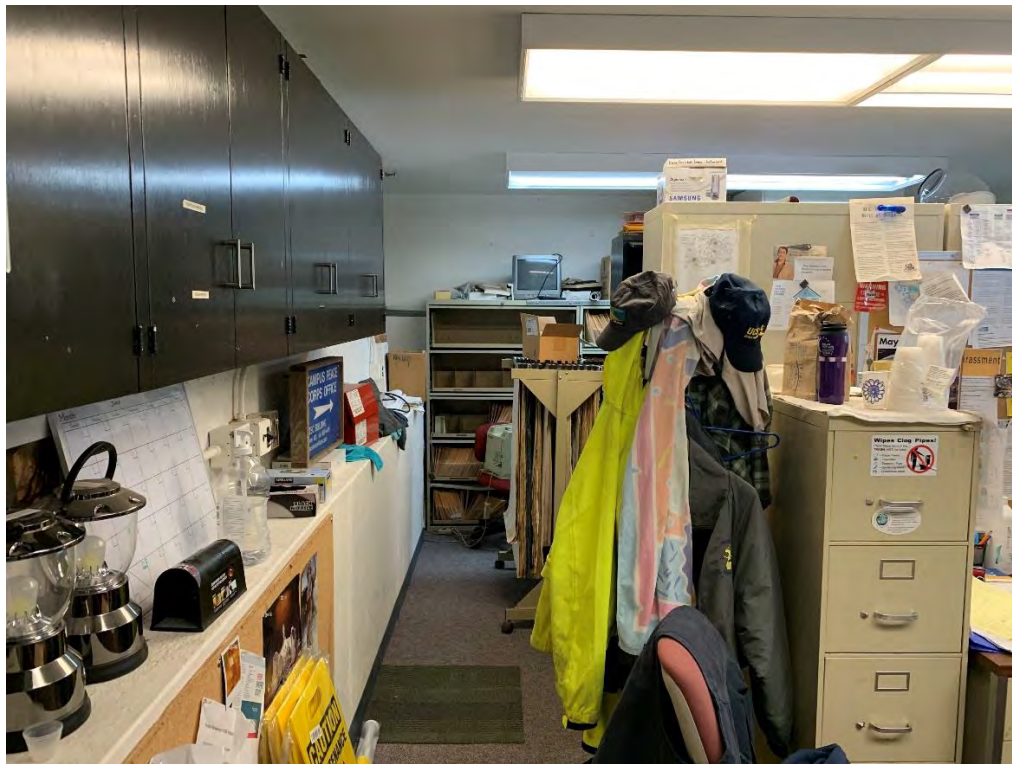
Unanchored File Cabinets and Tall Shelving in Basement Office

| | Description |
|---|--|
| P N/A <input checked="" type="checkbox"/> <input type="checkbox"/> | Other: Unanchored or poorly anchored file cabinets that could block egress. Comments: Observed in offices at first floor and at basement level. |
