DATE: 2019-06-30

UC Santa Cruz building seismic ratings Astronomy Shop B

CAAN #7172

University of California, Santa Cruz
ASCE 41-17 Tier 1 Seismic Evaluation
7172 - Astronomy Lab B

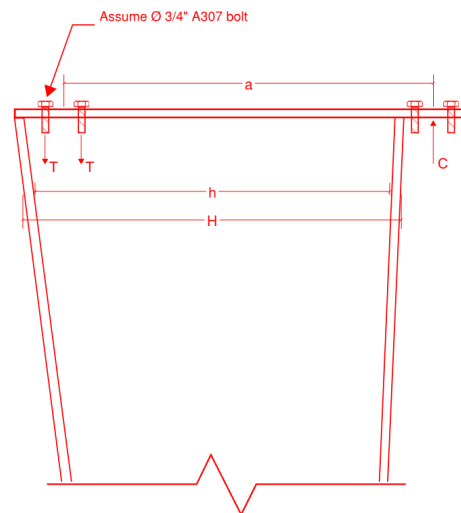
$$DCR_{Connection} := \frac{T_{bolt}}{\phi r_n} = 2.86$$

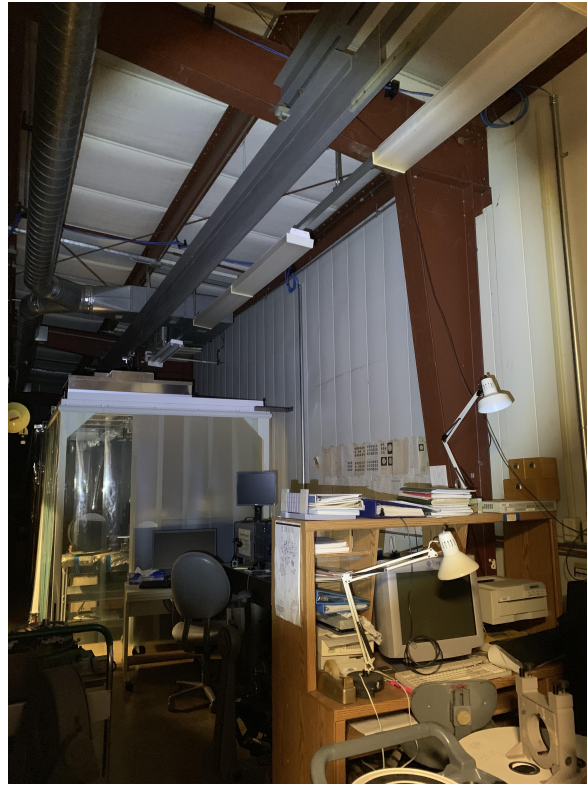
1. The lateral load path of the original structure is not complete. There are no tension only braces to transmit the load to the foundation in the longitudinal direction.
2. The moment connection in the portal frames in the original structure are not able to develop the elastic moment of the adjoining members based on an approximate calculation using field measurements. Connection dimensions are unknown for the additions.

Interior moment connection and potential brace location

A full retrofit of the structure's lateral system is necessary. Tension only bracing needs to be added in the longitudinal direction and the frames' moment connections need to be strengthened.

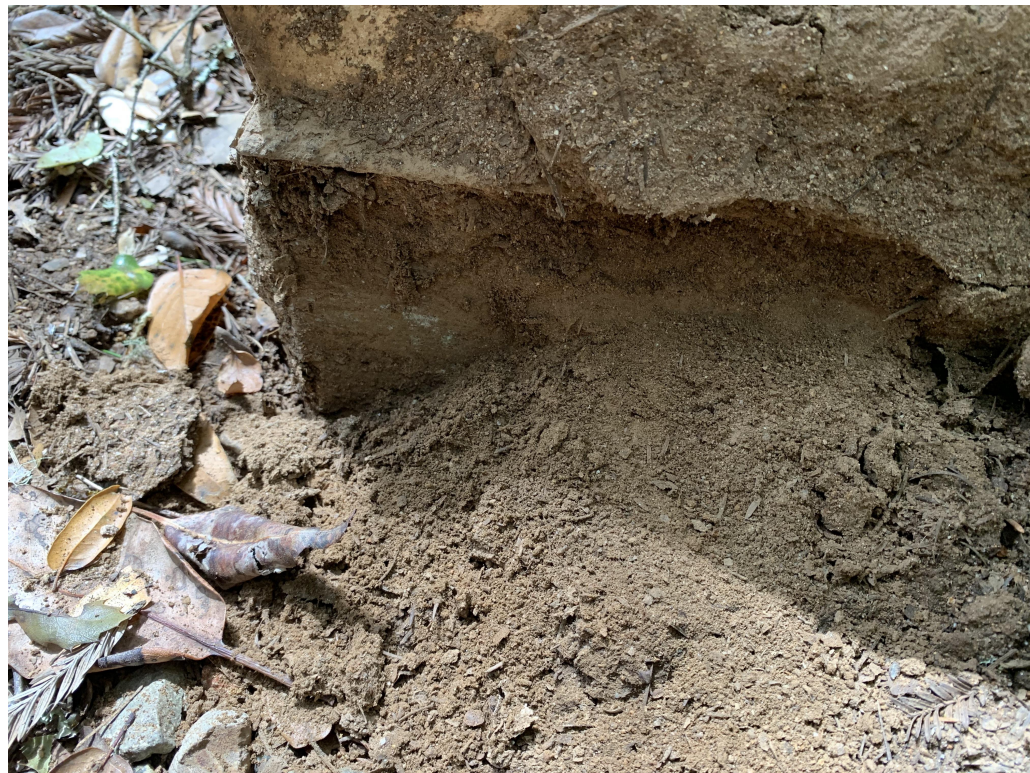
Foundation system: No information is available on the foundation system. There is a slab-on-grade based on the site visit. It is unknown what the foundation looks like under the portal frame columns.

Exposed foundation
