UC Santa Cruz building seismic ratings

Merrill College Academic Building

CAAN #7189

DATE: 2019-06-30

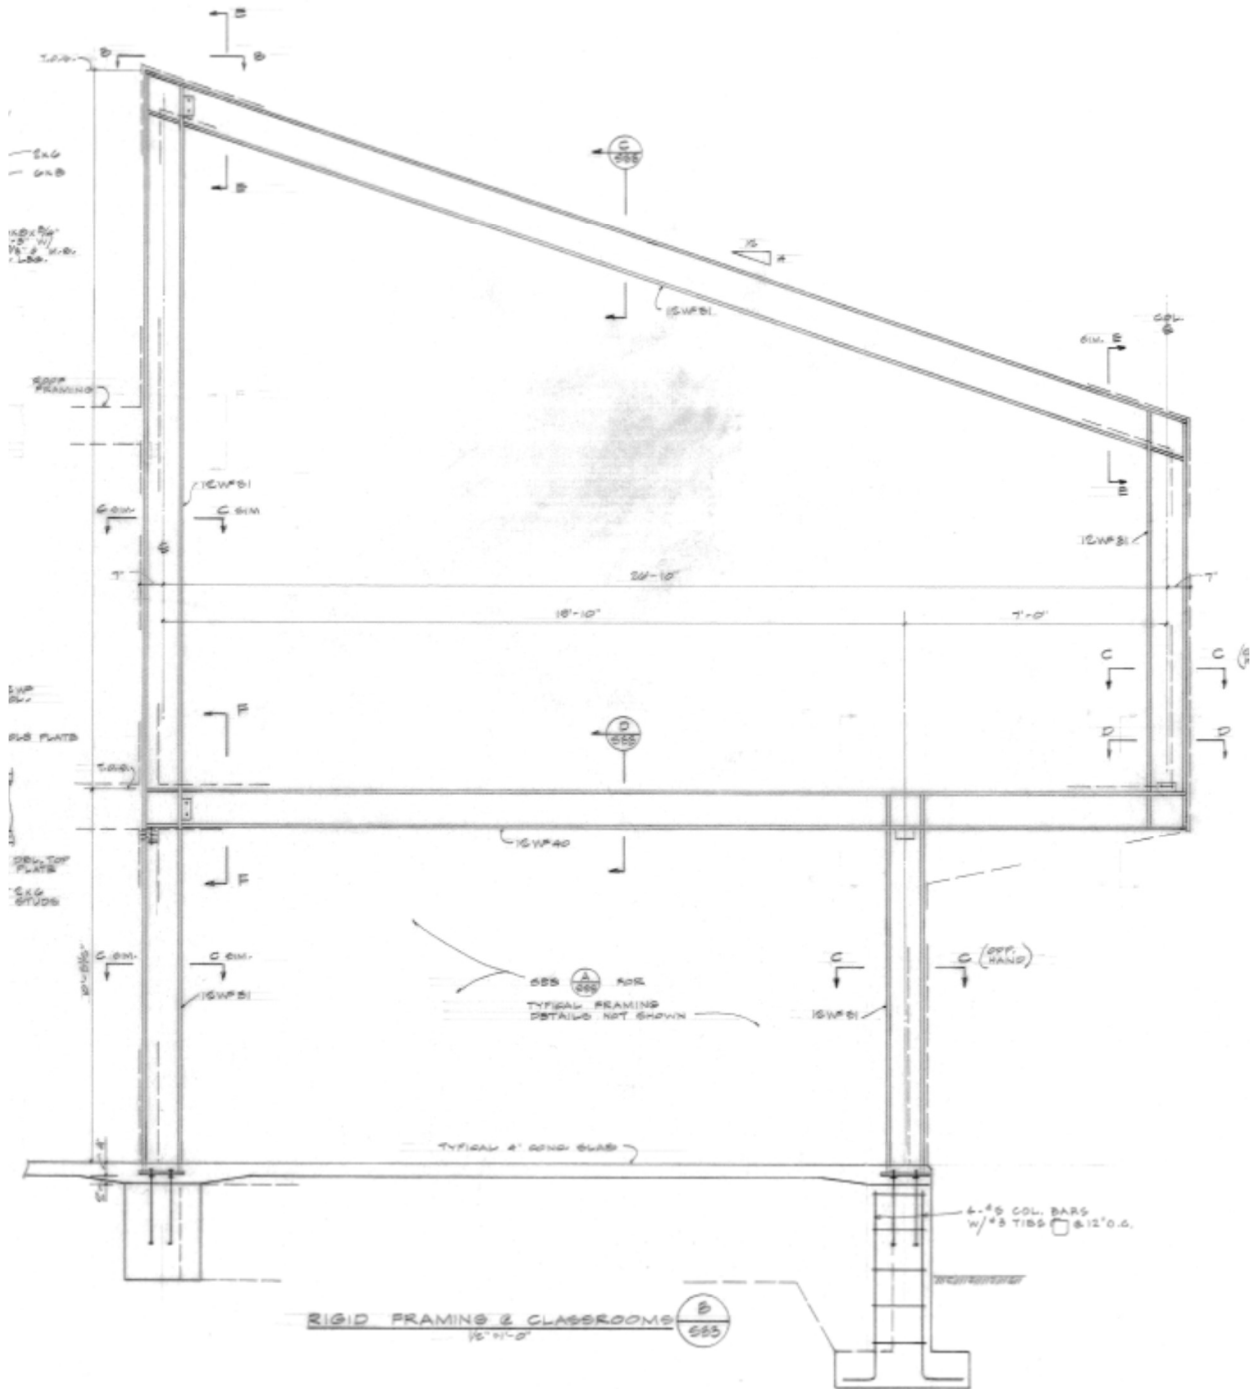
Steel moment frame

- The moment frame beam-column connections for the moment frame at the lecture halls are designed as full penetration welds, which was typical for pre-Northridge connection. The column panel zones do not have adequate shear capacity to develop the strength of the beams. Strong column-weak beam requirements are not satisfied at Level 2. The location of one of the columns offsets at Level 2, such that the column from Level 2 to roof is supported on a cantilevered beam. Although this moment frame is noncompliant per the Tier 1 checks, we judge that the moment frame is backed-up by the wood walls which would prevent excessive drift.

Despite the rating of IV, if the University has plans to modify the building, we recommend a Tier 2 evaluation to consider whether a) diaphragm chords and/or perimeter wall piers should be strengthened and b) the steel moment frame connections should be improved.

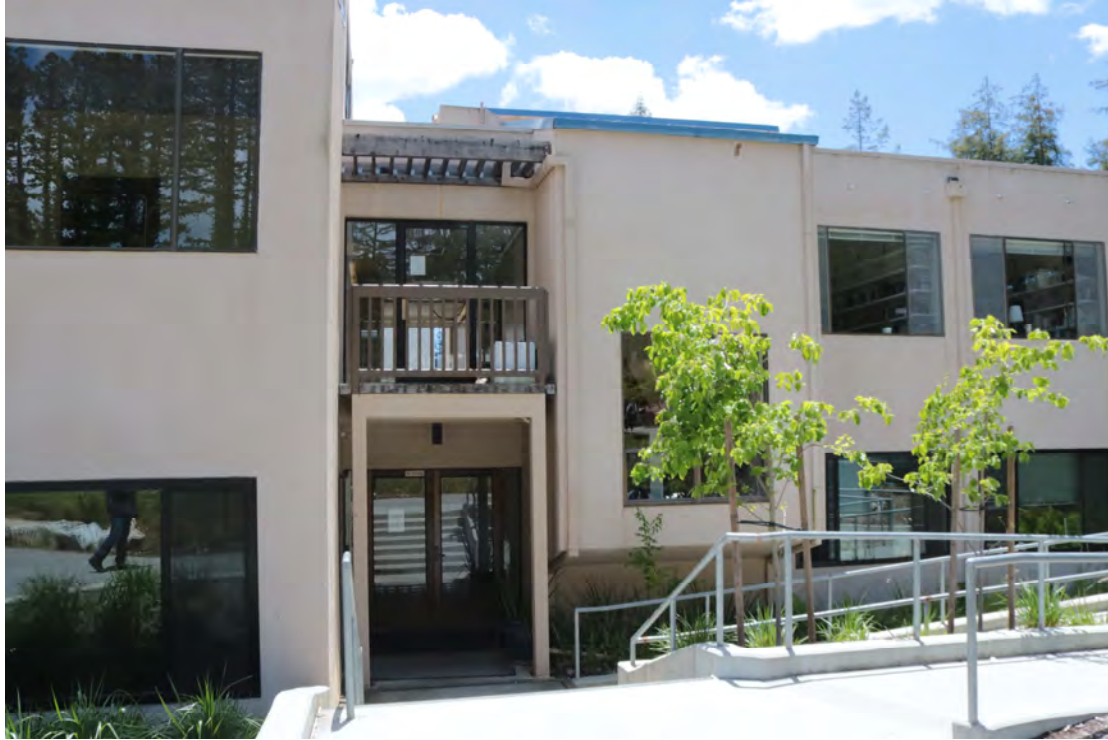
- Floor levels of the two wings of the building have different elevations. Earthquake damage may occur at the stairway that links the two wings of the building.

Junction between north and south wings, looking south-west
