UC Santa Cruz building seismic ratings
Hahn Art Facility, University of California Santa Cruz

CAAN #7199

DATE: 2018-12-31

Rating summary	Entry	Notes
UC Seismic Performance Level (rating)	V (Poor)	
Rating basis	Tier 1	ASCE 41-17 ¹
Date of rating basis	2018	
Recommended list assignment (UC Santa Cruz category for retrofit)	Priority B	Priority A=Retrofit ASAP Priority B=Retrofit at next permit application
Ballpark total construction cost to retrofit to IV rating ²	Medium (\$50 - \$200/sf)	See recommendations on further evaluation and retrofit.
Is 2018-2019 rating required by UCOP?	Yes	No previous rating reported
Further evaluation recommended?	Tier 2

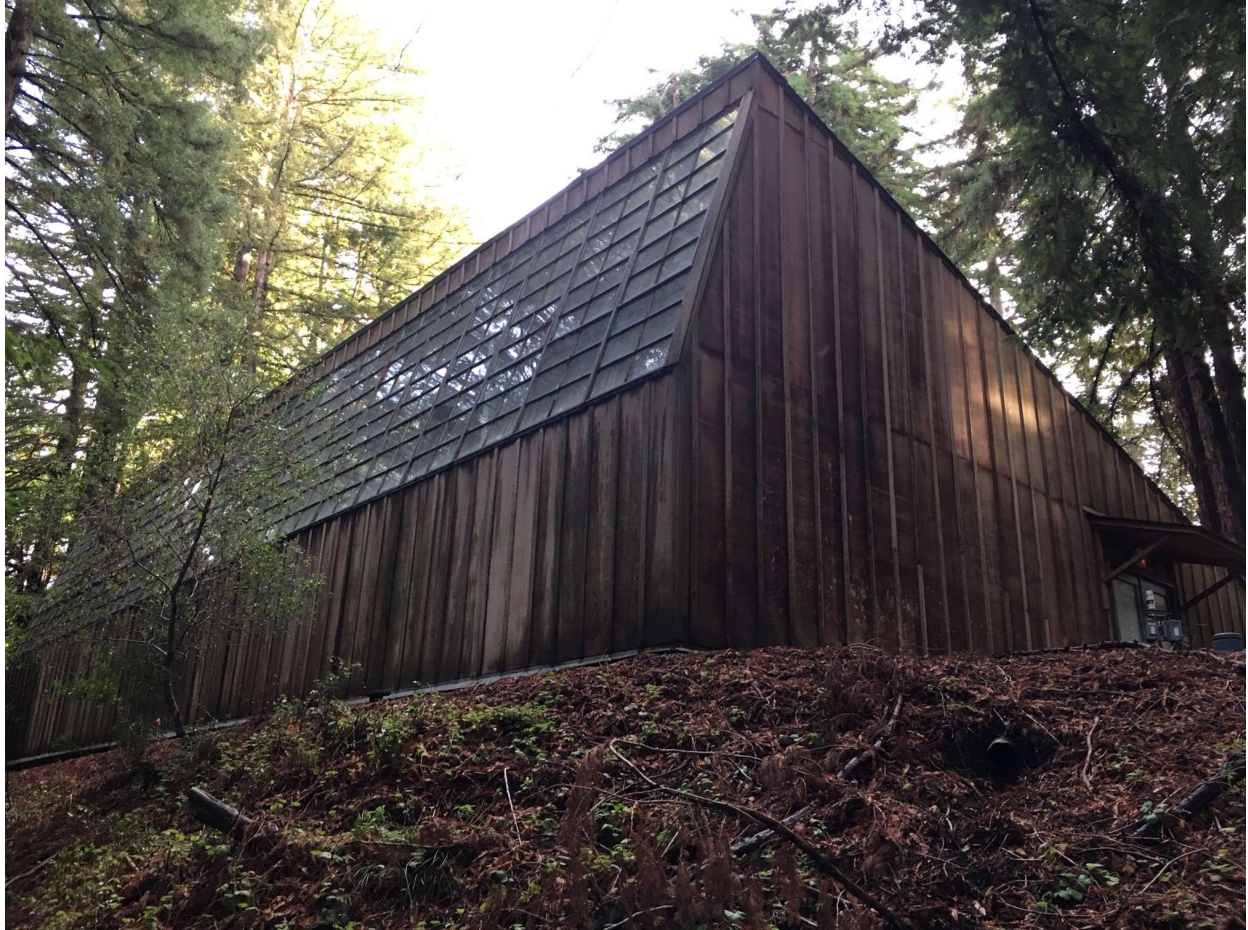
Figure: North elevation

The window at the north side of the building is approximately 12' tall x 80' long, and is located in elevation at the top of the north wall. Because the window slopes inward such that it is directly overhead the interior space, it appears that falling glass could pose a safety hazard in an earthquake, if the window is subjected to in-plane story drift demands that exceed the in-plane deformation capacities of the glass and frame. The structural deficiencies listed above may result in increased story drift over that typically seen in a building of this size, and thus may result in increased risk of window breakage.
