**UC Santa Cruz building seismic ratings**  
**Mt. Hamilton Garage – Res #7**

CAAN #7231

7281 Mt. Hamilton Road, Santa Cruz, CA 95140

Rating summary	Entry	Notes
UC Seismic Performance Level (rating)	V (Poor)	
Rating basis	Level 1	FEMA P-154 <sup>1</sup>
Date of rating	2019	
Recommended UC Santa Cruz priority category for retrofit	B	Priority A=Retrofit ASAP Priority B=Retrofit at next permit application
Ballpark total construction cost to retrofit to IV rating <sup>2</sup>	Very High	Location is remote. Building is very small.
Is 2018-2019 rating required by UCOP?	Yes	Building was not previously rated
Further evaluation recommended?	No

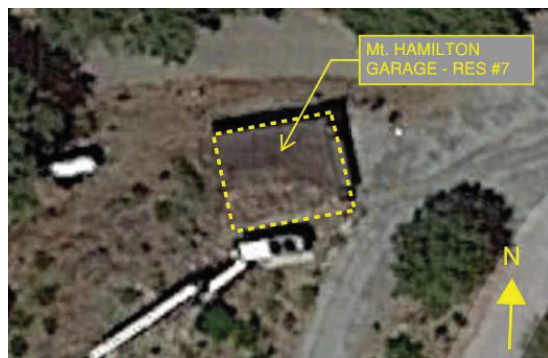
Plan

The structure utilizes the exterior sheathed walls as the primary lateral force-resisting system. A large garage door opening located on one exterior wall creates a "C"-shaped lateral system. As such, the building is torsionally irregular.

- The Mt. Hamilton Garage is torsionally irregular. It contains solid exterior walls on three sides; however, a large door opening is located one elevation which creates a "C"-shaped lateral force-resisting system. The deficiency is not considered significant because of the small size of the building and the relatively solid wall at the rear of the structure.

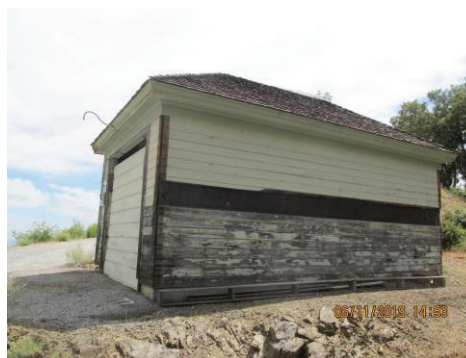
North Elevation (Looking Southwest)

The roof diaphragm is comprised of wood shingles over straight wood sheathing. The walls are horizontal wood siding over building paper and diagonal sheathing with let-in braces on the inside. The shingles, siding, and paper are significantly warped and deteriorated; nails are rusted. If continued occupancy is required, this structure may be a candidate for demolition, or removal and replacement of the existing roof, wall finishes, and sheathing down to the rafter and studs could be performed.

A Seismic Performance Level rating of V is assigned to this structure due to the significant level of deterioration of the roof diaphragm, wall sheathing and nailing. Had it been in better condition, it would have received a rating of IV. Although the building is likely torsionally irregular, the wall piers that remain adjacent to the door opening are deemed sufficient, and, given its compact geometry, the roof diaphragm likely would have contained sufficient capacity to distribute the rotational forces to the remaining walls.

No further analysis is required.

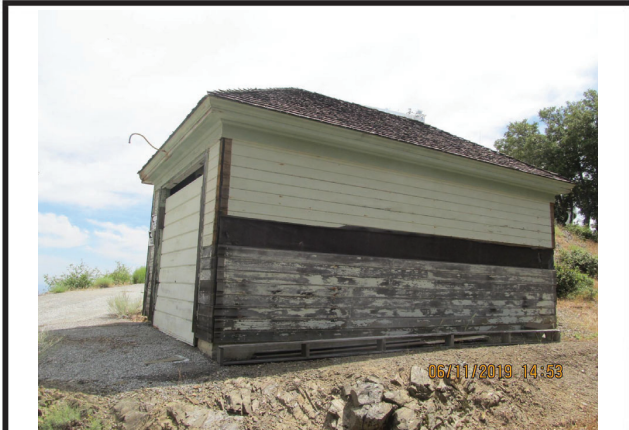
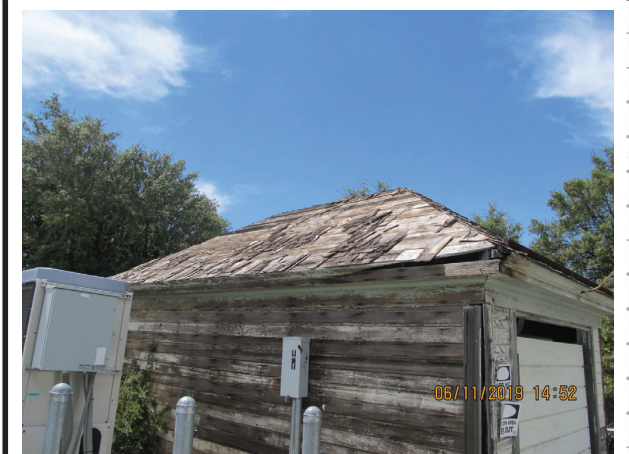
**Irregularities:**  Vertical (type/severity)  
 Plan (type) Torsion ("C"-shaped lateral system)

1. Roof diaphragm is wood shingles over straight sheathing. Walls are horizontal wood siding over building paper over diagonal sheathing with let-in braces on inside. Shingles, siding, and paper are significantly warped and deteriorated; nails are rusted. Garage door is boarded shut, and building is abandoned.
