DATE: 2019-06-28

UC Santa Cruz Building Seismic Ratings

Mt Hamilton Laboratory and Measuring Building

CAAN #7279

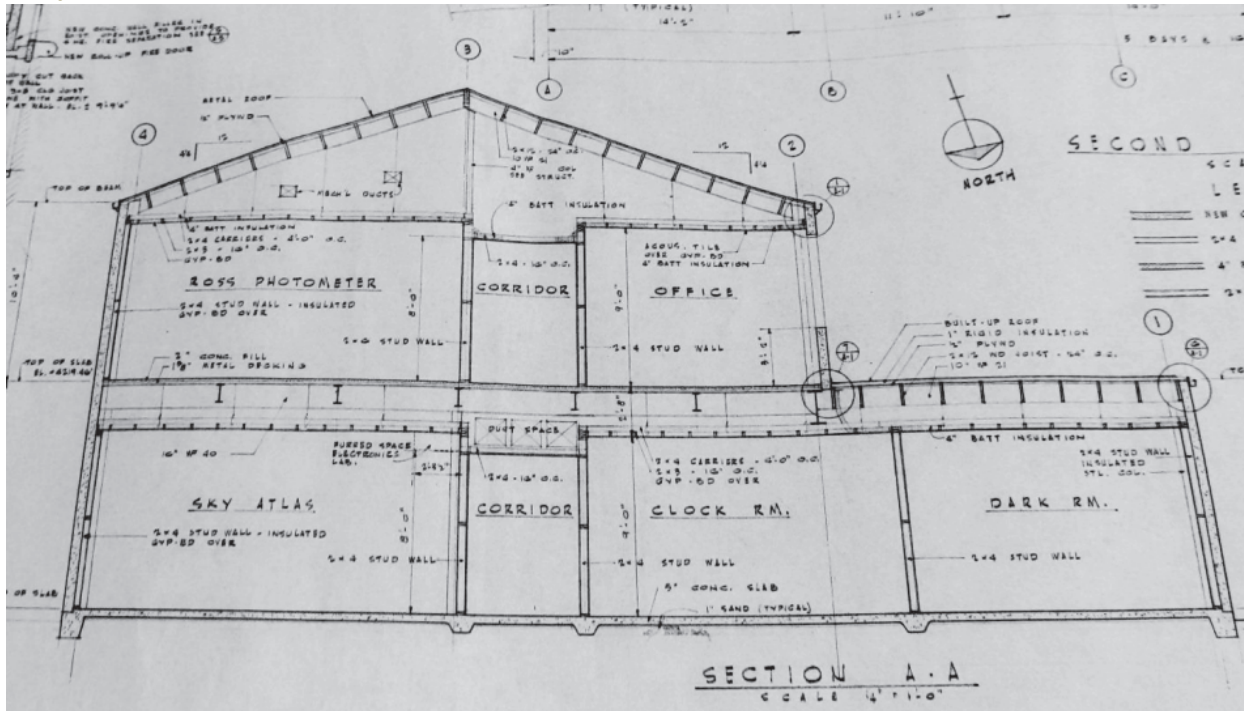
- Three tilt-up panels on the north side of the second floor (Line 2) are supported on steel framing without a clear load path for shear or overturning.
- The one-story lobby wing to the west side is tied to the two-story wing and to the adjacent Main Building (#7240) without a gap. Lateral support for this wing in the north-south direction appears to be a “new wall” in the adjacent building, but we do not find details for this condition in the available drawings for Building 7240. This roof area could separate from the adjacent structure.
- Heavy mechanical equipment, tanks, and concrete housekeeping pads are located at the second floor and appeared to be anchored but not to current standards. It is not known if all the gas lines have flexible connections.

Architectural Section A-A/A-2 (Tilt-Up Panels at Line 2 Supported on Steel Framing. Plywood Roofs Above Second Floor and at Low Roof at Right, Metal Deck with Fill at Second Floor on Left)

Recommend further field investigation and evaluation to clearly identify load path and capacity of connections between diaphragms and walls, and walls to foundations. Identify in-plane and out-of-plane capacity of supports for tilt-up walls, including second story wall panels supported outboard of steel framing at the second floor.

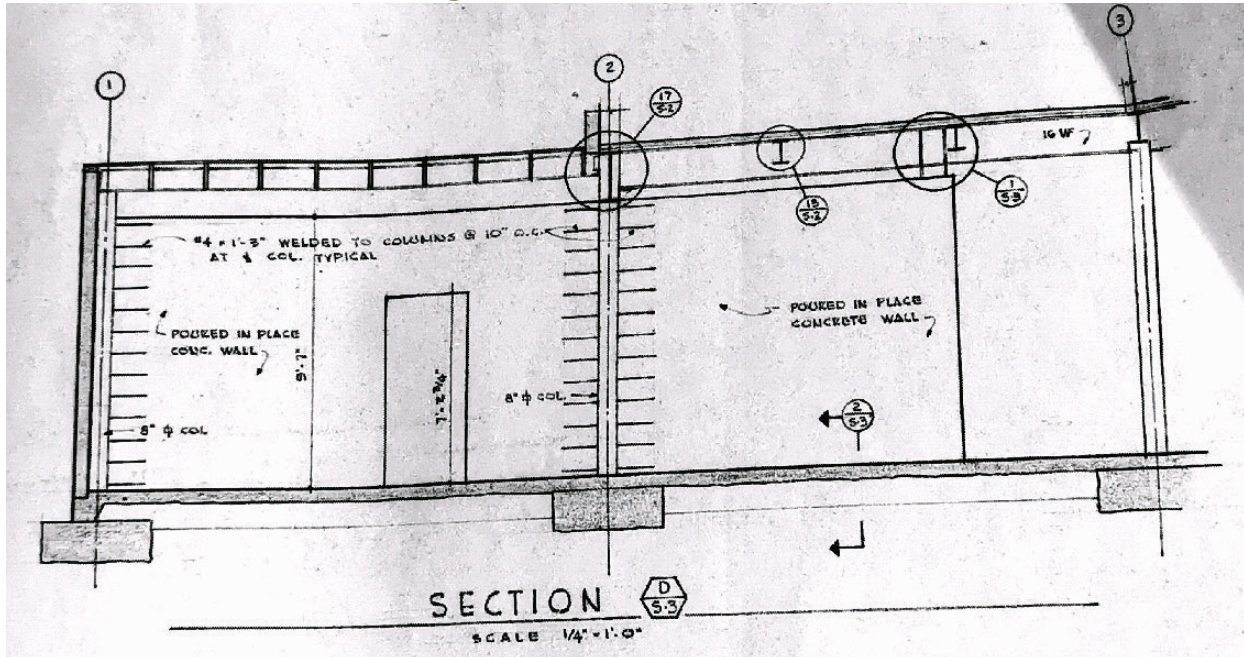
Structural Elevation at Partial Height N-S CIP Concrete Wall at Line D on Slab-On-Grade

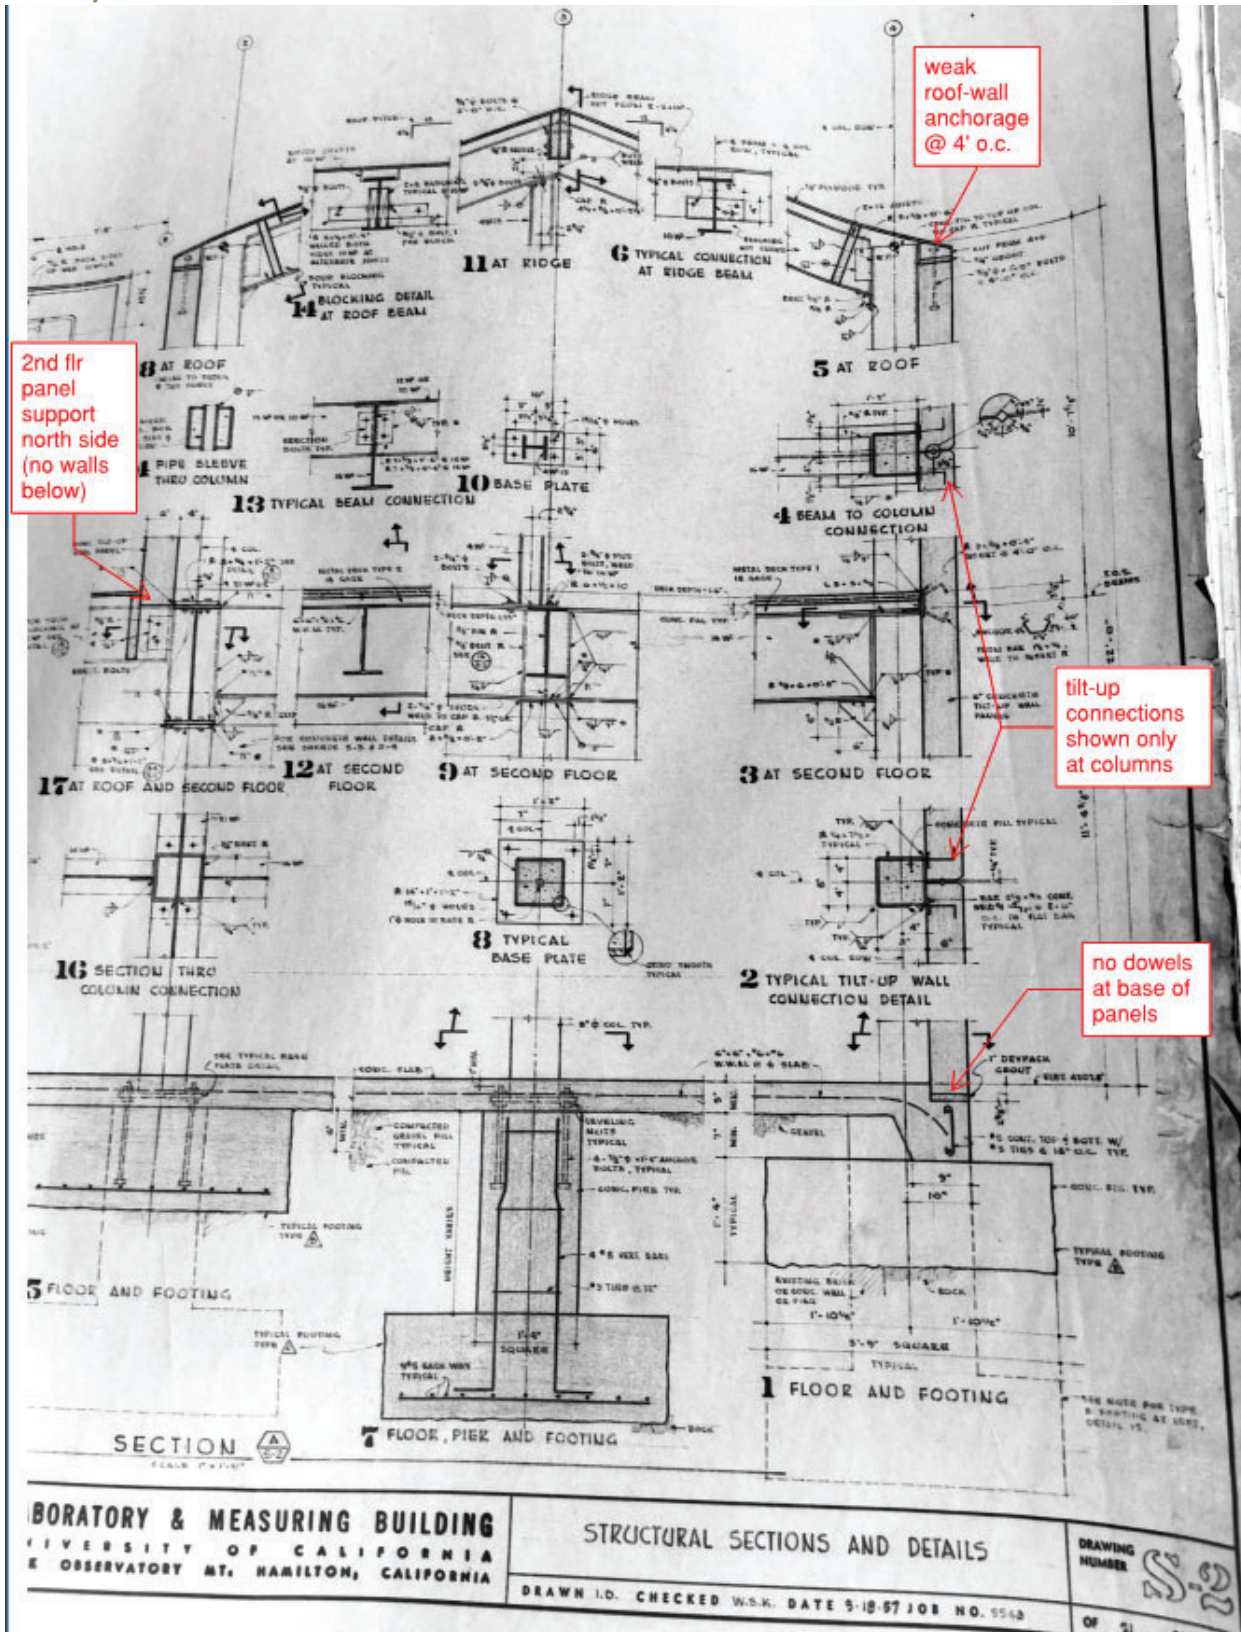
- Connections from the steel framing to the walls have limited capacity. The tilt-up panels appear to be connected for both in-plane and out-of-plane loading only by way of welded embeds at the steel columns; we do not find details for the ledger connections to the walls. There are limited positive connections at the steel columns shown in the original drawings from the tilt-up panels to the foundations.

Structural Section A/S-2 with Details (Weak In-Plane and Out-of-Plane Anchorage of Tilt-Up Panels)

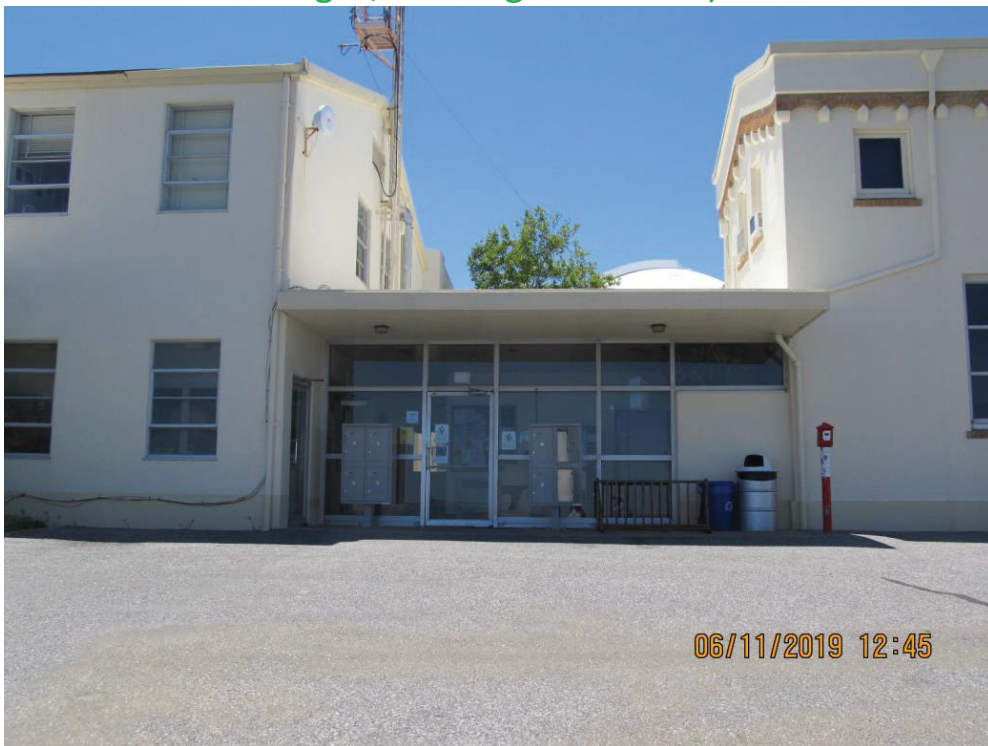
North Elevation of Canopy (Two-story Portion at Left, Canopy at Center, CAAN 7240 Provides Support at Right, Looking South)

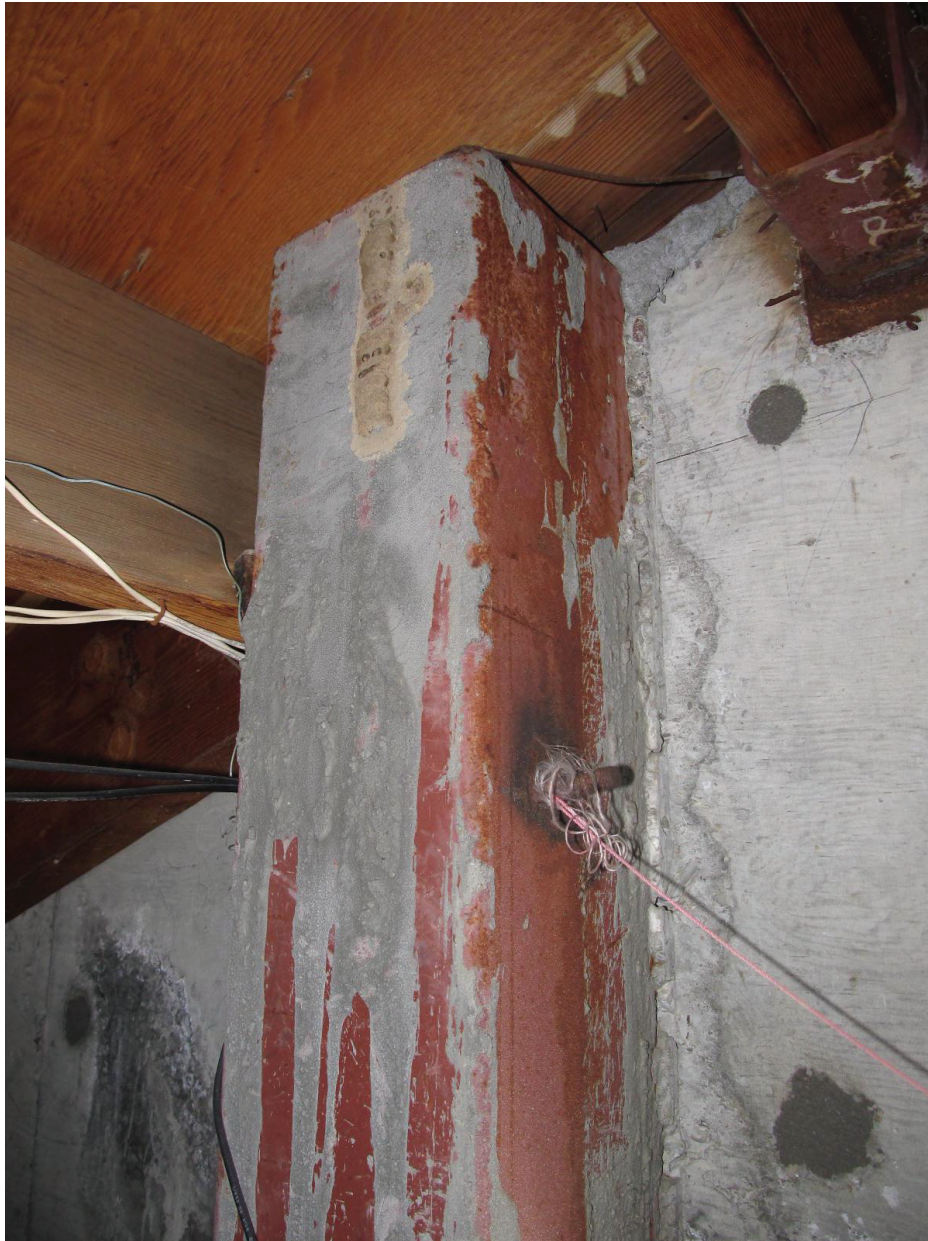
Building condition: The building shows signs of exterior weathering and interior wear that are typical for buildings of this vintage. Some minor concrete cracking was observed at an exposed column in the attic space.

Steel Column Filled with Concrete Attached to Tilt-up Panel in the Attic

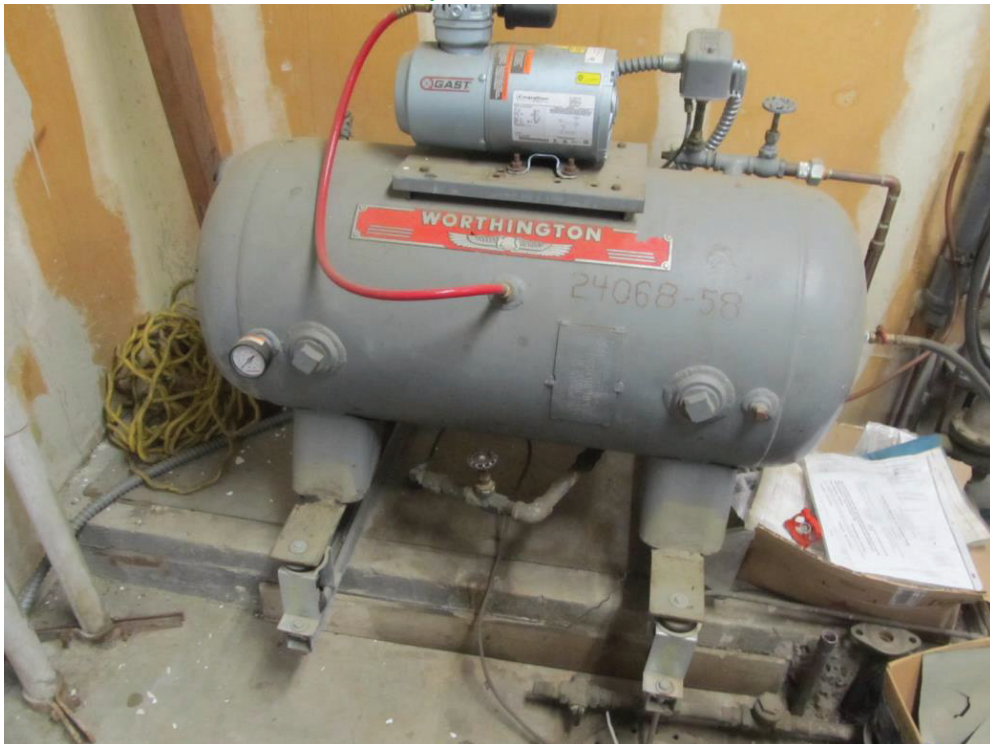
Poorly anchored mechanical equipment is located at the second floor.

Poorly Anchored Tank at Mechanical Room
