UC Santa Cruz building seismic ratings

Theater Arts B Drama Building

CAAN #7312

DATE: 2019-06-30

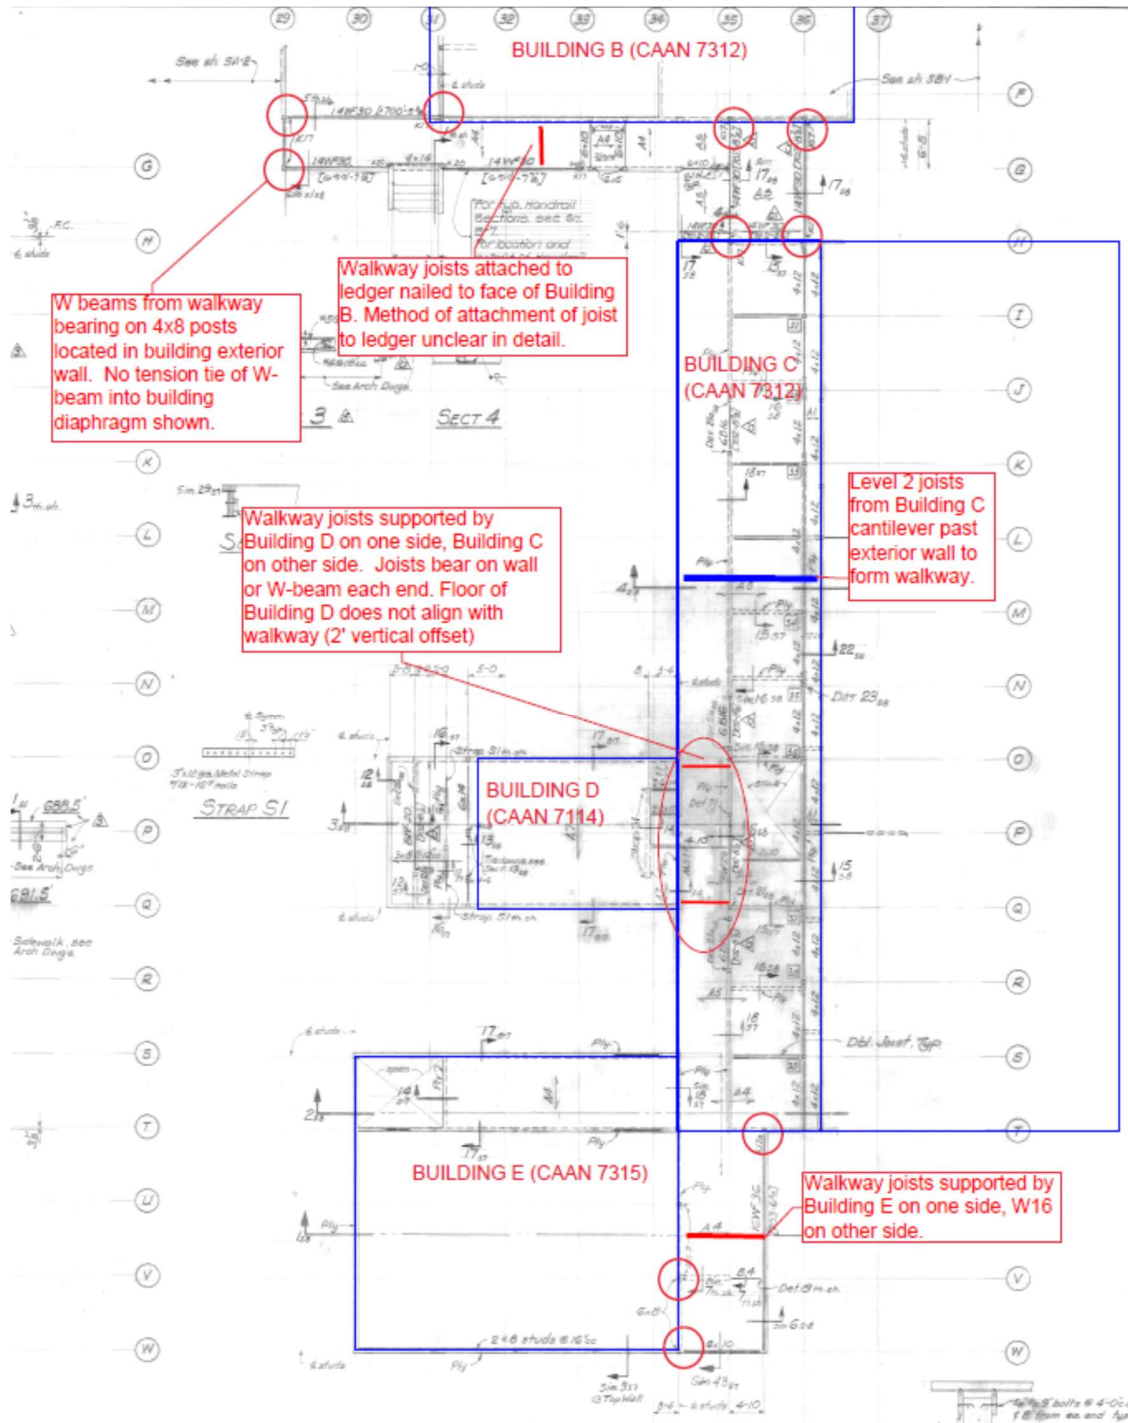
Plan at walkway:

- The Level 2 exterior walkway connects five buildings – CAAN 7311, 7312, 7313, 7314, and 7315. There are no seismic separations in the walkway between buildings, and differential movement between the buildings could cause damage in the walkway. At this building, the walkway joists are connected to a ledger that is face-nailed to the face of the east exterior wall. The connection of the walkway joists to the ledger are not shown on the drawings. If the walkway joists are not adequately tied into the building, the walkway joists could lose their support if the building moves west, away from the walkway.

- Locations where walkway W-beams are supported on posts located within building exterior walls shown:

- Locations where walkway joists are attached to ledger nailed to face of building exterior wall shown:

We recommend that the Campus perform a more detailed review of the adequacy of the plywood sheathed walls for both shear capacity and for floor-to-wall hold-down connections. The campus should also check the condition of the exterior walkway and consider providing separation joints in the walkway between buildings. An evaluation of the adjacent elevator structure should be done. We put the building on Priority Category A, because the walkway modifications should be done as soon as possible.

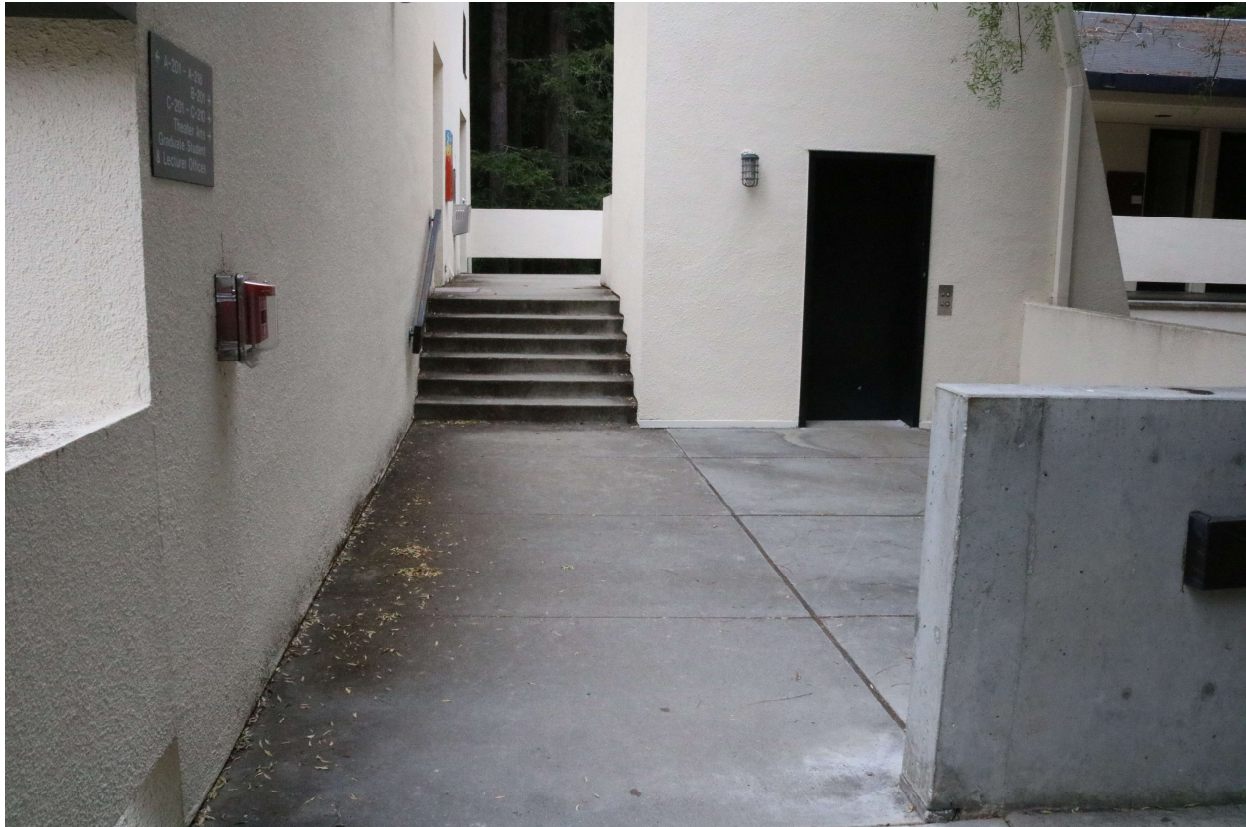
- An elevator structure is located on the east side of this building and appears to be connected to this building by the Level 2 walkway. No drawings were available for the elevator structure. This structure should be evaluated.

Walkway at east side of building (building to the left, elevator structure to the right)

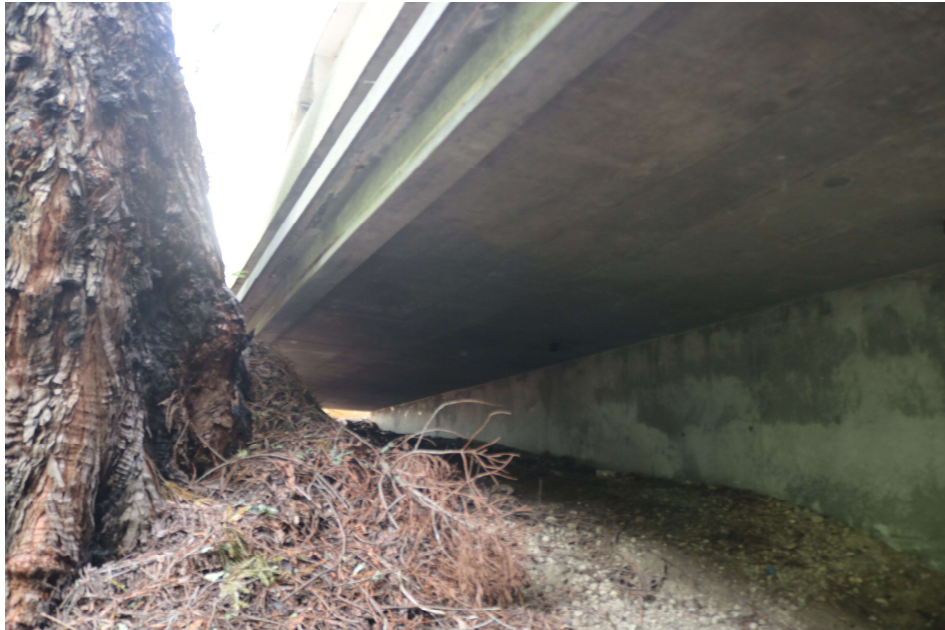
North side of building, looking east. Foundation wall below Level 1 and cantilever slab at Level 1

<input type="radio"/> C <input checked="" type="radio"/> NC <input type="radio"/> N/A <input type="radio"/> U <input type="radio"/> <input type="radio"/> <input type="radio"/> <input type="radio"/>	<p>VERTICAL IRREGULARITIES: All vertical elements in the seismic-force-resisting system are continuous to the foundation. (Commentary: Sec. A.2.2.4. Tier 2: Sec. 5.4.2.3)</p> <p>Comments: Wall at north side of building bears on cantilevered concrete slab at Level 1 instead of bearing on grade beams.</p>

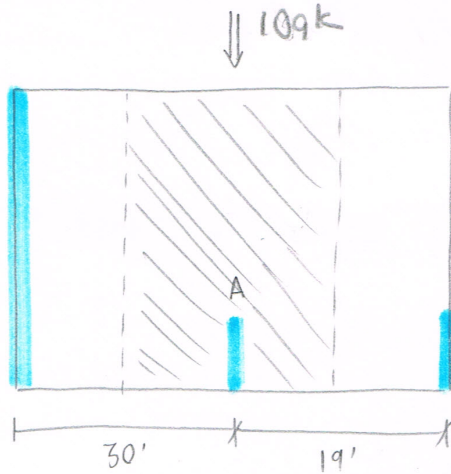
ROOF

USING FLEX DIAPHRAGM ASSUMPTION, CALCULATE LOAD TO WALL A:

$$\text{DISTRIBUTED LOAD } w = \frac{109k}{49'} = 2.2 \text{ klf}$$

$$\text{TRIBUTARY LENGTH OF WALL A } L_T = \frac{30'}{2} + \frac{19'}{2} = 24.5'$$

$$F_{WALL,A,R} = w \times L_T = (2.2 \text{ klf})(24.5') = \underline{\underline{54.5 k}}$$

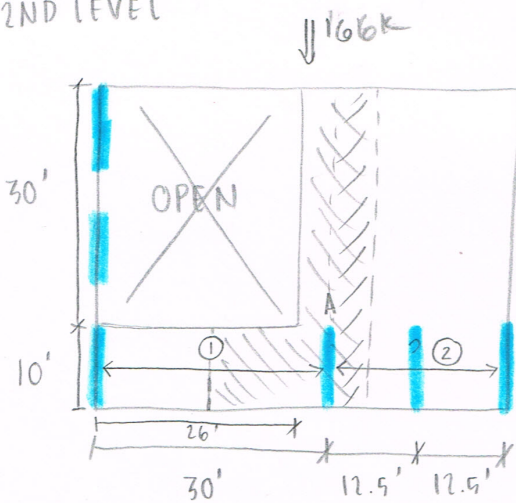
2ND LEVEL

USING FLEX DIAPHRAGM ASSUMPTION, CALCULATE LOAD TO WALL A:

DISTRIBUTED LOAD OVER REGION 1 w_1

$$= \frac{166k}{(2^{\text{ND}} \text{ FLOOR AREA})} \times 10'$$

$$= \frac{166k}{(55' \times 40' - 26' \times 30')} \times 10'$$

$$= \frac{166k}{1424 \text{ ft}^2} \times 10' = 1.2 \text{ klf}$$

DISTRIBUTED LOAD OVER REGION 2 w_2

$$= \frac{166k}{1424 \text{ ft}^2} \times 40' = 4.6 \text{ klf}$$

$$\text{TRIBUTARY LENGTH OF WALL A ON SIDE 1 } L_{T,1} = (30'/2) = 15'$$

$$\text{TRIBUTARY LENGTH OF WALL A ON SIDE 2 } L_{T,2} = (12.5'/2) = 6.25'$$

$$F_{WALL,A,L} = w_1(L_{T,1}) + w_2(L_{T,2})$$

$$= (1.2 \text{ klf})(15') + (4.6 \text{ klf})(6.25')$$

NG
