UC Santa Cruz building seismic ratings

Theater Arts C Studio Building

CAAN #7313

DATE: 2019-06-30

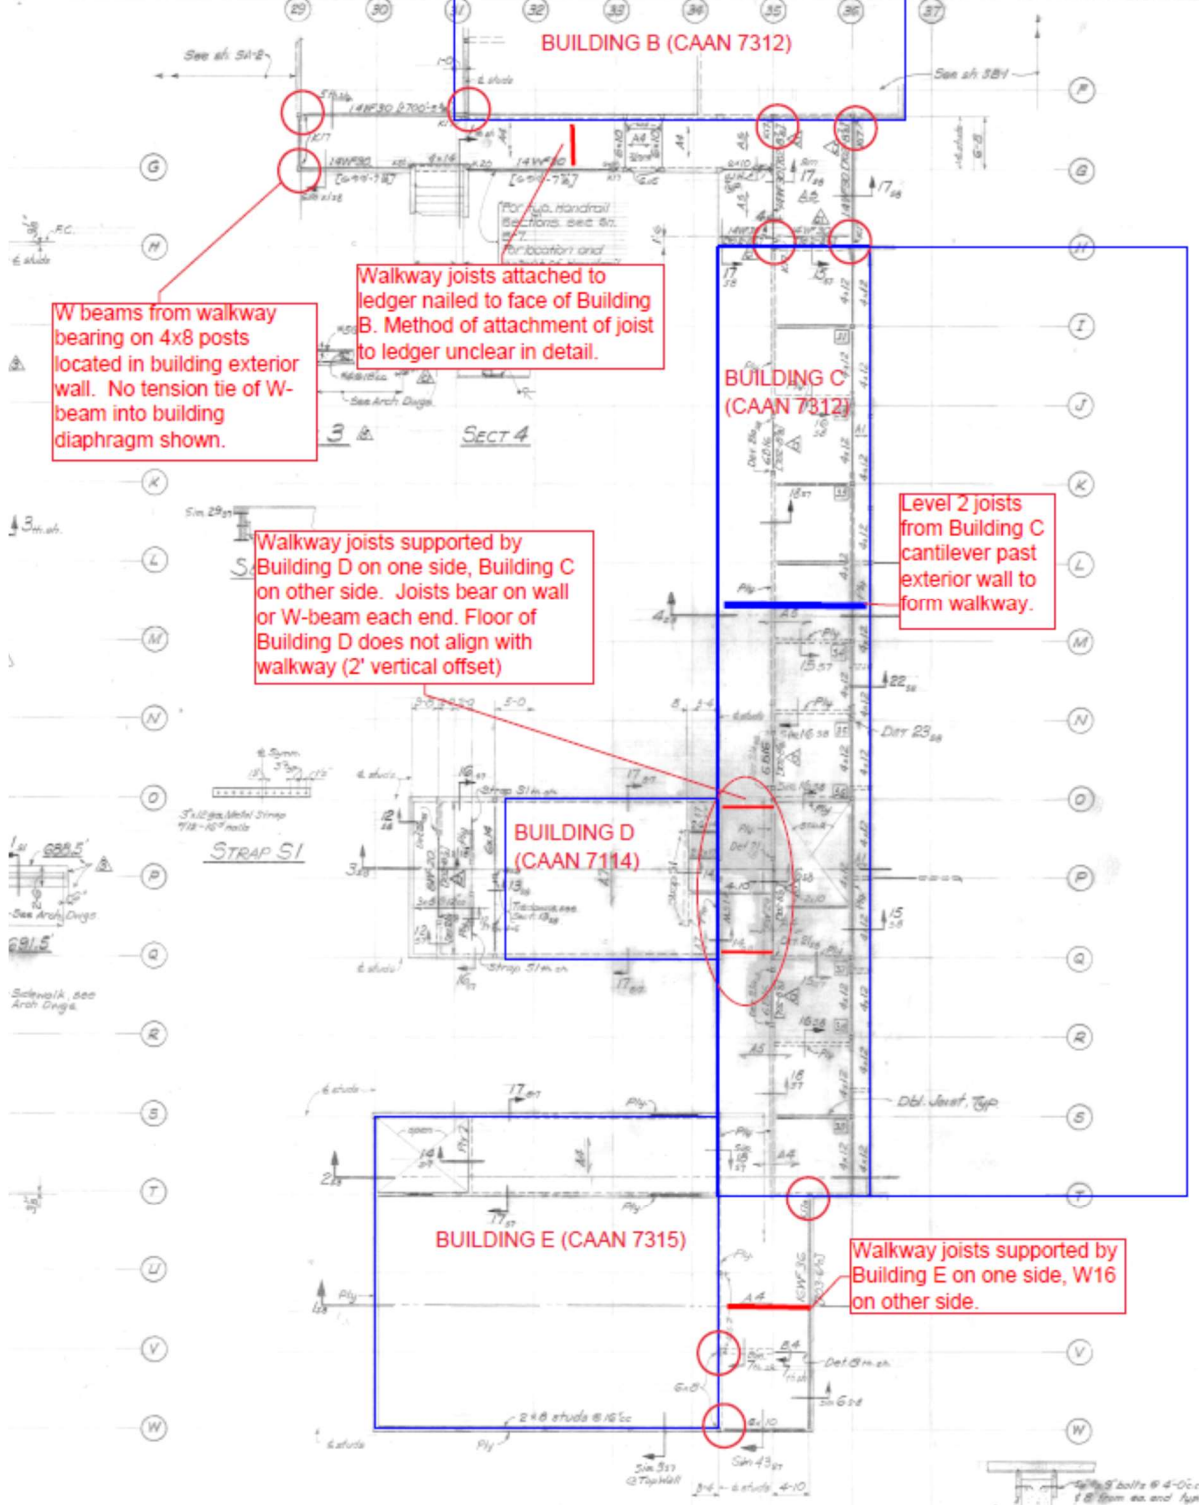
Plan at walkway:

- The Level 2 exterior walkway connects five buildings – CAAN 7311, 7312, 7313, 7314, and 7315. There are no seismic separations in the walkway between buildings, and differential movement between the buildings could cause damage in the walkway.

- At the stair between gridlines O and Q, the walkway joists are supported on a ledger nailed to the face of the south exterior wall of this building at one end of the joist, and to the face of the north exterior wall of Building D (CAAN 7314) at the other end of the joist. Differential movement between the buildings could cause the walkway joists to lose their support.

- Locations where walkway W-beams are supported on posts located within building exterior walls shown: ○
- Locations where walkway joists are attached to ledger nailed to face of building exterior wall shown:

We recommend that the Campus perform a more detailed review of the adequacy of the short walls for both capacity and for floor-to-wall hold-down connections, and of the high and low roof diaphragms. The drawings are not clear, but possibly Building D (CAAN 7313) roof shares a common wood shear wall with this building. This should be investigated further in a Tier 2 analysis. The campus should also check the condition of the exterior walkway and consider providing separation joints in the walkway between buildings. We put the building on Priority Category A, because the walkway modifications should be done as soon as possible.
