UC Santa Cruz building seismic ratings

Kerr Hall

CAAN #7376
500 Kerr Road, Santa Cruz, CA 95064
UCSC Campus: Main Campus

DATE: 2019-07-15

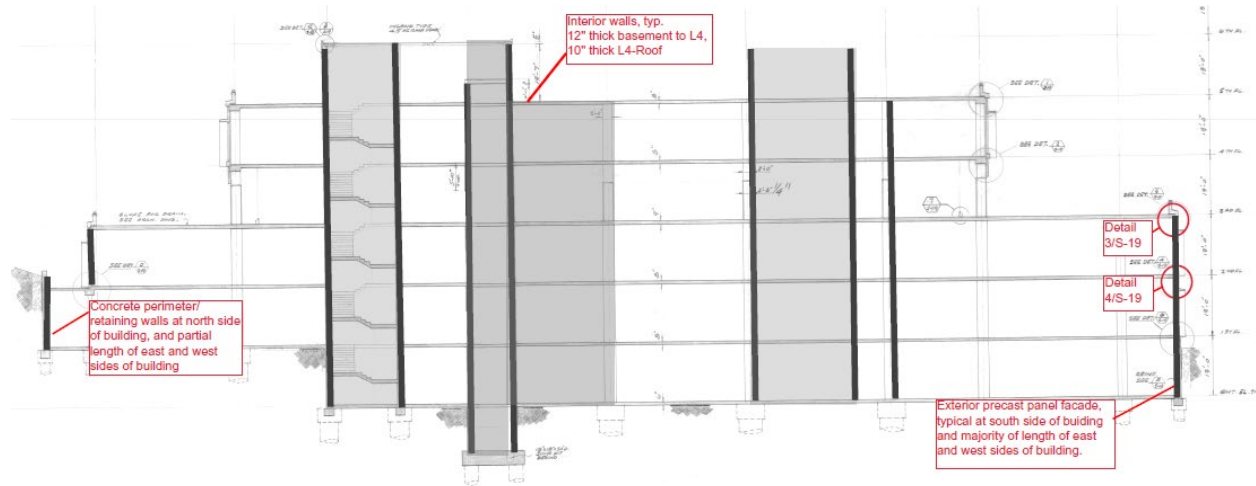
Annotated building section (looking east)

- Walls in north-south direction are overstressed at Level 2, where the floor plate size increases compared to floors above, but wall length is not increased proportionally.

- Walls at stair core are relatively tall and narrow ($L/h = 16'/65' = 0.25$) and overturning capacity may be insufficient. A minor concern is that at the base of the walls, caisson vertical reinforcement is not developed fully into the pile cap (20db provided versus 28db required by ACI 318-14).

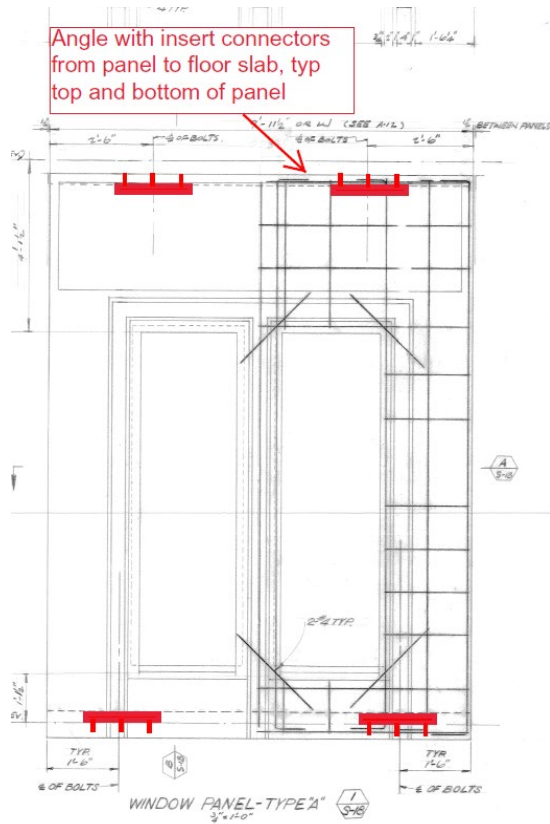
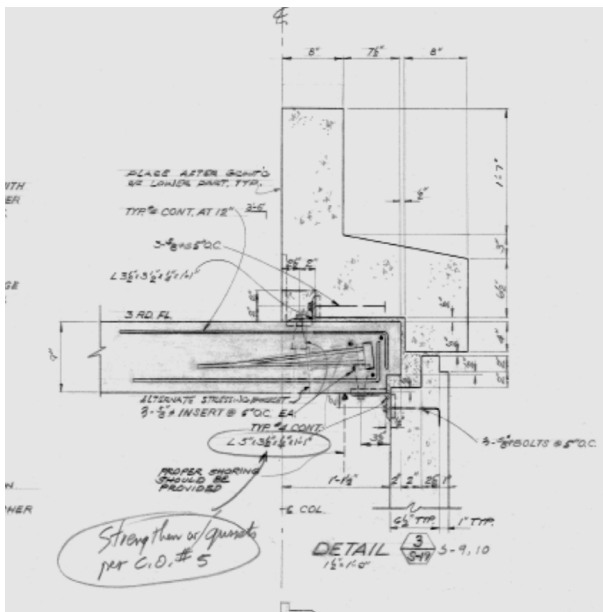
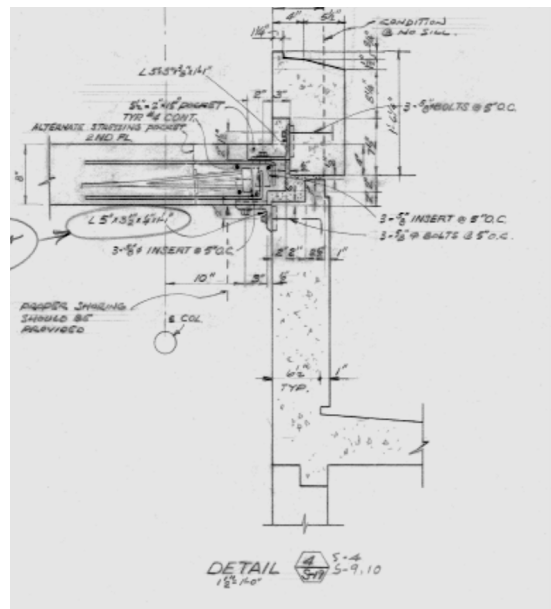
Typical precast panel elevation

- The exterior precast concrete panel facade is attached to the floor and roof slabs with nonductile shallow anchors. The panel connections do not appear to be detailed to accommodate story drift demands.

The building is rated VI (Very Poor) because of the potential life-safety hazard of the precast panel façade. This facade has nonductile attachments to the floor and roof slabs and may disconnect from the building under story drift demands. The entry canopy at the main entrance at Level 2 also may pound against the building façade and create damage to the façade at the entry way.

We recommend that the University perform a more detailed evaluation as a precursor to probable structural retrofit. A Tier 2 evaluation of the deficiencies would be an appropriate starting point.
