**UC Santa Cruz building seismic ratings**  
**Oakes College Residence A13-15**

CAAN #7408  
 220 Oakes Road, Santa Cruz, CA 95064  
 UCSC Campus: Main Campus

DATE: 2019-06-30

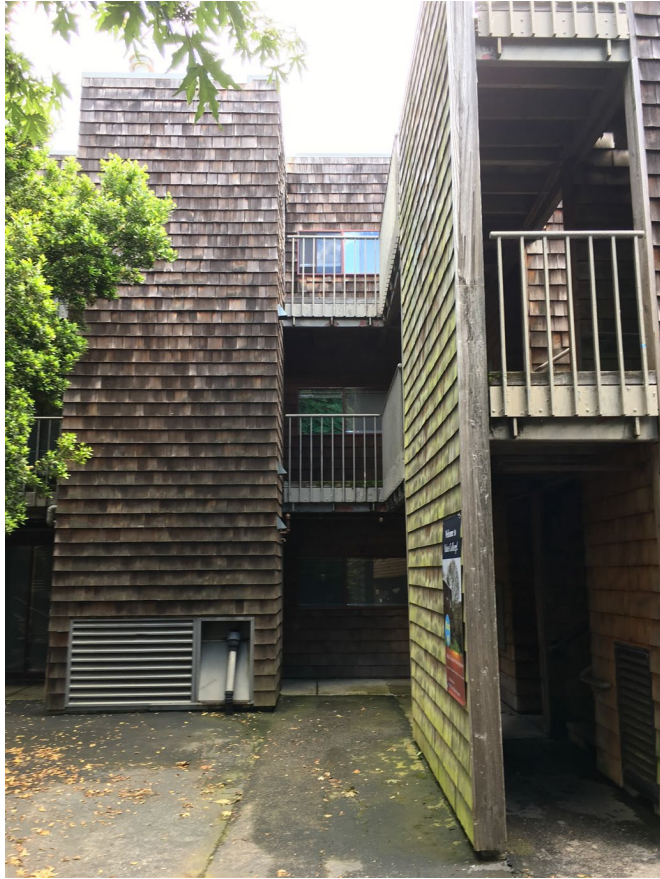
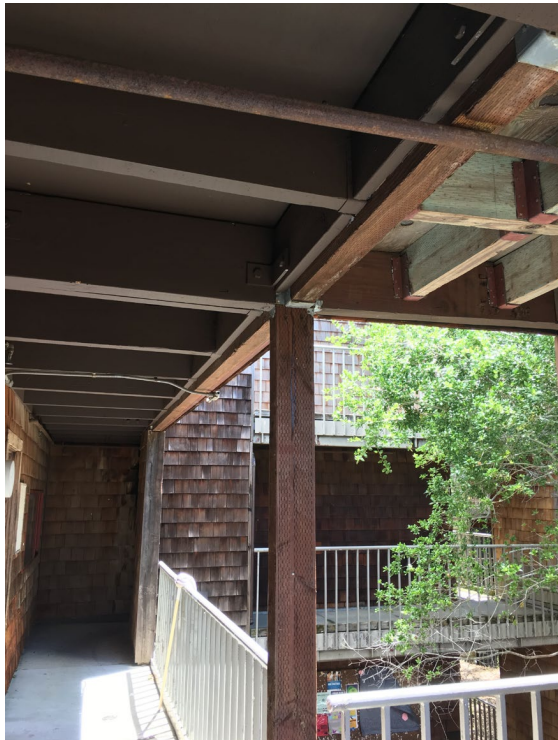
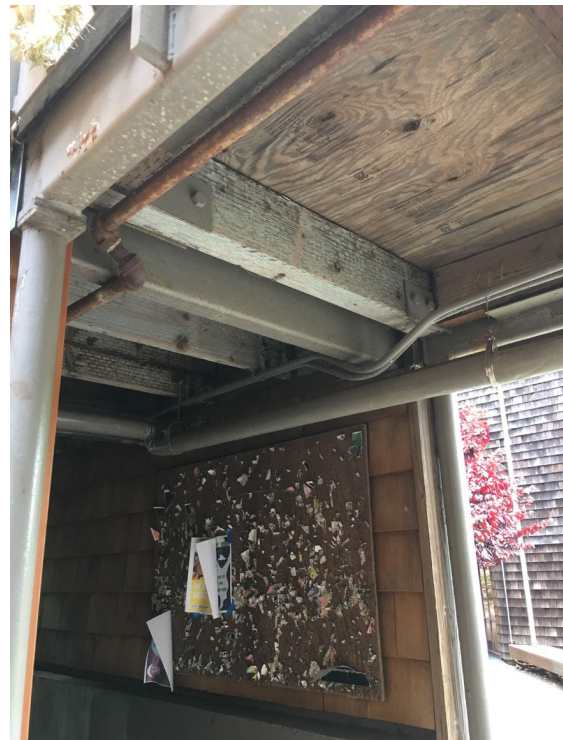
Photos of walkway and stairs

- The shear wall hold-downs do not have a shrinkage compensating device and additional deflections would be expected from slack connections.
- The shear wall aspect ratios do not meet the Tier 1 checklist requirements, but the stress check and structural detail of these walls appear adequate.
- The seismic gaps between the building units at the walkways are small and some pounding is expected in a seismic event.
- The stair connections do not have any deformation capability because of their rigid connection top and bottom. We expect that the walkway structure will experience damage/non-linear behavior in a seismic event because of this.

We observed no clear concerns. The stair connections at the exterior walkway is rigid at both ends and may present drift compatibility issues in a seismic event.

Although we rate the building as IV (Fair), we recommend that the Campus perform a more detailed review of stair connections, for both a condition assessment and adequacy of the connections for a seismic event. We put the building on Priority Category B, as the above items should be done if there are any plans for modifying the building.
