UC Santa Cruz building seismic ratings
Visual Arts Facilities-Building E

CAAN #7497

Elena Baskin Visual Arts, Santa Cruz, CA 95064

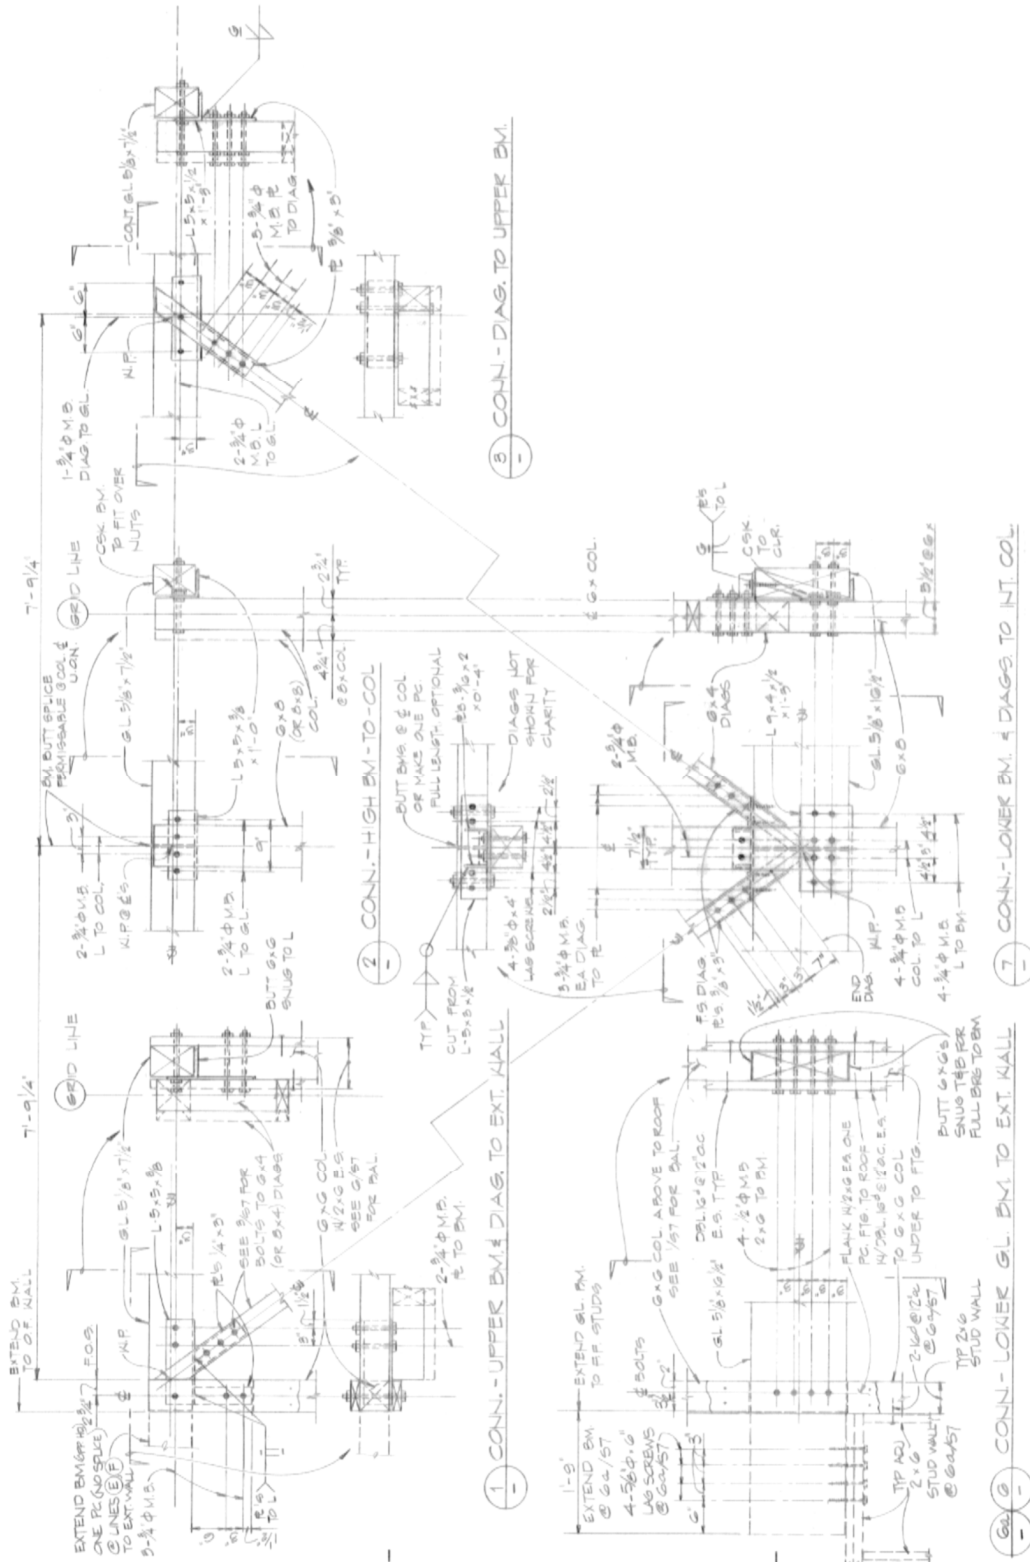
- The braced frames rely on a complicated set of force transfer details that include bolts in shear in the wood. These details have reduced end distances (4D rather than 7D) and limited ductility compared to a plywood shear wall that dissipates energy through nails in bending, and they are ultimately likely to lead to longitudinal splitting of the wood. This is an unusual structural system not covered by the wood frame Tier 1 checklists of ASCE 41-17. A Tier 2 deficiency-based analysis of the frames, their internal connections, and their connections to the shear walls is needed to understand better the capacity and performance of this lateral force-resisting system.

Connection Detail between Main Elements of the Wood Diagonal Braced Frames

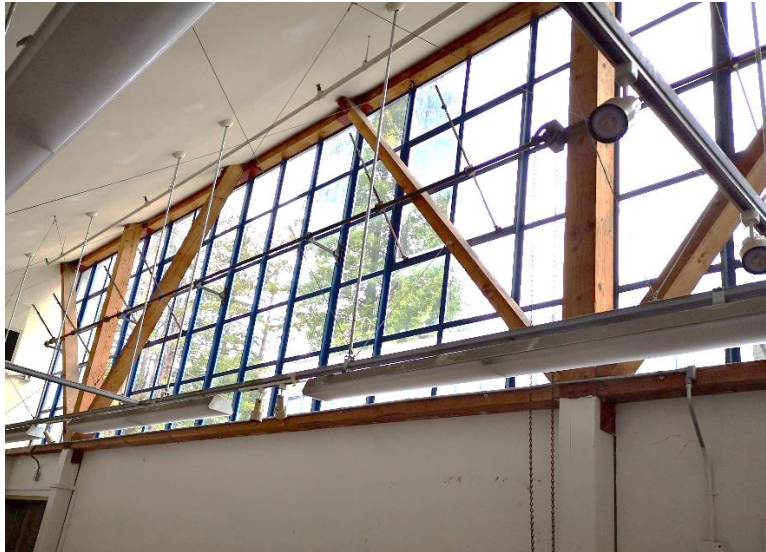
Wood Braced Frame at Exterior Wall

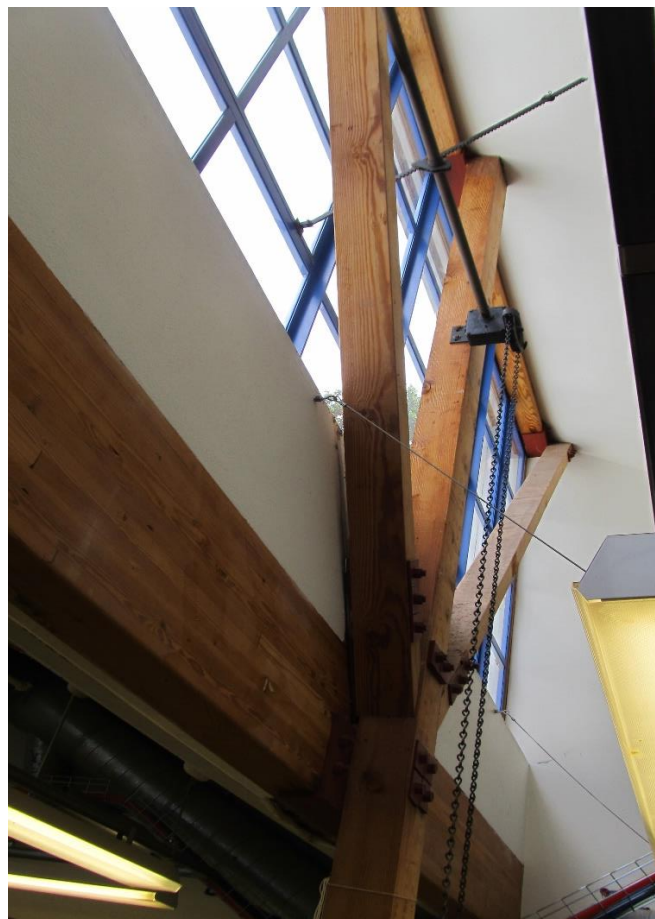
Interior Wood Braced Frame

We recommend that the campus perform a Tier 2 evaluation to review the lateral force-resisting capacity of the wood braced frame members, internal connections, and connections to the plywood shear wall. While ductility is low, it may be that there is sufficient capacity due to low demands. If the braced frames were found to be inadequate, connections could be strengthened or supplemental lateral resistance could be added, such as steel moment frames to help continue to preserve the clerestory light. Retrofits would also include positive anchorage at the canopy to perimeter stud walls to prevent cross-grain bending. We assign the building to Priority Category B, as the retrofit of the building should be done when there are any plans for renovation.

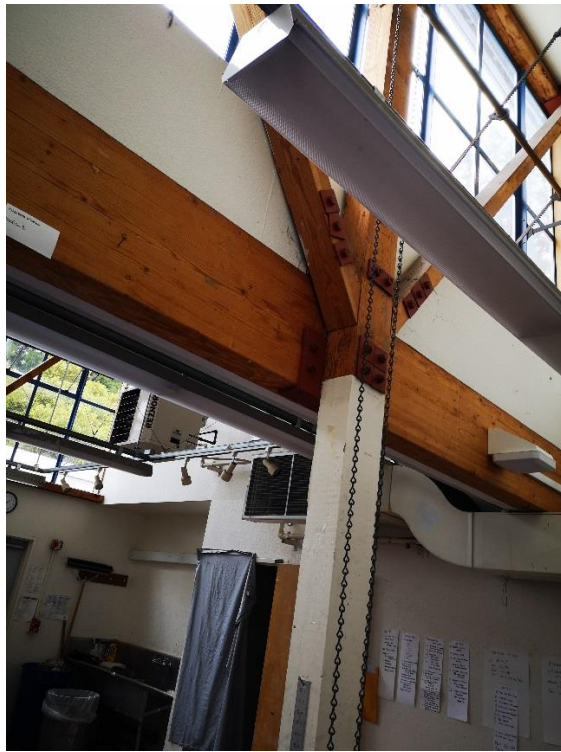
Close-up of Brace-to-Column Details (Detail C/S6)

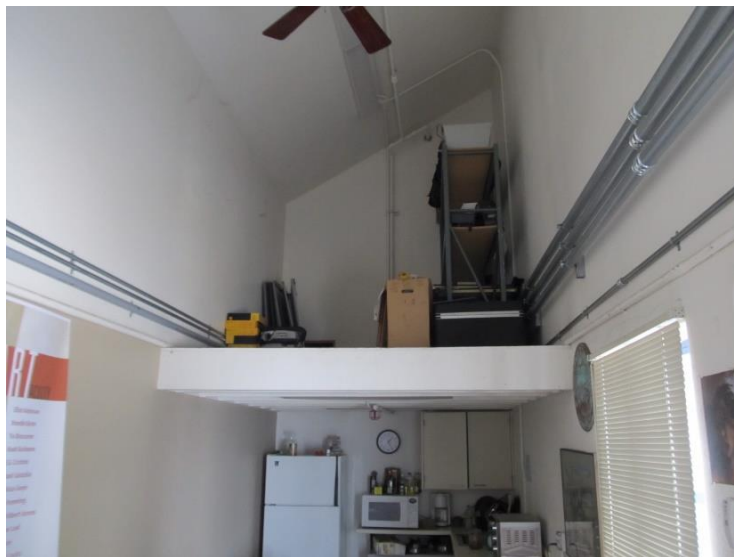
Small light storage mezzanines inside office spaces were observed during the brief site visit performed on 16 May 2019. Items stored on the mezzanines are considered as falling hazard during an earthquake event. Lockers in the corridor should be properly braced to avoid tipping over.

Storage Mezzanine in Room E110

C NC N/A U <input type="radio"/> <input checked="" type="radio"/> <input type="radio"/> <input type="radio"/>	<p>MEZZANINES: Interior mezzanine levels are braced independently from the main structure or are anchored to the seismic-force-resisting elements of the main structure. (Commentary: Sec. A.2.1.3. Tier 2: Sec. 5.4.1.3)</p> <p>Comments: There are some light storage mezzanines that are not seismically braced.</p>
