Rating form
completed by:**RUTHERFORD + CHEKENE**
ruthchek.com

DATE: 2019-06-28

UC Santa Cruz Building Seismic Ratings
P.E. Fitness Center

CAAN #7726

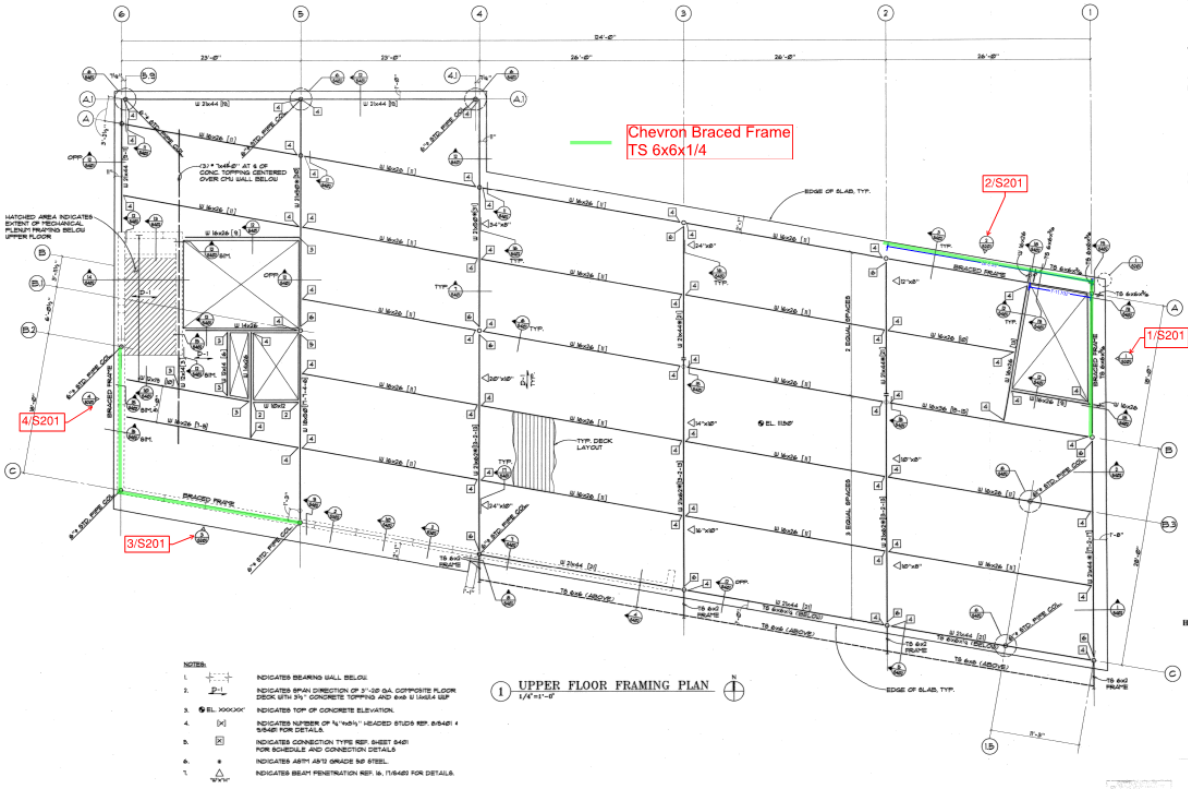
Second Floor Structural Plan with Braced Frame Locations Marked

- There is a large diaphragm opening adjacent to the braced frames between Gridlines 1A and 1B and Gridlines 1A and 2A at the second floor. The opening can significantly limit the ability of the diaphragm to transfer seismic forces to the braced frames.

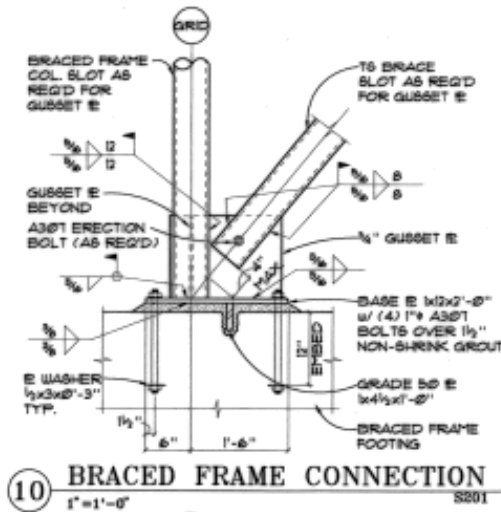
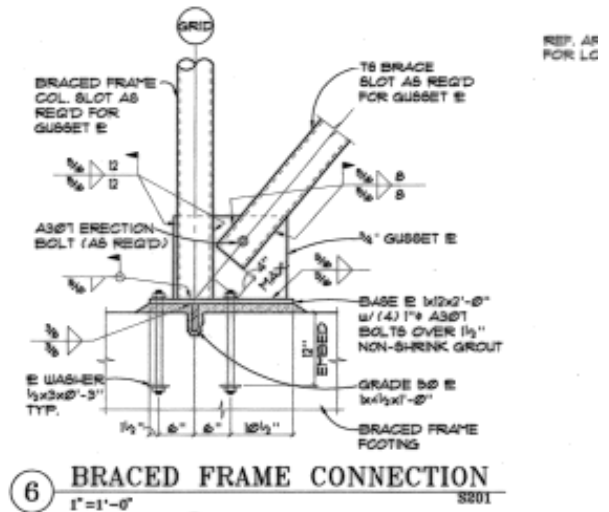
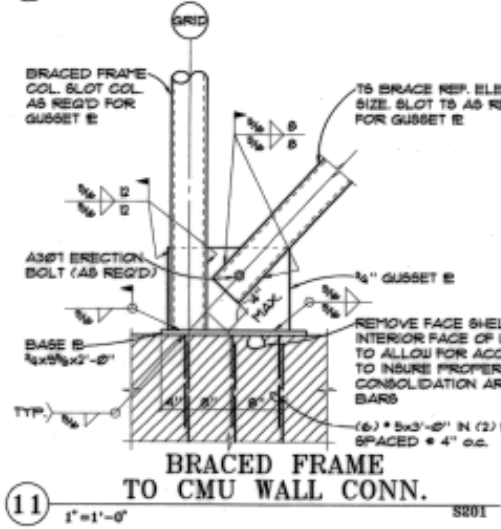
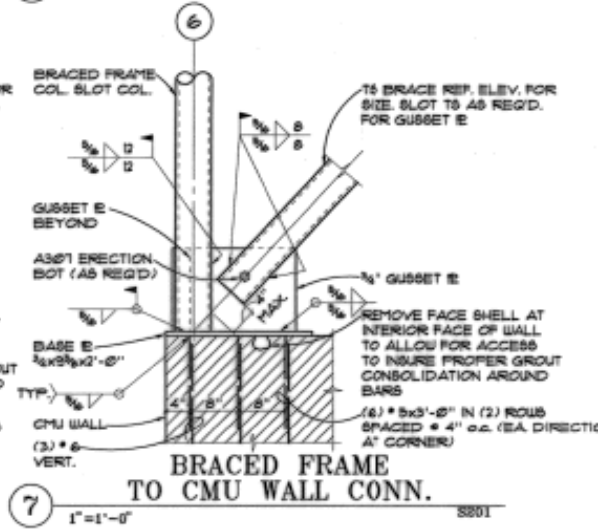
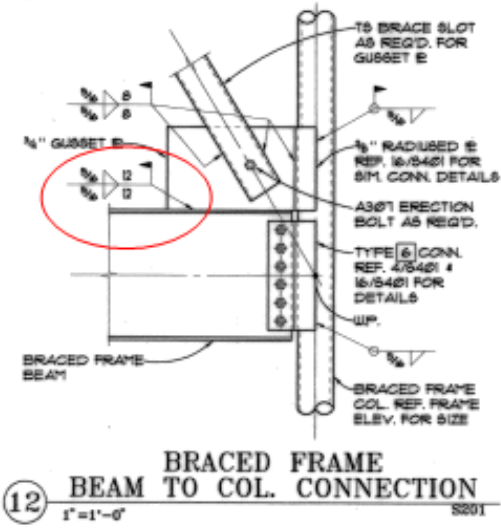
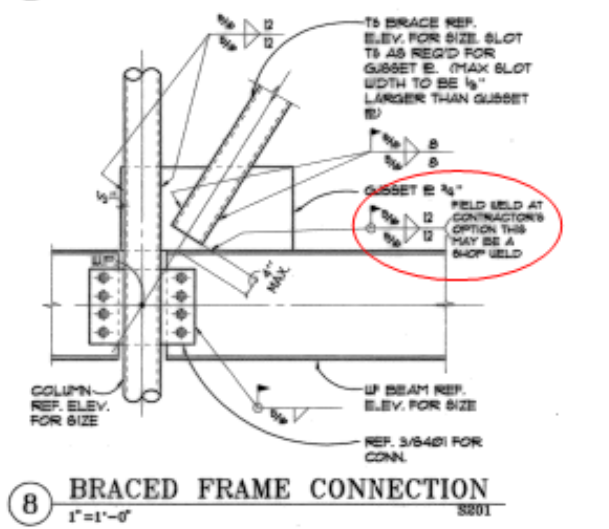
Typical Braced Frame Connections (Note Details 8 and 12 show 5/16 fillet weld from gusset plate to top beam flange)

- The braced frame connections were not built as shown on the structural drawings. The 5/16 double fillet from the gusset to the top flange of the beam was missing on both sides of the corner column at one location we observed (see photo in Appendix A). This severely limits the capacity of the braced frames.
- At the second floor, in 5C-6C grid, the seismic force-resisting system changes from a one-bay braced frame to 10" x 71.5 ft CMU wall. This occurs at B.2-C also. Per ASCE 41-17, geometric irregularities can affect the dynamic

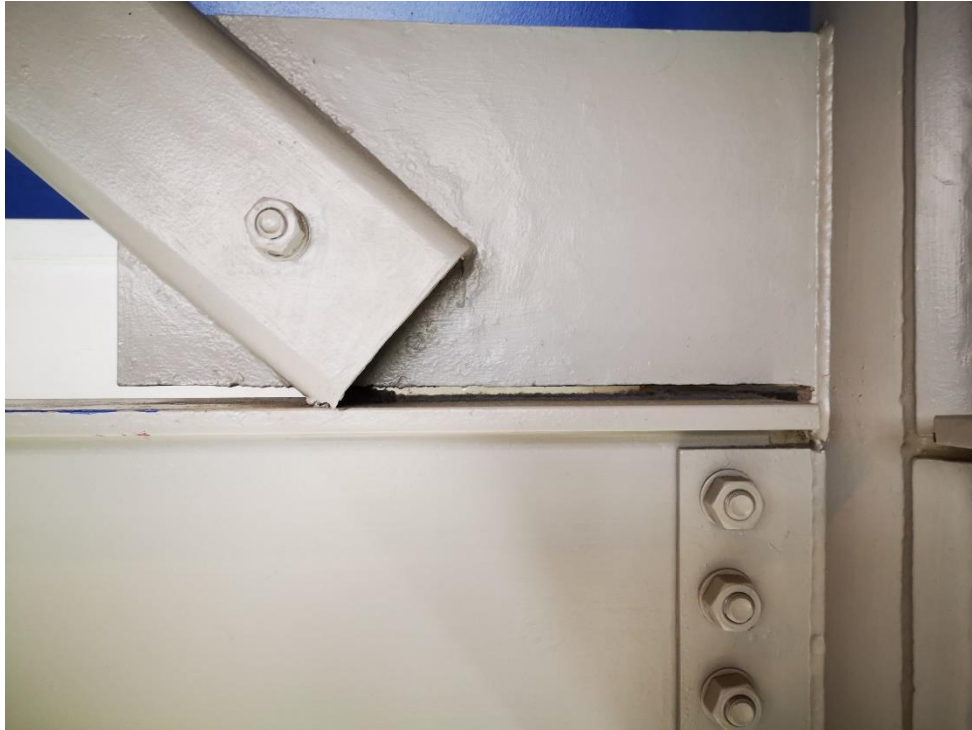
Braces are expected to experience overall buckling in compression and yielding in tension. The lack of welds from the gusset plates to the beam severely limits the connection capacities. Because of their width-thickness ratio, braces are not anticipated to sustain many inelastic cycles of axial deformation. Braces may fracture prematurely. If braces are able to resist many inelastic cycles, brace end connections may fracture at their net sections. If that does not occur, the gusset connection with a discontinuous load path may tear apart from the column. Assuming none of the preceding occurs and the braces develop large unbalanced vertical loads, then beams intersecting braces may yield in flexure and undergo very large deformations. If braces are able to develop their tension strength, there are two frame columns which resist loads from orthogonal directions which may need to resist compressive load in excess of their strength. If that occurs, loss of vertical load-carrying support over a limited area may be a possibility.

Brace Connection Without Weld at Bottom of Gusset Plate as Shown in Structural Details

This building continuously serves students. We did verify that the posted occupant load is less than 300; as a result, the building need not be classified as Risk Category III. Given the continuous use of the building by students, we recommend that advanced Tier 2 or Tier 3 analyses be conducted to more carefully ascertain its seismic risk. More advanced analyses will also help identify the magnitude of retrofit required to bring into compliance the detailing and strength deficiencies identified.

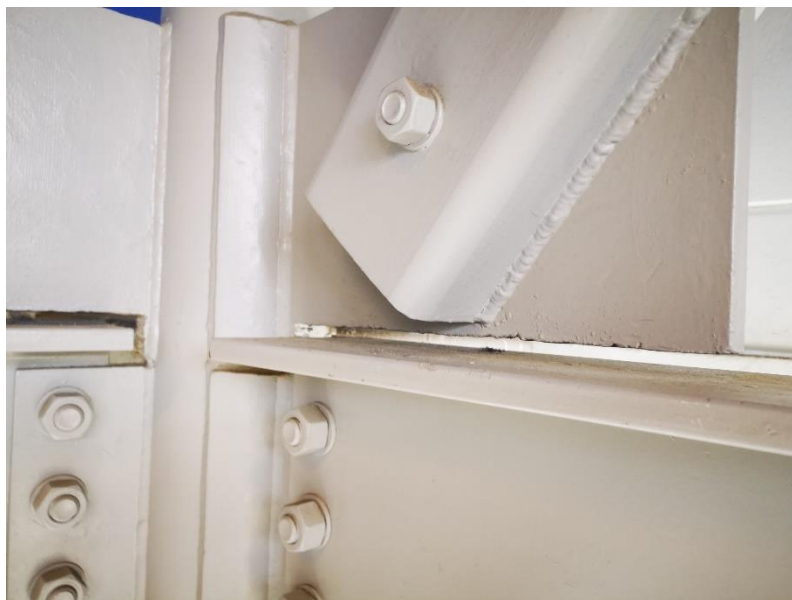
Gusset Plate is Not Welded to the Floor Beam (Second Floor Connection Along Line A, between Lines 1 and 2)
