RUTHERFORD + CHEKENE
ruthchek.com

UC Santa Cruz building seismic ratings
Earth & Marine Sciences
(Lecture Hall B206 Steel Braced Frames)

CAAN #7775.2

552 Red Hill Road, Santa Cruz, CA 95064

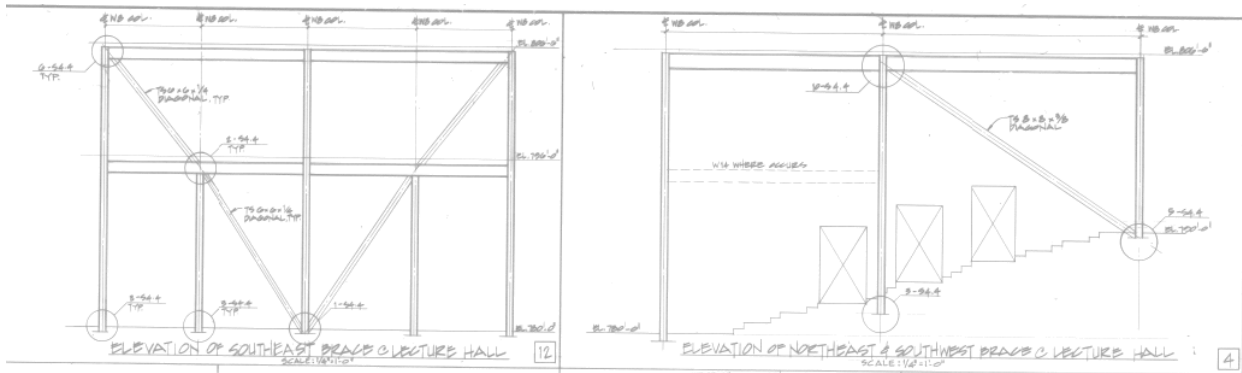
Structural Details of Braced Frames

Structural system for lateral forces: The roof is supported by four braced frames located along the two longitudinal sides and along two interior transverse lines of framing. Two additional lines of bracing support the small mezzanine level along the south and east walls. The braced frames along the two longitudinal walls have a single concentric brace; braced frames in the transverse direction include two braces in each frame. The braced frames were designed per the 1988 UBC using an allowable stress design base shear of $V=0.183W$ and an R_w value of 8. The connections were not designed for the brace tensile capacity.

- Redundancy: There are only two lines of bracing in each direction and only one brace each in the longitudinal frames.
- Brace connection strength: The brace connections were not designed to develop the capacity of the braces and are likely to fail prematurely in a large earthquake.

- Non-compact brace members: The width-to-thickness ratio of the braces is such that the braces will not exhibit moderately ductile behavior.
- Ceilings: Heavy overhead ceilings and lights with cascading levels, curving surfaces, and unknown boundary conditions may be vulnerable to failure.

We recommend performing a Tier 3 nonlinear evaluation to obtain a more refined quantification of axial loads. We recommend that nonlinear analyses be performed to better quantify the axial demands at both the brace connections and frame columns and determine the likelihood of frame column buckling and loss of vertical load-carrying capability.

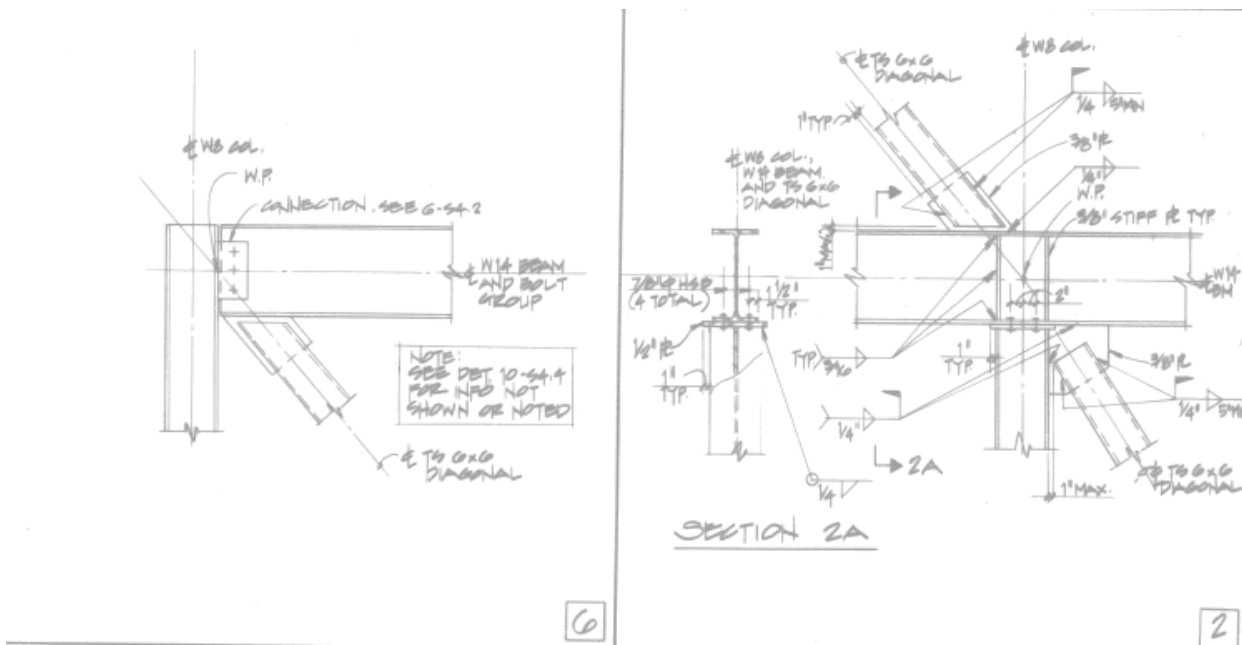
Typical Brace Connection Details (Not Designed for Capacity of Braces)

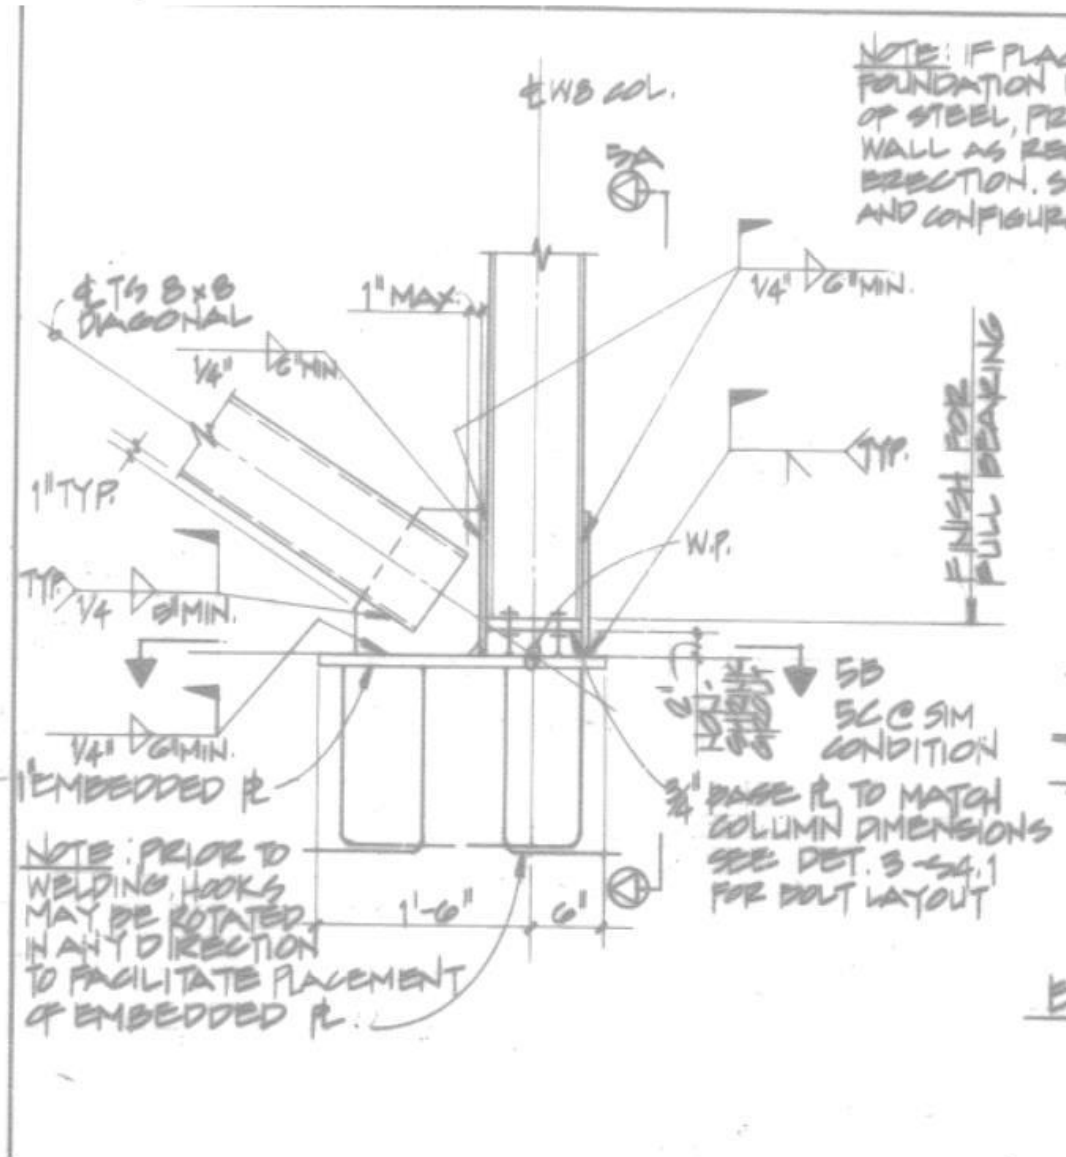
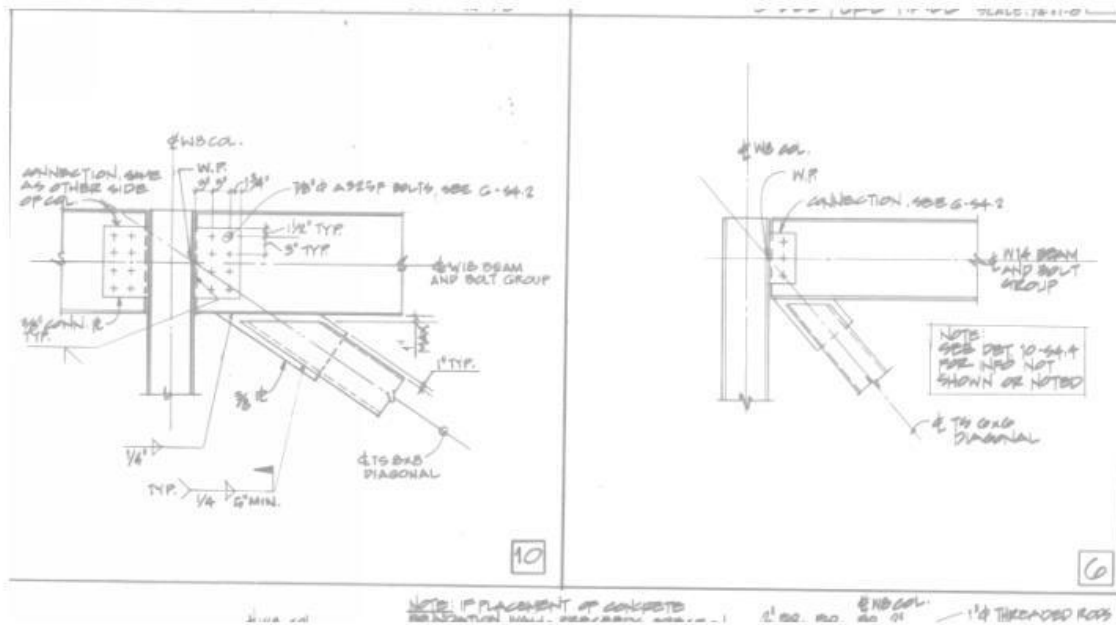
from drawings sheet S4.4

The demand calculated using the capacity of the braces is

$$F_{\text{demandbrace}} := A_{\text{brace}} \cdot 1.25 \cdot F_y = 468 \cdot \text{kip}$$
