UC Santa Cruz building seismic ratings
Earth & Marine Sciences (Concrete Shear Wall Lab Blocks C & D)

CAAN #7775

552 Red Hill Road, Santa Cruz, CA 95064

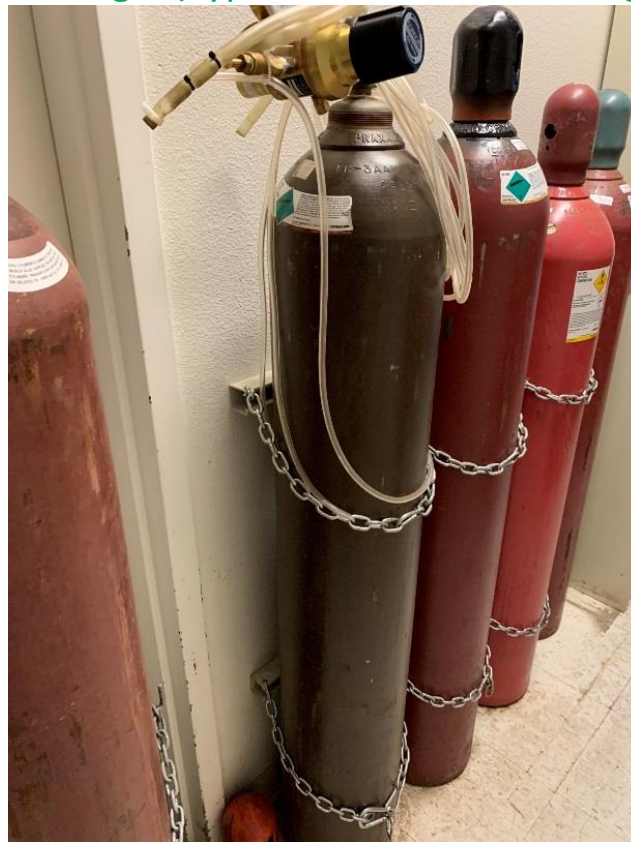
Building C Room C514 (3 Cylinders Anchored to Wall, One Anchored to Dolly, One Unanchored)

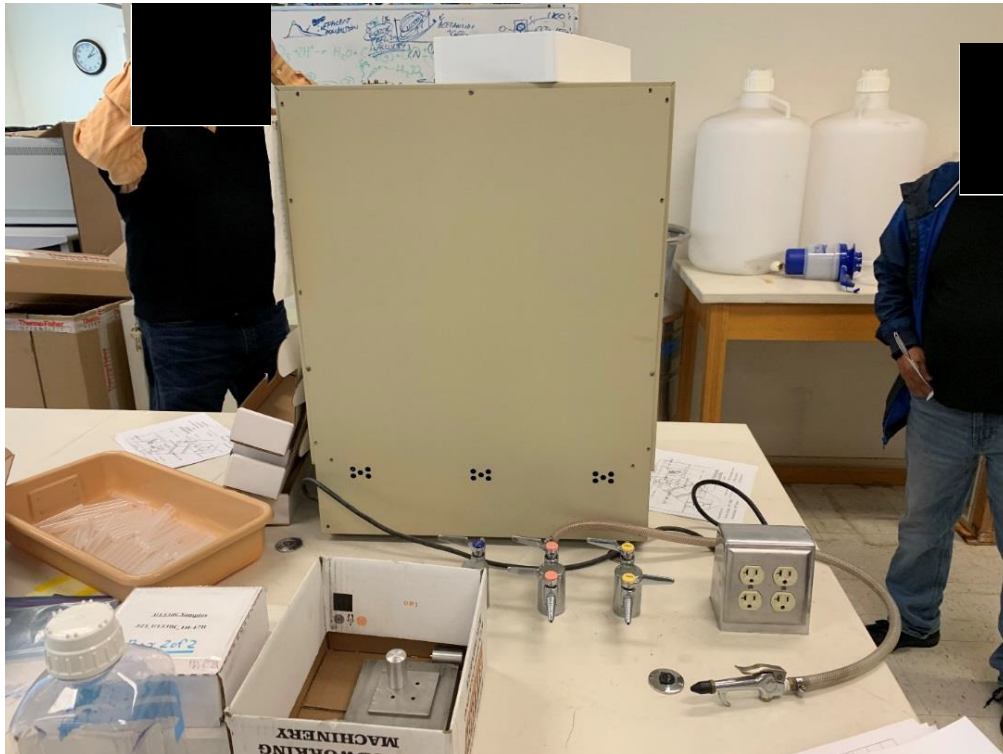
Building C Room C514 Laboratory Equipment Unanchored

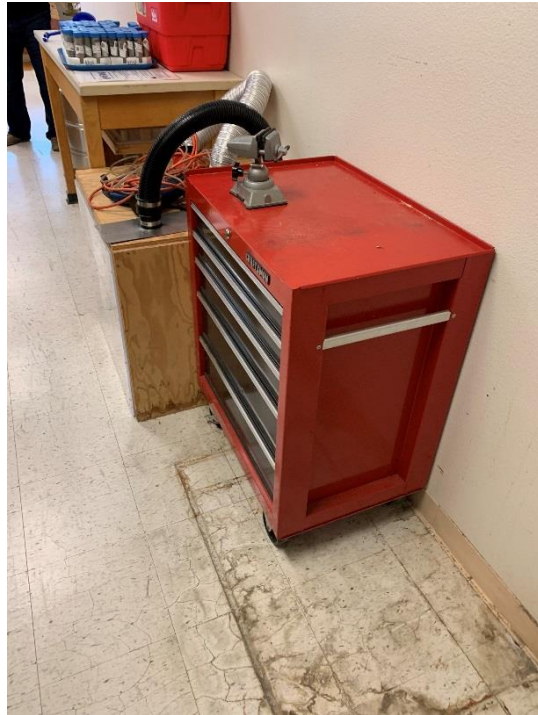
Building C Room C514 Toolbox Unanchored

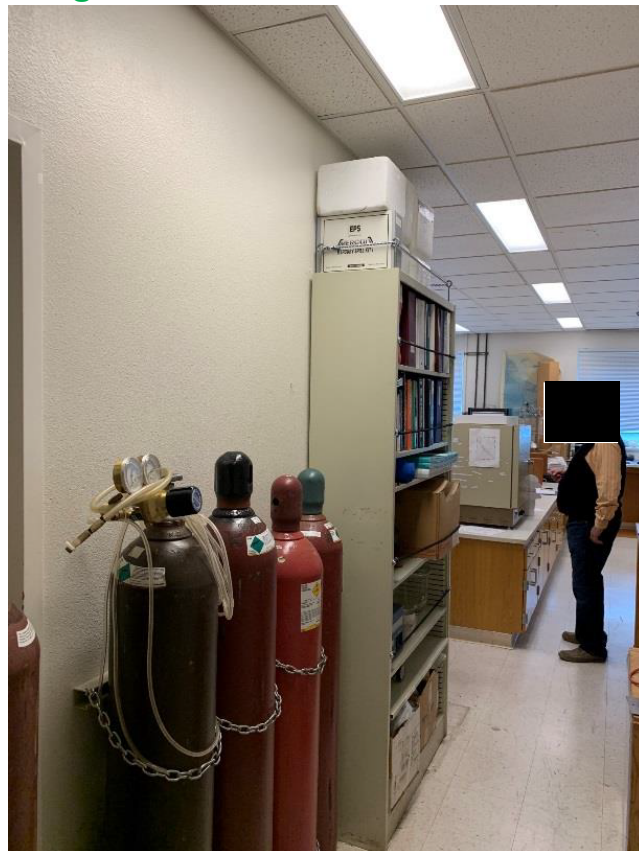
Building C Room C514 Tall Cabinet Unanchored

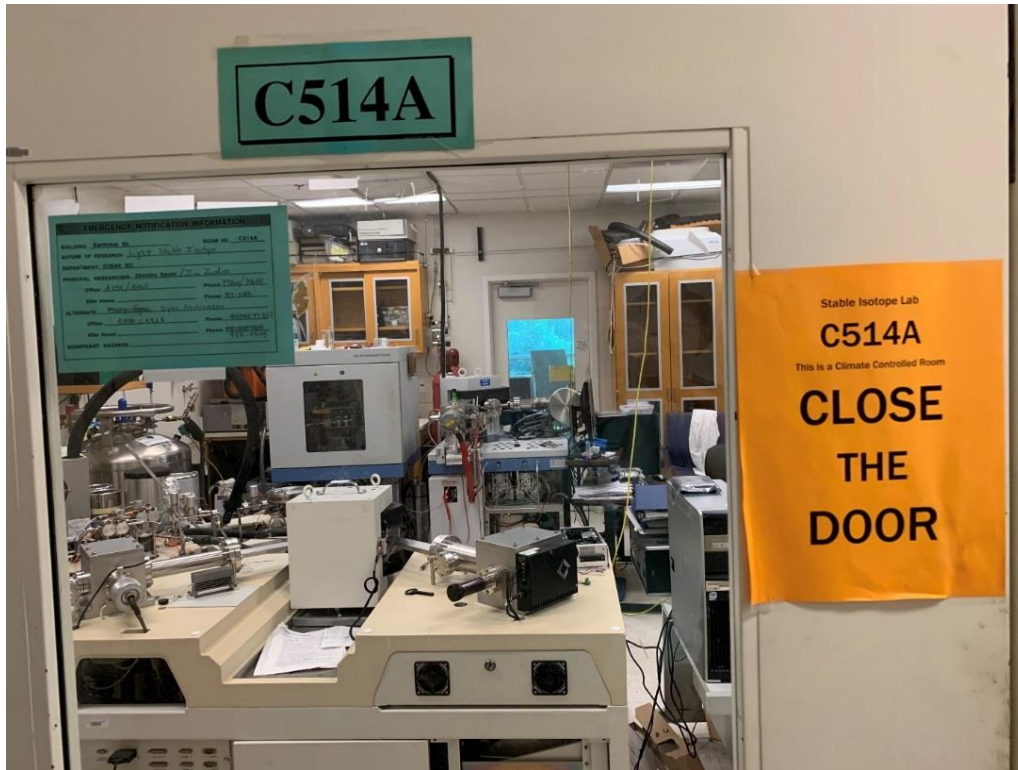
Building C Room C514A Unanchored Laboratory Equipment

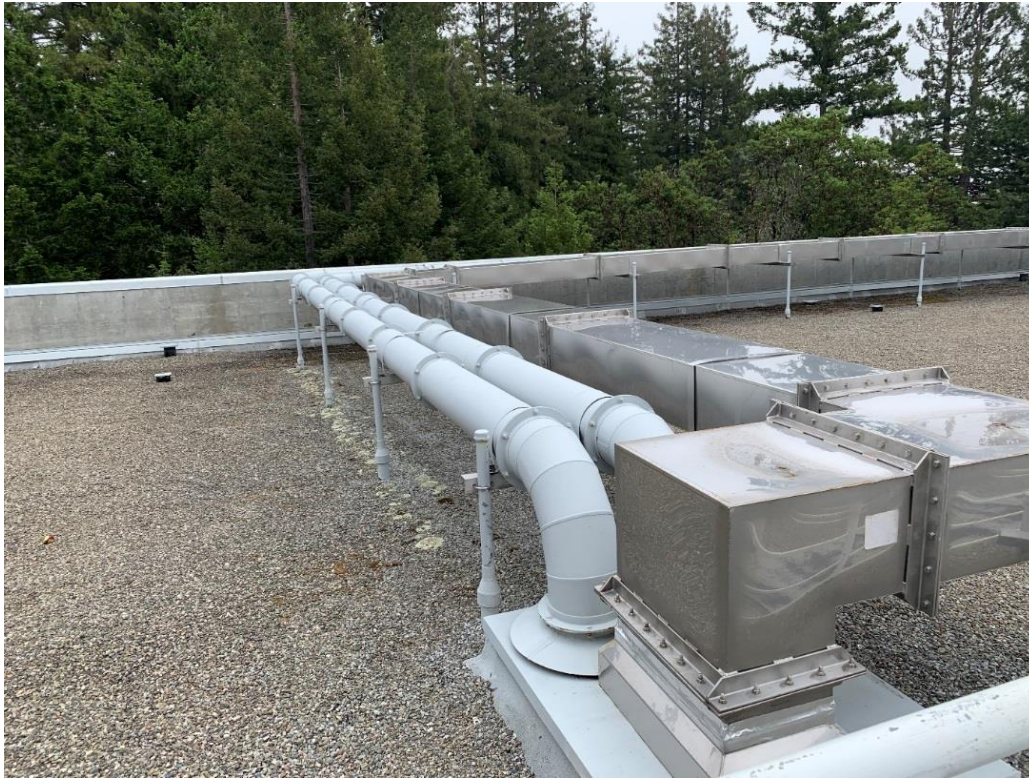
Laterally Unrestrained Pipes at Roof (Building D)

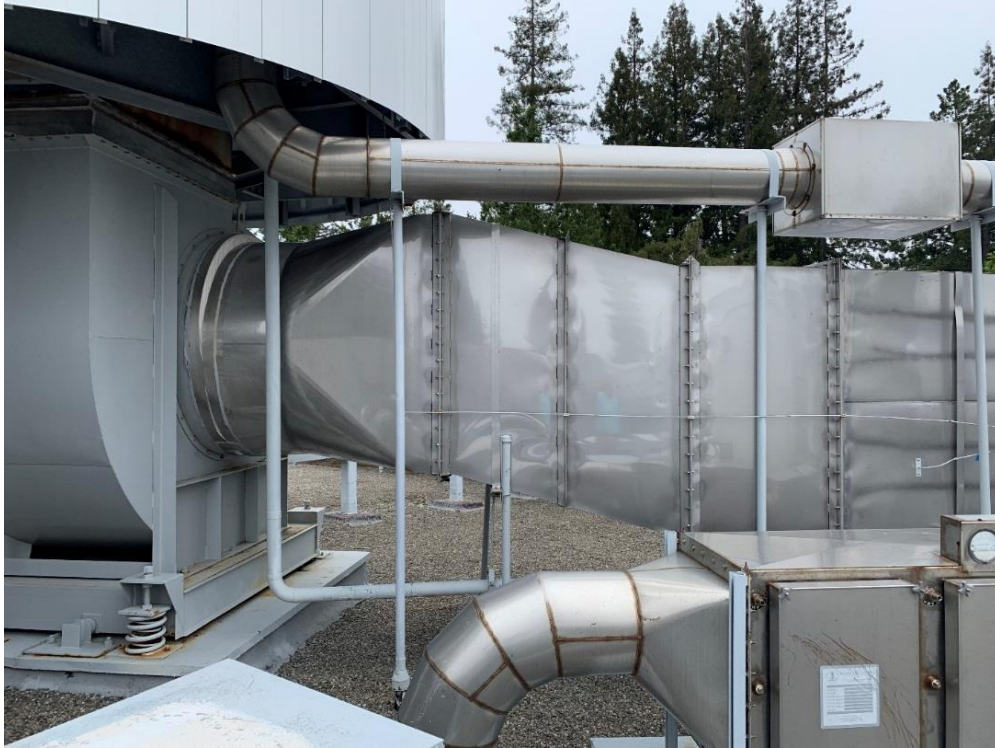
Laterally Unrestrained Pipes and Ducts at Roof (Building D)

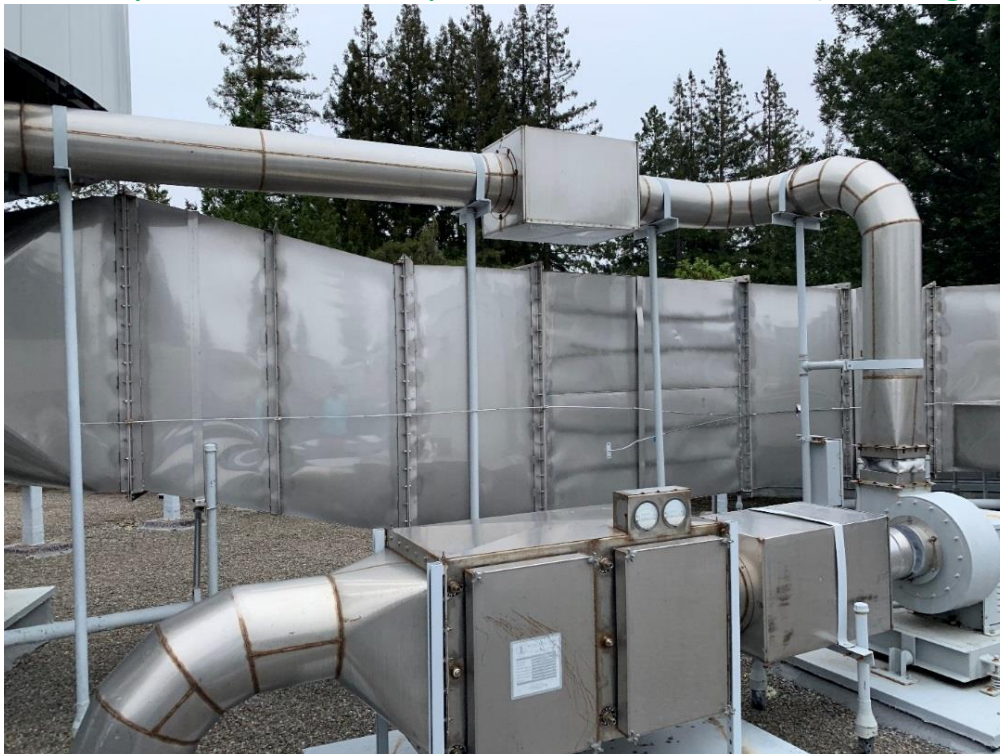
Laterally Unrestrained Pipes and Ducts at Roof (Building D)

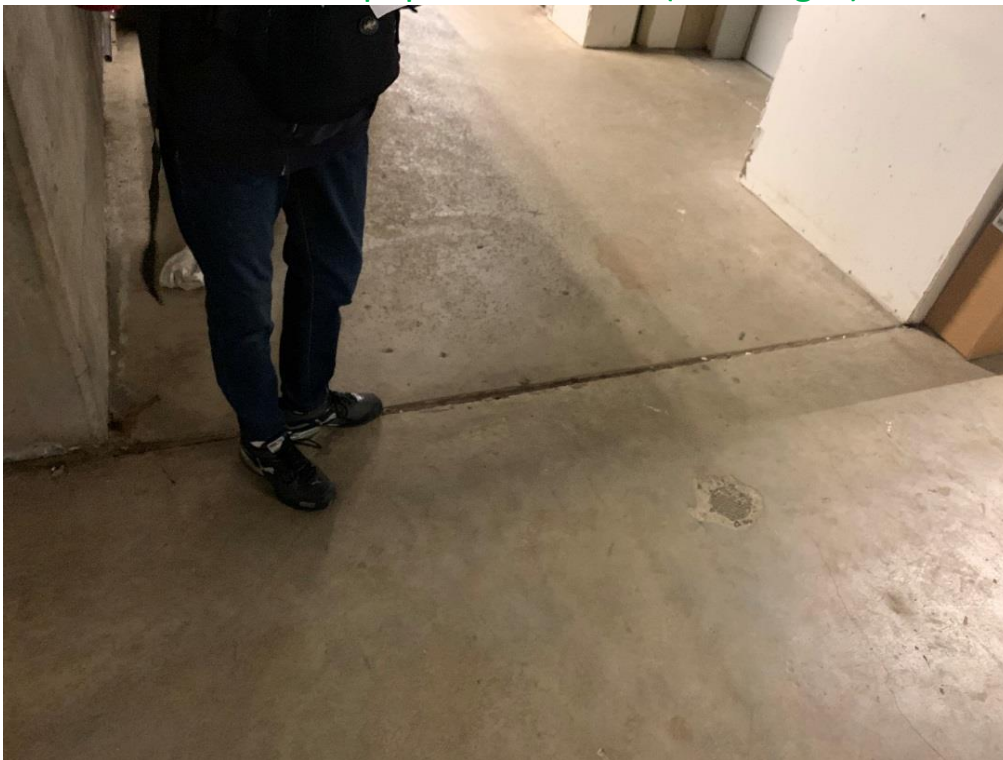
- Due to the many wall openings, the shear walls appear to have inadequate shear capacity at the three lower levels in both directions using the ASCE 41-17 Quick Check procedure. The peak demand-to-capacity ratio is 2.0. The walls are basically deep spandrels with narrow piers between windows.
- The 2" seismic gap between the concrete Lab Blocks is inadequate by current standards, but the buildings are relatively stiff, and the floors are aligned at three levels, so this may result in pounding but not expected to cause severe damage.

Basement Separation 1" Between Building D and Building C

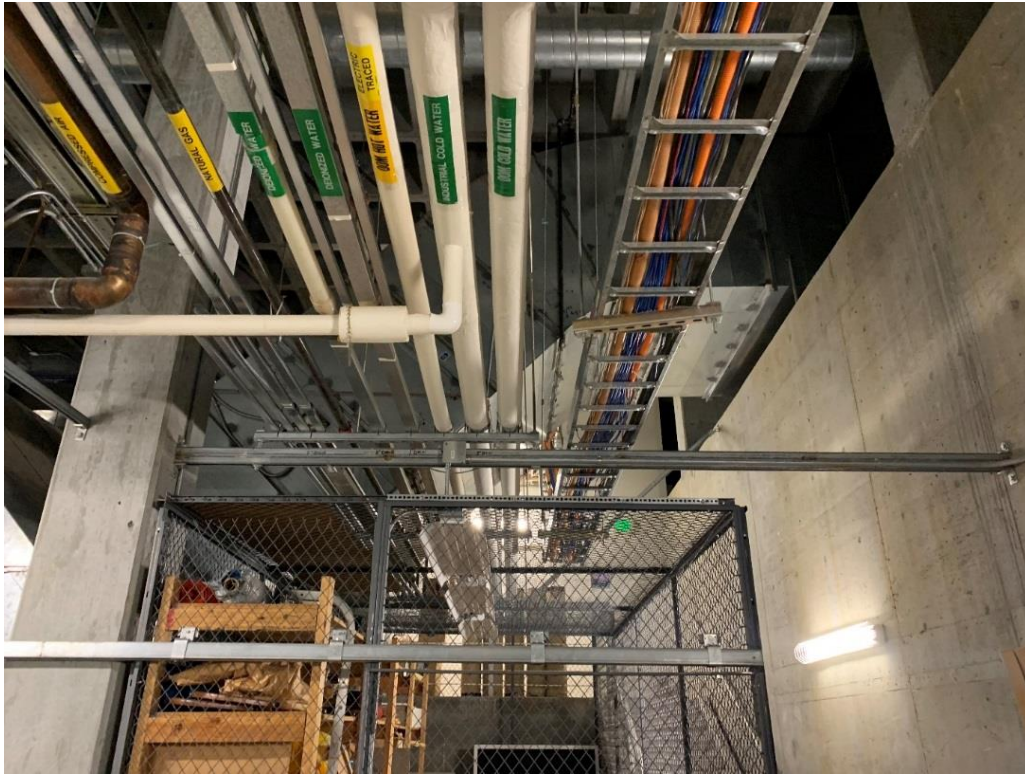
Laterally Unrestrained Pipes and Cable Trays at Basement (Building D)

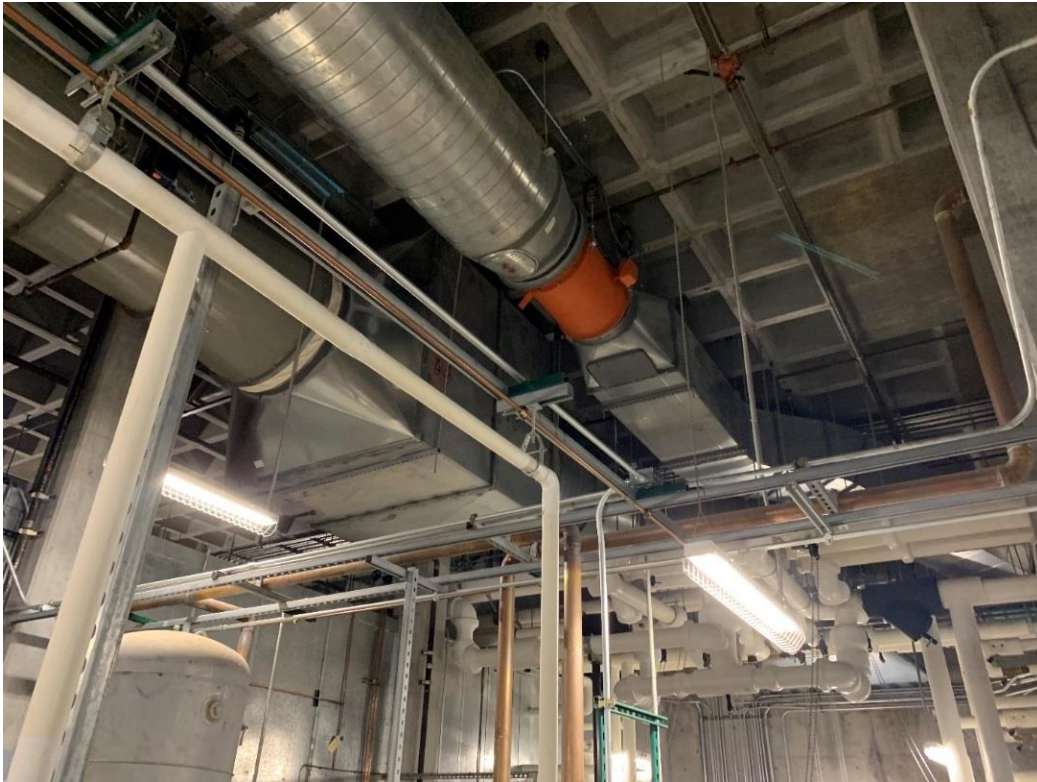
Laterally Unrestrained Ducts and Piping at Basement (Building D)

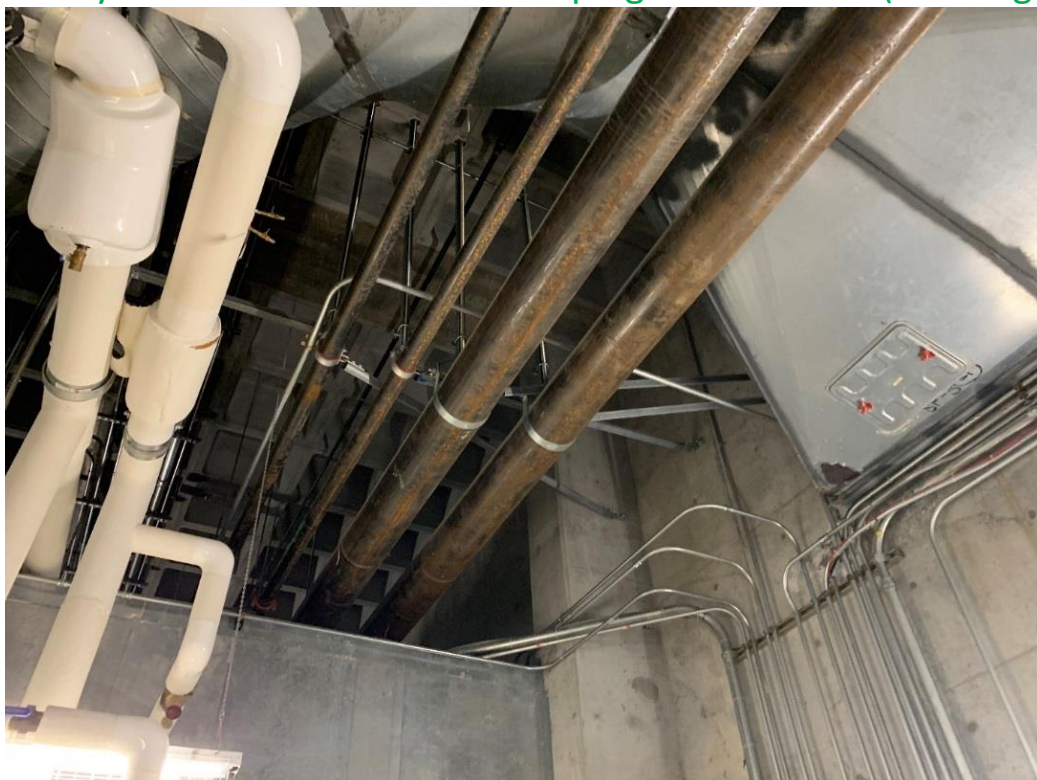
Laterally Unrestrained Ducts and Piping at Basement (Building D)

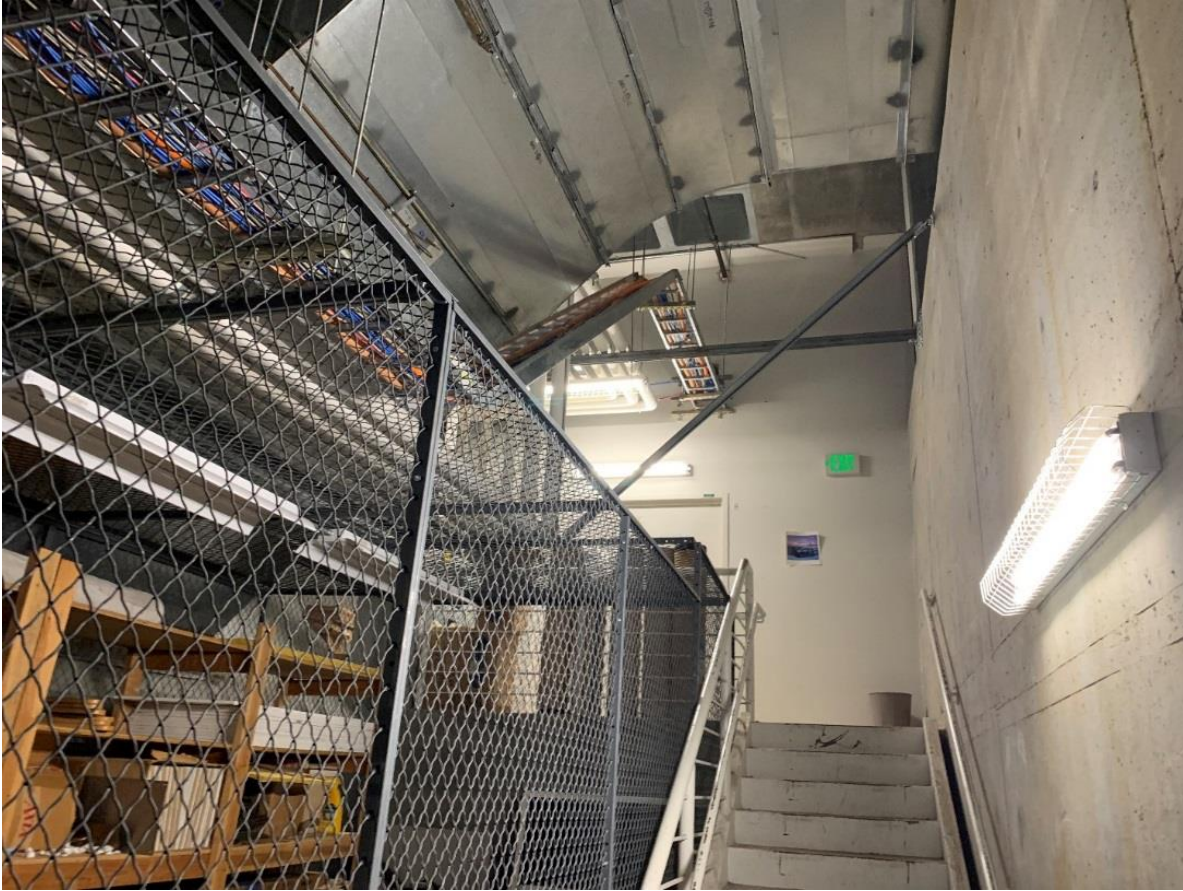
Unrestrained and Restrained Materials in Cage at Basement
(Building D)

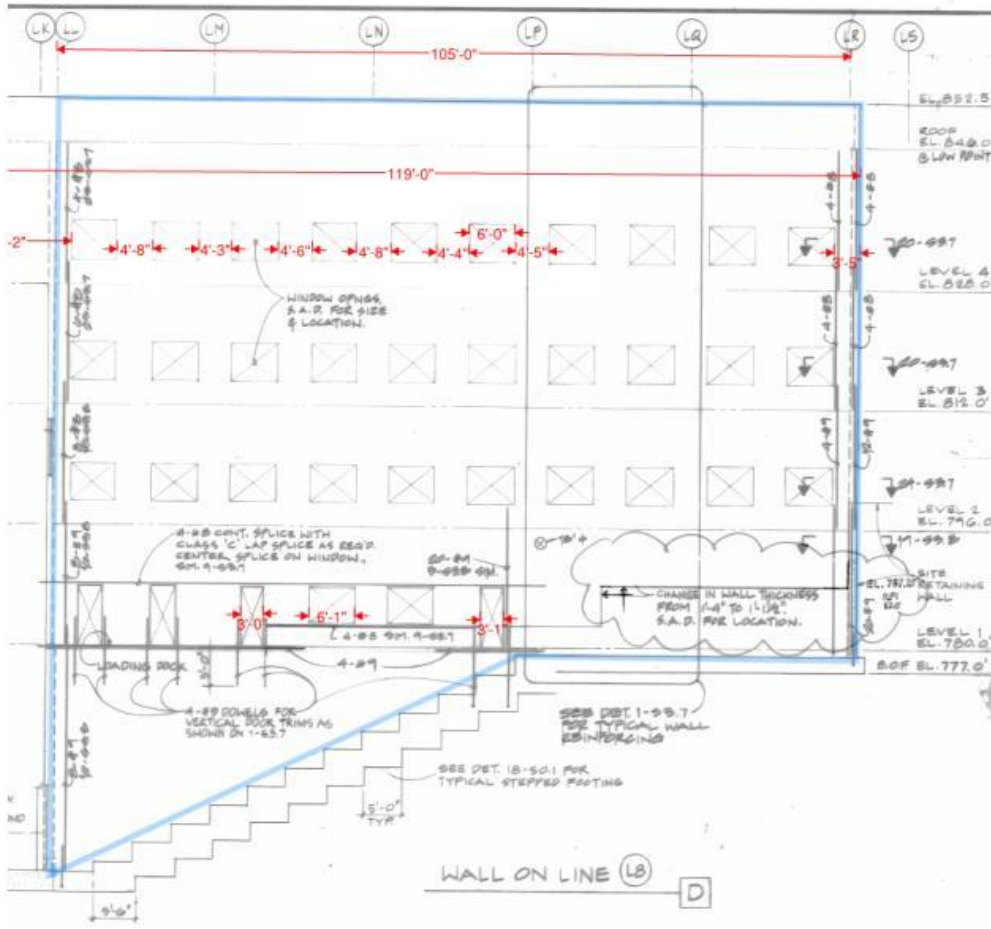
Line L8

$$Swall_{L81st} := \frac{V_1}{2 \cdot M_s \cdot A_{wall_{L81st}}} = 144.149 \cdot psi \quad \text{Larger than } 126.5psi \text{ does not comply}$$

We recommend performing a nonlinear Tier 3 evaluation to obtain a more refined quantification of wall behavior mechanisms and deformation capability to see if acceptance criteria are satisfied via the use of more advanced calculations and expected strengths.
