RUTHERFORD + CHEKENE

DATE: 2019-06-28

UC Santa Cruz building seismic ratings
Visual Arts Facilities-Building I

CAAN #7815

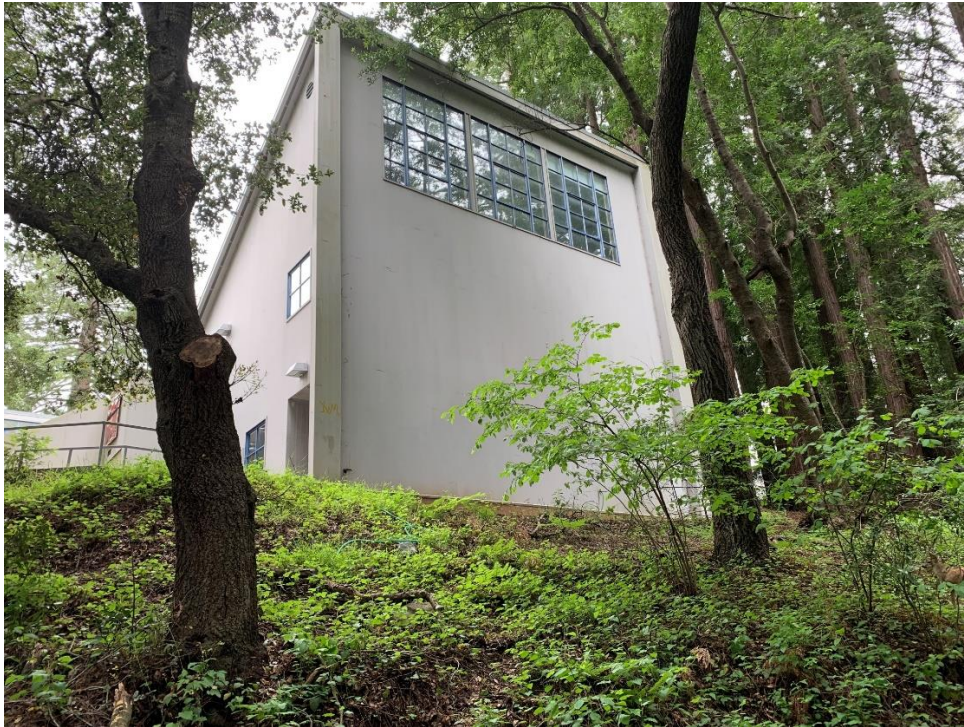
There are no major deficiencies. Average loads per lineal foot in the north and south plywood shear walls from east-west loading are below the Quick Check threshold. If a tributary area approach is used, the loads at the north wall with its large clerestory window are relatively high, still below the Quick Check threshold with a D/C ratio of 0.92.

Reference north wall with large window

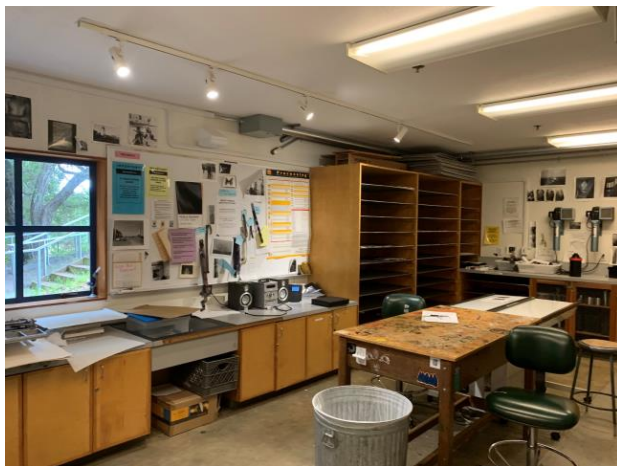
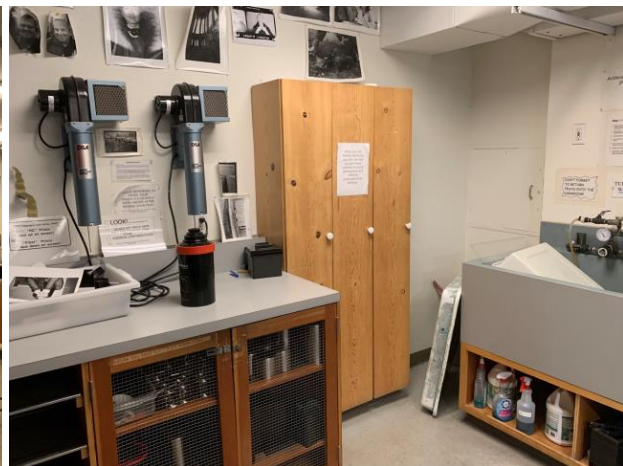
Shelves and cabinets in the office

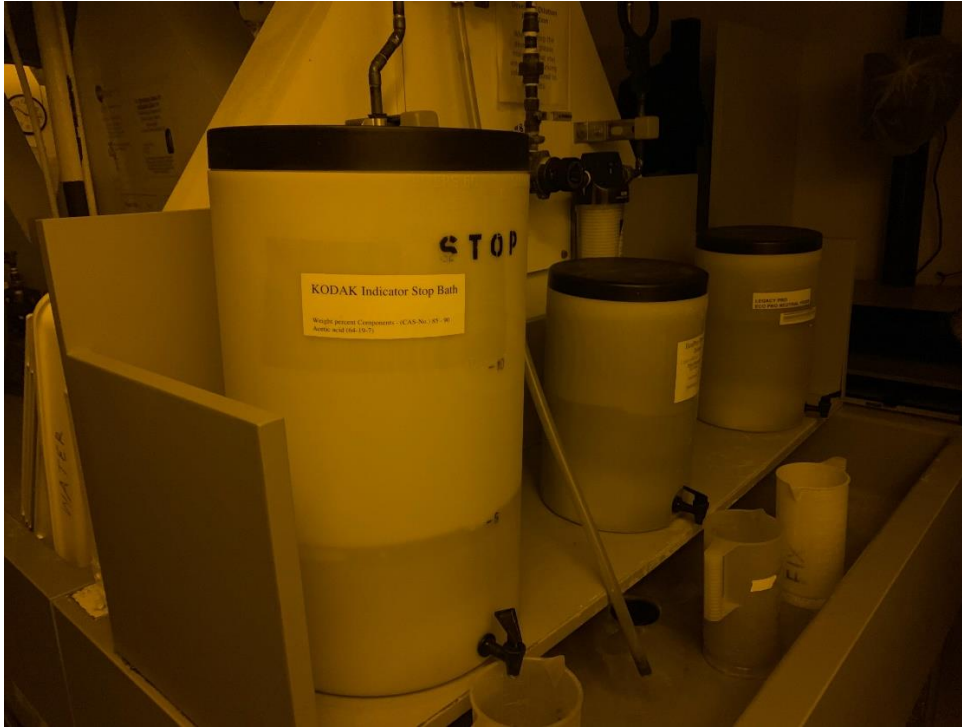
Tanks in the dark room are not properly anchored.

Unbraced chemical tanks in dark room
