**UC Santa Cruz building seismic ratings**  
**Theater Arts L Experimental Theater**

CAAN #7923

DATE: 2019-06-30

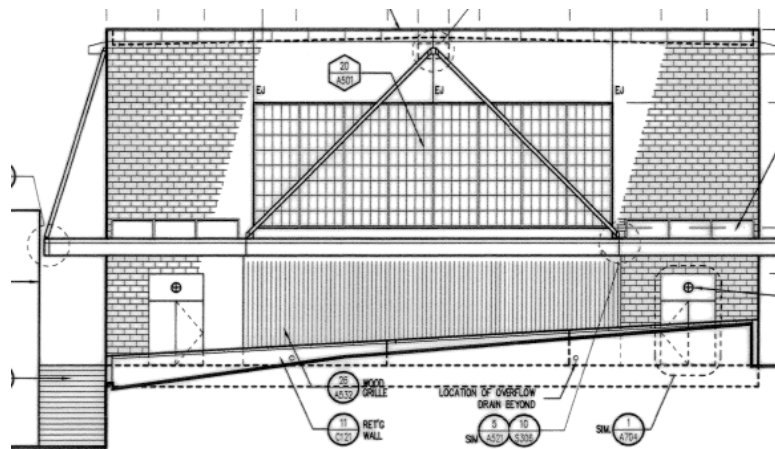
- The large window opening in the south RM shear wall -see South Elevation drawing below- affects the geometrical regularity of the building; however torsional effects are not a concern because of the relative light weight of the supported roof, where most of the building mass is provided by the shear walls.
- The second-floor composite metal deck catwalk is connected to perimeter supporting walls by puddle welds. Also, the metal deck roof diaphragm is connected to perimeter supporting steel by puddle welds. Current research suggests that welded connections of metal deck to supporting steel provide less ductility than other connection types such as fasteners.
