**RUTHERFORD + CHEKENE**

DATE: 2019-06-28

**UC Santa Cruz building seismic ratings**  
**Visual Arts Facilities-Building L**

CAAN #7926

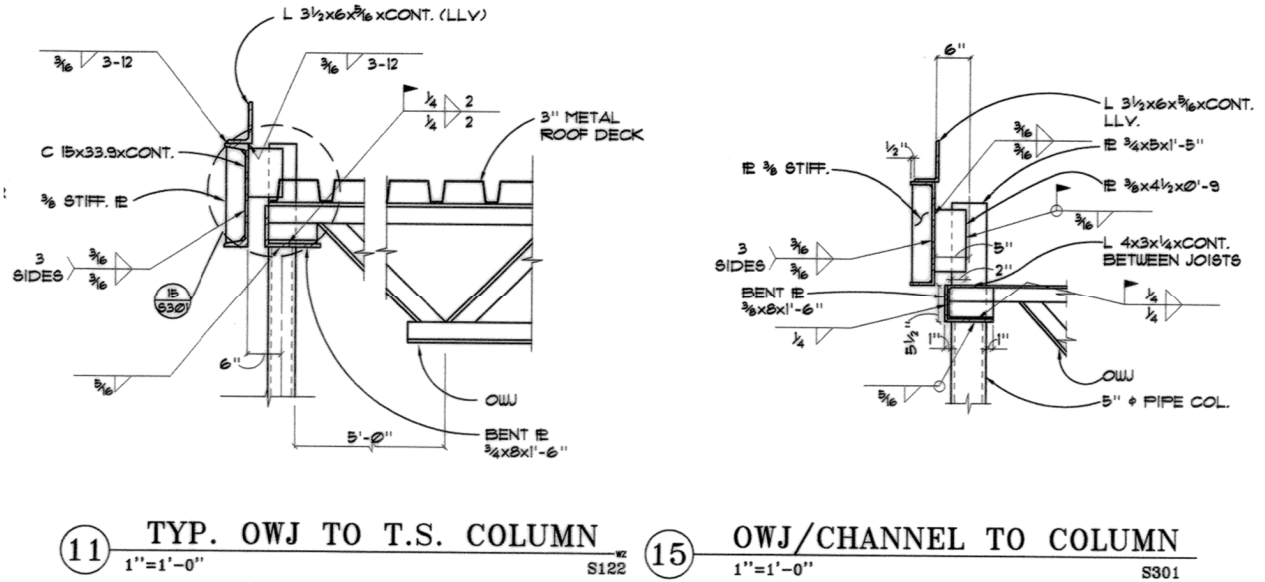
**Detailed joist-to-column connection (Detail 11 and 15 per Sheet S301)**

- The joist-to-column connection detail is different from the detail shown in the structural drawings. The main differences are: (1) an angle was welded at the end of the joist; one leg is welded above the top chord of the joist and the other to the top of the bearing plate (see the pictures in Appendix A), this angle connects all the steel columns; (2) A vertical steel plate was welded to the end of the joist to stiffen the top chord and to transfer vertical load; (3) Two thick bearing plates were welded to the column horizontal plate. During the site visit, it was not possible to inspect the welds used in this connection. Without closer inspection, it is not clear if there is a compliant positive tie from the joist to the bearing plate and then from the bearing plates to the column cap plate.

We recommend that the campus perform a Tier 2 evaluation to review the lateral force-resisting capacity of the diagonal bracing members, their connections, the cantilever columns, the roof-to-wall connections, and the joist-to-column connections. If the braced elements were found to be inadequate, replacement of the elements could be made with tubes including horizontal struts at the top of the diagonals, and the connections could be strengthened if the welds are found inappropriate. We assign the building to Priority Category B, as the retrofit of the building should be done when there are any plans for modifying or change of occupancy. Falling hazards reduction, such as the unbraced lockers, should be addressed.

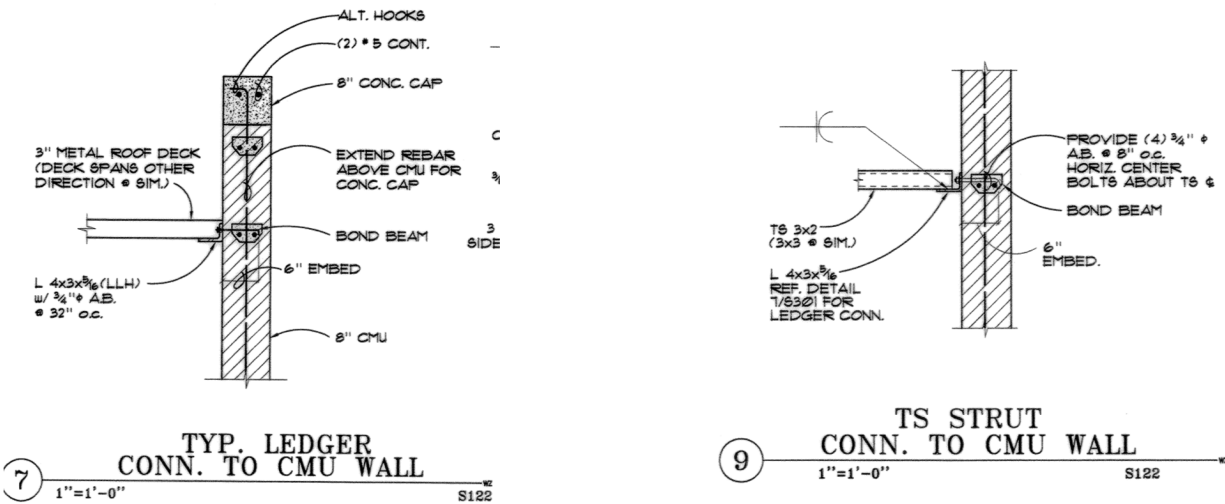
**Roof-to-wall connection (Details 7/S301 and 9/S303)**

- Roof-to-wall tie: The typical roof-to-wall tie per Detail 7/S3.01 at the west and east walls relies on puddle welds from the deck to the top of an L4x3x3/8" ledger which are connected with 3/4" diameter bolt at 32" o.c. to a bond beam in the CMU wall. In addition, there are two concentrated tube-to-wall connections along the wall length per Detail 9/S3.03 that use a similar approach as Detail 7/S3.01, but with four anchor bolts centered about the tube. At the south wall, the deck flutes are parallel to the wall, so the only out-of-plane tie is from the open web joists to a pocket in the wall per Detail 9/S3.01. At the pocket, the top chord of the joist bears on a base plate which has two 3/4" anchor bolts into the CMU wall which resist loads in shear. Information showing how the top chord of the joists is connected to the base plate is missing.

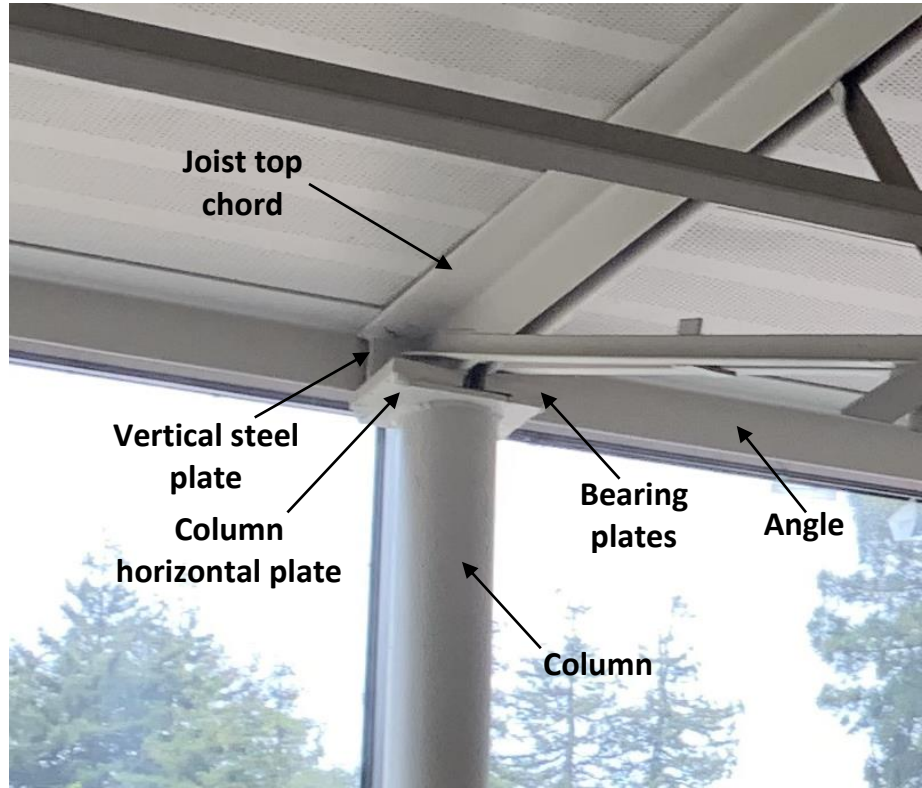
Close-up of the joist-to-column connection
