Date: 06/28/2019

UC Santa Cruz building seismic ratings
Visual Arts Facilities-Building M

CAAN #7927

Elena Baskin Visual Arts, Santa Cruz, CA 95064

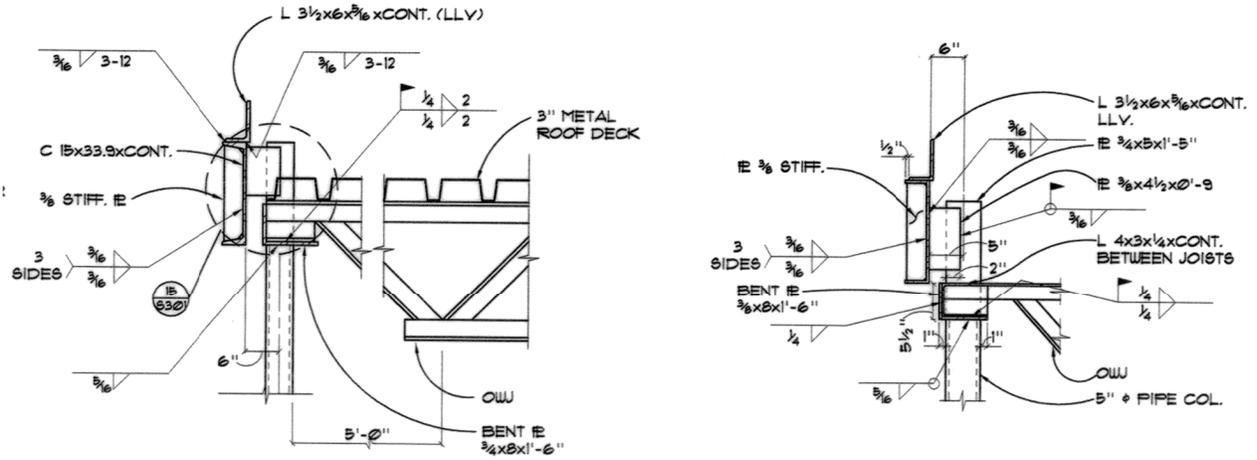
Joist-to-column connection (Details 11 and 15 per Sheet S301)

- The joist-to-column connection detail is different from the detail shown in the structural drawings. The main differences are: (1) an angle was welded at the end of the joist, one leg is welded above the top chord of the joist and the other to the top of the bearing plate (see the last two pictures on Appendix A); this angle connects all the steel columns; (2) A vertical steel plate was welded to the end of the joist to stiffen the top chord and to transfer vertical load; (3) Two thick bearing plates were welded to the column horizontal plate. During the site visit, it was not possible to inspect the welds used in this connection. Without closer inspection, it is not clear if there is a compliant positive tie from the joist to the bearing plate and then from the bearing plates to the column cap plate.

We recommend that the campus perform a Tier 2 evaluation to review the lateral force-resisting capacity of the diagonal bracing members, their connections, the cantilever columns, the roof-to-wall connections, and the joist-to-column connections. If the braced elements were found to be inadequate, replacement of the elements could be made with tubes including horizontal struts at the top of the diagonals, and the connections could be strengthened if the welds are found inappropriate. We assign the building to Priority Category B, as the retrofit of the building should be done when there are any plans for modifying or change of occupancy. Falling hazards reduction, such as the unbraced lockers, should be addressed.

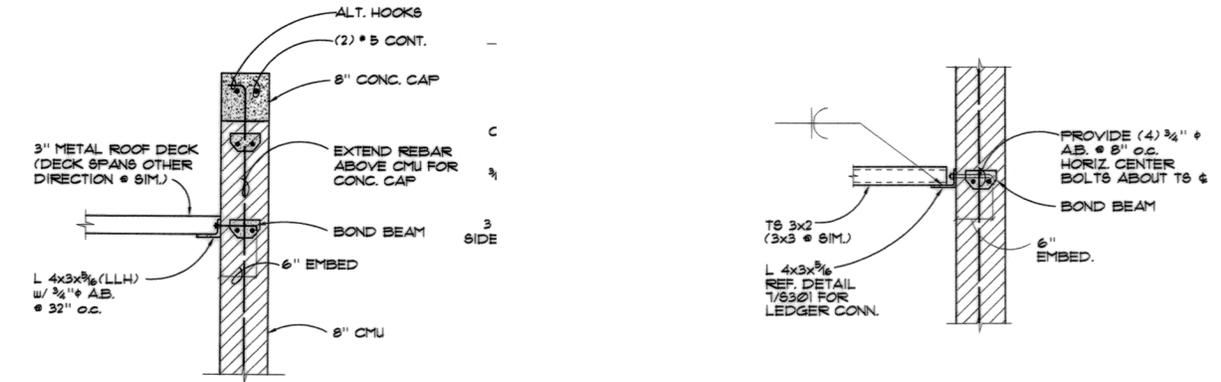
Roof-to-wall connection (Details 7/S301 and 9/S303)

- Roof-to-wall tie: The typical roof-to-wall tie per Detail 7/S301 at the west and east walls relies on puddle welds from the deck to the top of an L4x3x3/8" ledger which are connected with 3/4" diameter bolt at 32" o.c. to a bond beam in the CMU wall. In addition, there are two concentrated tube-to-wall connections along the wall length per Detail 9/S3.03 that use a similar approach as Detail 7/S3.01, but with four anchor bolts centered about the tube. At the south wall, the deck flutes are parallel to the wall, so the only out-of-plane tie is from the open web joists to a pocket in the wall per Detail 9/S3.01. At the pocket, the top chord of the joist bears on a base plate which has two 3/4" anchor bolts into the CMU wall which resist loads in shear. Information showing how the top chord of the joists is connected to the base plate is missing.

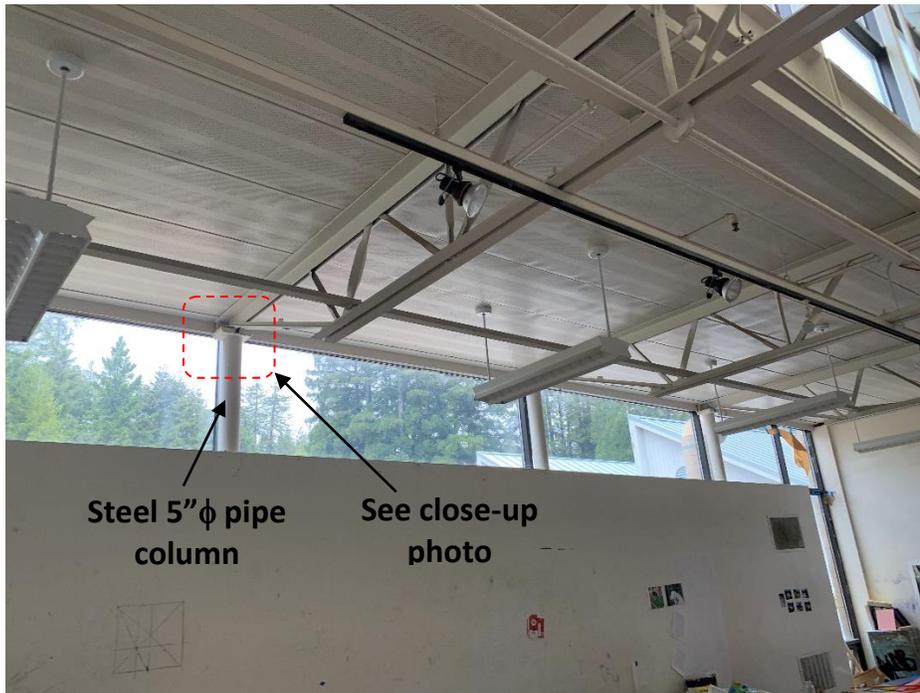
- Tension rod diagonal "X" bracing (3/4"φ ASTM A36 rods connected to a 1/2" steel plate) are used in three of the five bays along Gridline C to brace the bottom portion of the steel pipe columns below the clerestory window. The top of the connection is located at 9' above the grade and 4'-3" below the top of the columns, so the columns must cantilever up the remaining distance from the top of the braces to the top of the columns at the roof level. In addition to cantilever bending, because the rods have no tension stiffness or strength, they will introduce a seismic shear at the middle of the columns, similar to the effect created by a K-braced system, potentially compromising the vertical load-carrying capacity of the columns. The calculated average axial stress in the diagonal rods is 70% greater than the allowable stress per Tier 1 evaluation.

Steel pipe columns of north side of the building

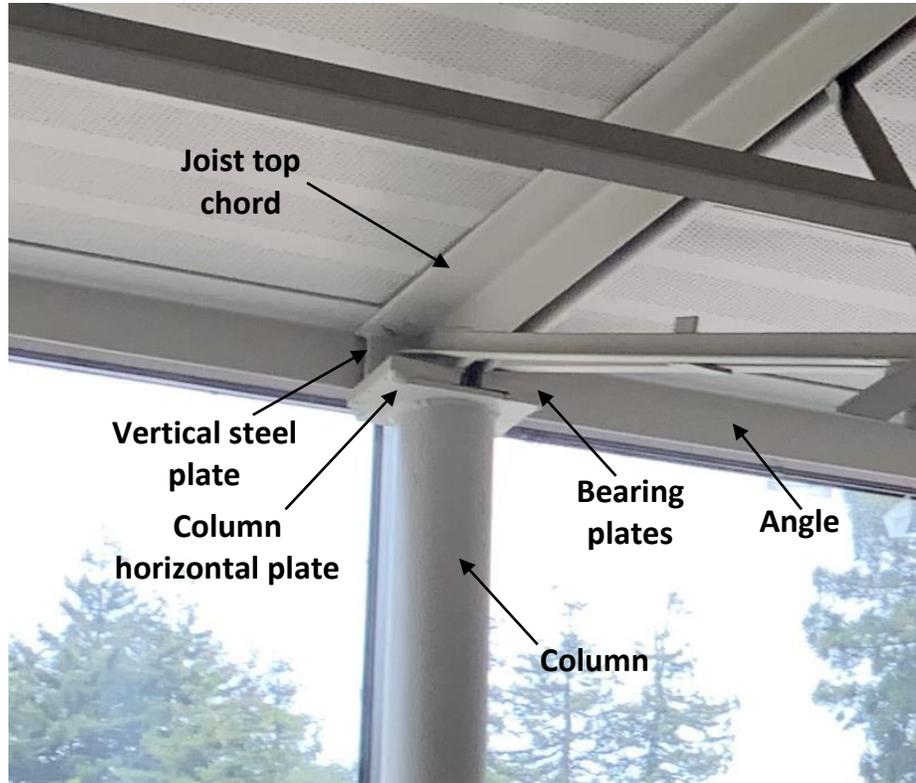
Close-up of the joist-to-column connection

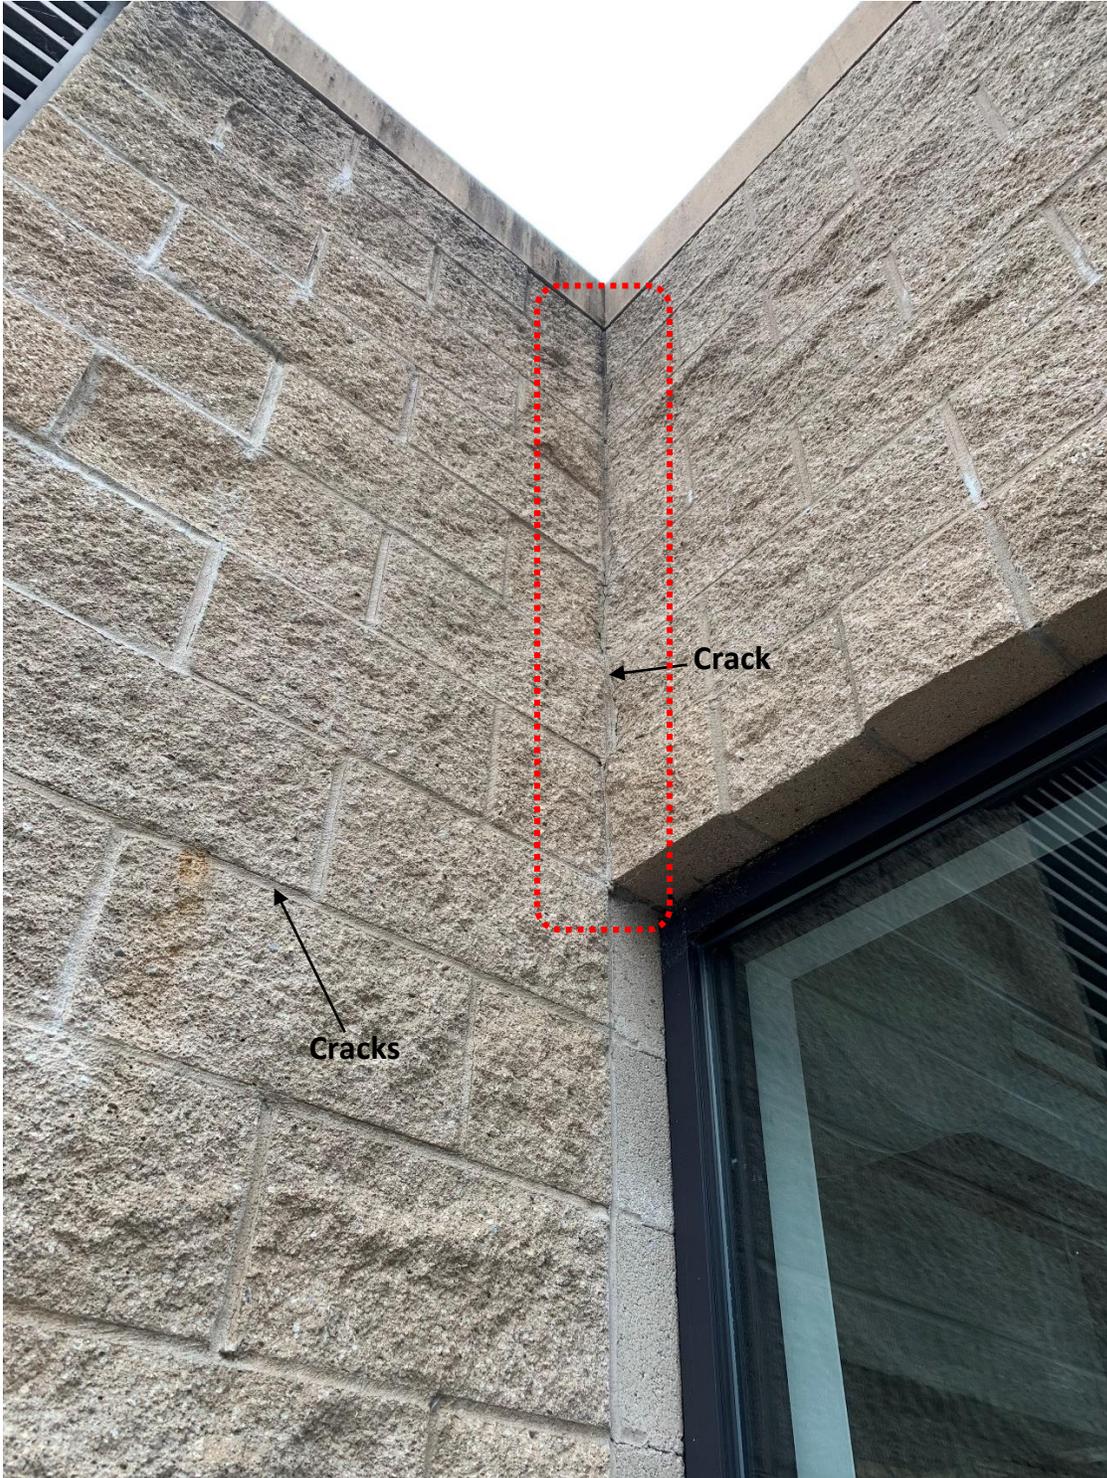
Building condition: Some cracking was observed in the CMU walls at the intersection of the south wall of the painting room with the orthogonal wall of the storage room. Staining was observed on face of the CMU and wood wall on the north side. The observed conditions do not appear to significantly impact lateral force resistance.

Intersection of main storage room wall (left)
with painting studio south wall (right)

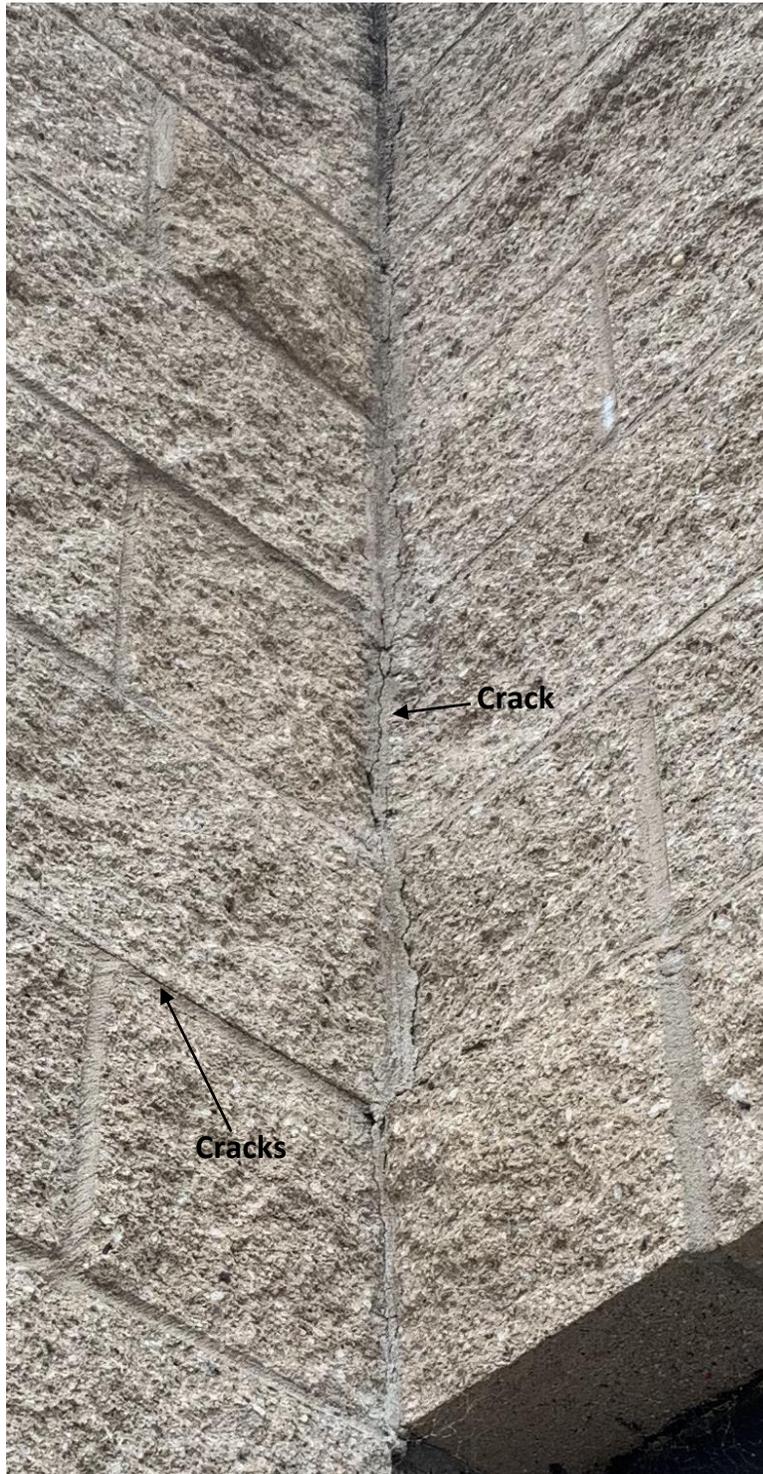
Close-up of the cracks
