DATE: 2019-06-30

UC Santa Cruz building seismic ratings Astronomy Shop B

CAAN #7172

University of California, Santa Cruz
ASCE 41-17 Tier 1 Seismic Evaluation
7172 - Astronomy Lab B

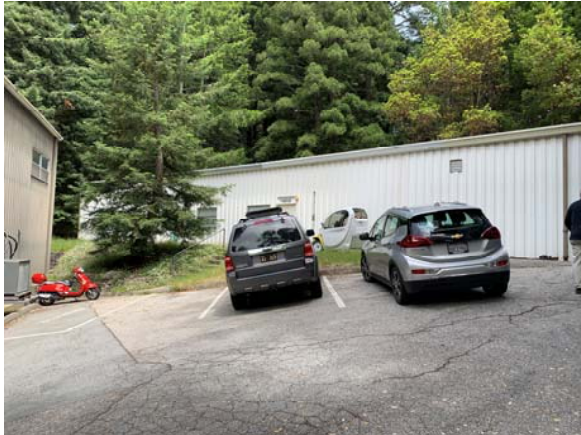
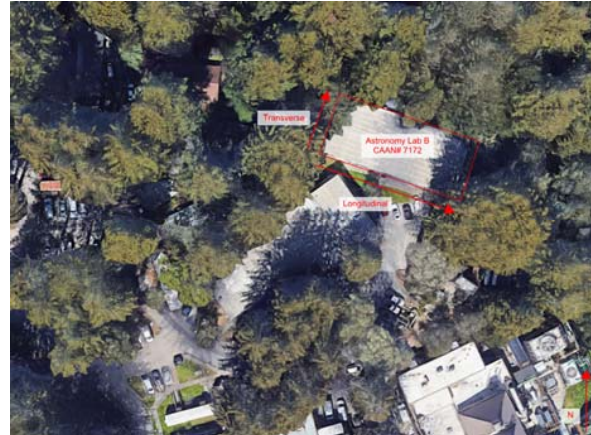
6/28/19

The building is a single story tilt up portal frame with lightweight metal panels serving as the roof and exterior walls. There should be tension only braces in the longitudinal direction. It appears that some of the braces were removed or not installed based on the site visit. Information on the foundation is not available. There appears to be a slab on grade based on the site visit.

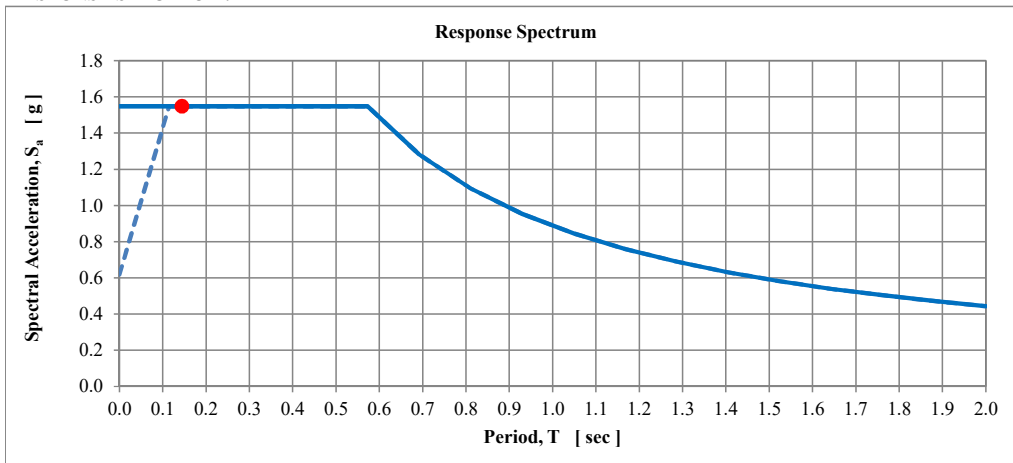
RESPONSE SPECTRUM:

h_n = 14.0 ft (Base to Roof) Building Height [ASCE 41-17, §4.4.2.4]
 C_t = 0.020 (Building Type S3) Period Coefficient [ASCE 41-17, §4.4.2.4]
 β = 0.750 (Building Type S3) Period Exponent [ASCE 41-17, §4.4.2.4]
 T = 0.145 sec = $C_t h_n^\beta$ Fundamental Period [ASCE 41-17, Eq. 4-4]

n = 1 (n = 1) Total Number of Stories
 C = 1.3 (Building Type S3) Modification Factor [ASCE 41-17, Table 4-7]
 S_a = 1.548 g = MIN { S_{X1} / T , S_{XS} } Spectral Acceleration [ASCE 41-17, Eq. 4-3]
 V = 2.012 W = $C S_a W$ Pseudo Lateral Force [ASCE 41-17, Eq. 4-1]
