UC Santa Cruz building seismic ratings
Hahn Art Facility, University of California Santa Cruz

CAAN #7199

DATE: 2018-12-31

Rating summary	Entry	Notes
UC Seismic Performance Level (rating)	V (Poor)	
Rating basis	Tier 1	ASCE 41-17 ¹
Date of rating basis	2018	
Recommended list assignment (UC Santa Cruz category for retrofit)	Priority B	Priority A=Retrofit ASAP Priority B=Retrofit at next permit application
Ballpark total construction cost to retrofit to IV rating ²	Medium (\$50 - \$200/sf)	See recommendations on further evaluation and retrofit.
Is 2018-2019 rating required by UCOP?	Yes	No previous rating reported
Further evaluation recommended?	Tier 2

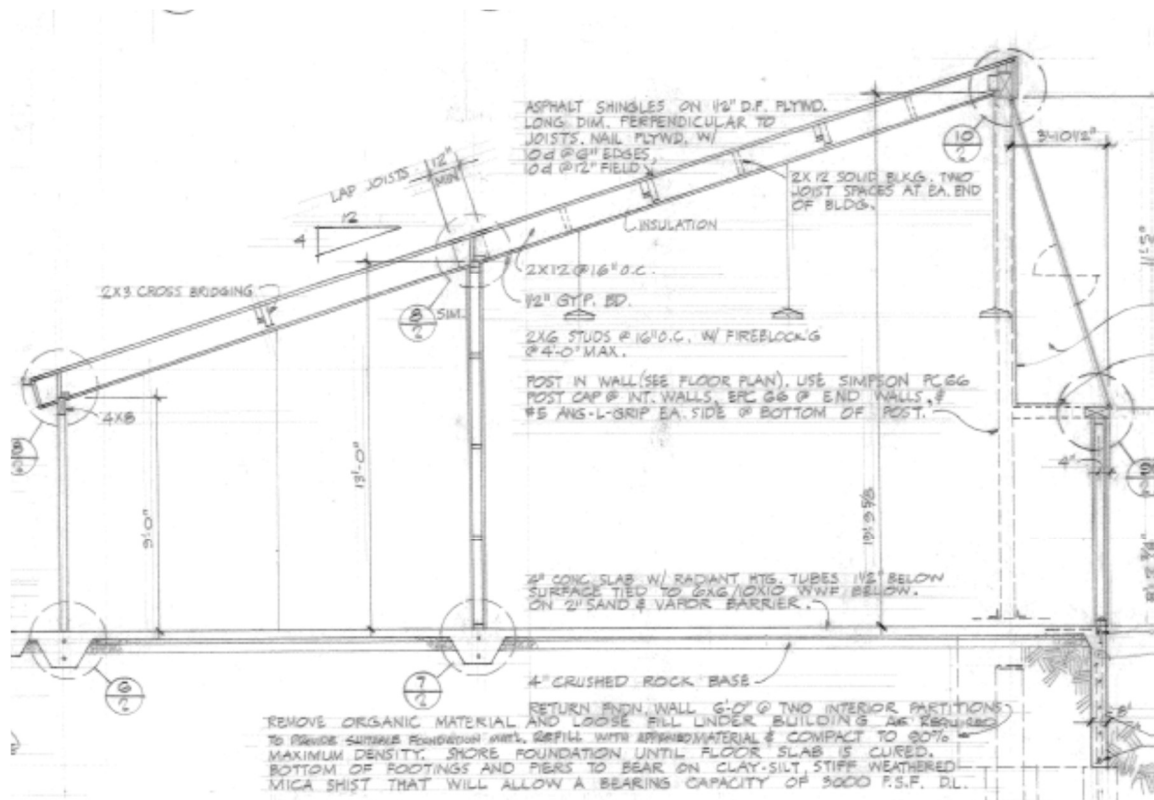
Figure: Annotated floor plan

- The building may have significant plan-torsion response to earthquake ground shaking in the east-west direction, because of the eccentric wall layout, which locates all east-west walls at the south end of the building. The resulting plan torsion may cause increased stress at the east-west walls on Line B. The roof diaphragm is unblocked and may allow excessive in-plane displacement and the north wall that has the clerestory, although the diaphragm aspect ratio, with 80' depth mitigates this issue. Building code requirements since about 1980 have not permitted flexible wood diaphragms to resist plan torsion, as the roof diaphragm is called on to do in this structure.

- No continuous collector is provided at Line B, possibly leading to overstress at the connection of the roof diaphragm to the shear walls on Line B.
- Joists are lapped spliced over Line B with no straps installed to provide continuity at the splice, resulting in a lack of a continuous chord member at the east and west edges of the building. However, the low aspect ratio of the building diaphragm (depth = 80'), combined with the nailing of the joists to the plywood sheathing which serves to splice the joist together, indicate that this deficiency may not be critical.

- North-south walls at the south end of the building are relatively short in length (9' long) relative to the height of the roof (14' average height). Overturning moment demands at the base of the walls may be relatively high. No hold-down connections from the walls to their foundation are shown in the drawings.

We recommend that the University perform a more detailed seismic evaluation to determine whether retrofitting is required. A Tier 2 linear analysis may be appropriate, including calculations to determine the expected story drift at the window wall. Applicable retrofit measures may include improving roof connectivity for chords and collectors, providing diagonal rod bracing under the roof diaphragm, providing plywood sheathing at the existing east-west interior walls, and/or augmenting hold-down capacity of walls.

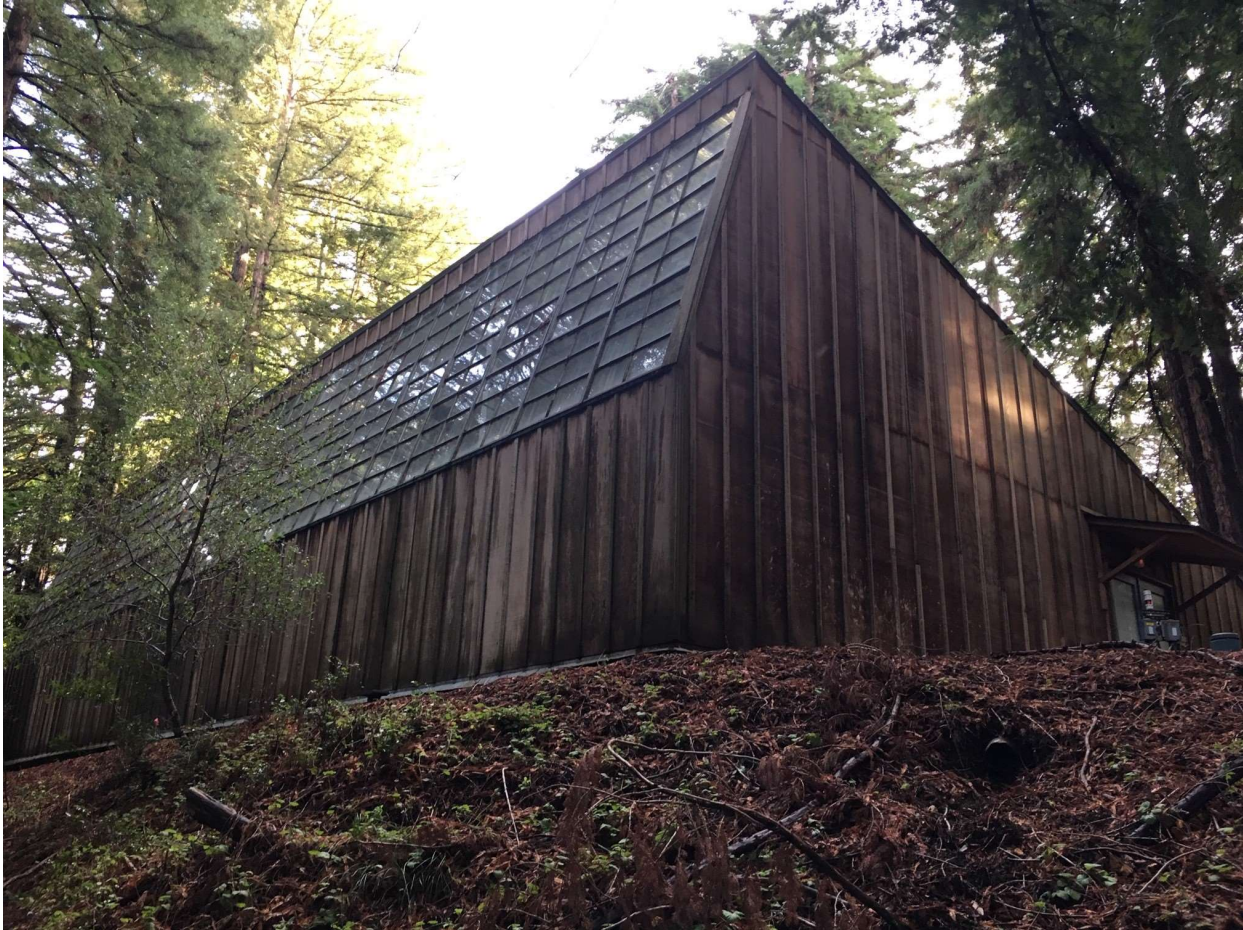
Figure: North elevation

The window at the north side of the building is approximately 12' tall x 80' long, and is located in elevation at the top of the north wall. Because the window slopes inward such that it is directly overhead the interior space, it appears that falling glass could pose a safety hazard in an earthquake, if the window is subjected to in-plane story drift demands that exceed the in-plane deformation capacities of the glass and frame. The structural deficiencies listed above may result in increased story drift over that typically seen in a building of this size, and thus may result in increased risk of window breakage.

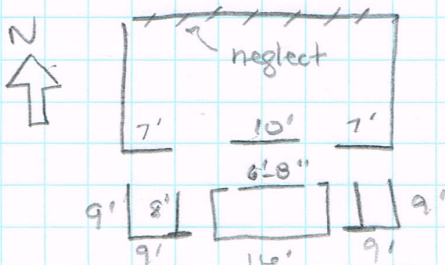
◦ Neglect north wall (no connection to roof) + interior gyp walls

$$\text{North-south } L = 24'(2) + 9'(4) + 8'(2) = 100'$$

$$\text{East-west } L = 9'(2) + 7'(2) + 16' + 10' + 8' + 3'' = 64'$$
