UC Santa Cruz building seismic ratings

Theater Arts B Drama Building

CAAN #7312

DATE: 2019-06-30

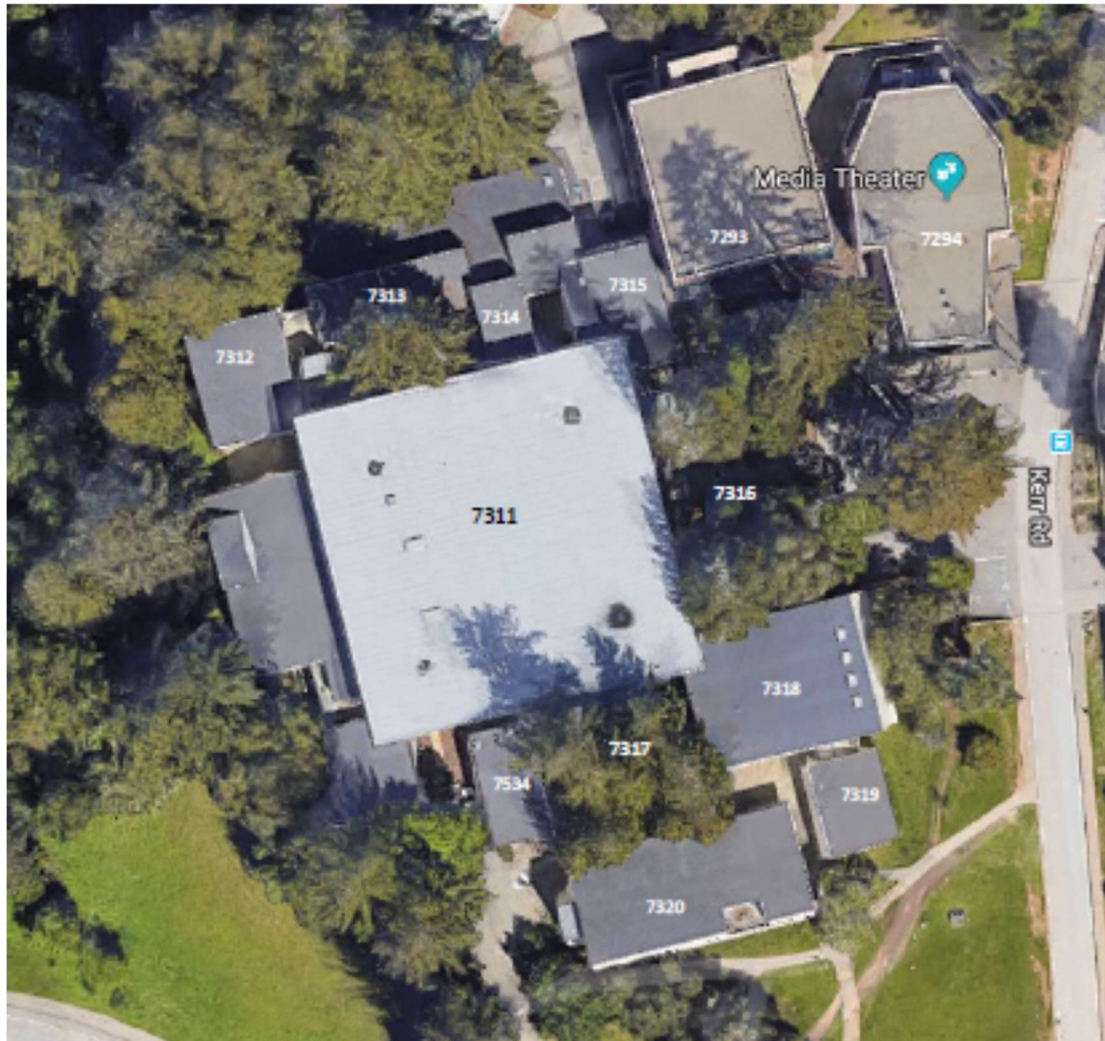
Site map at Theater Arts complex

Walkway at east side of building (building to the left, elevator structure to the right)
