UC Santa Cruz building seismic ratings

Kerr Hall

CAAN #7376
500 Kerr Road, Santa Cruz, CA 95064
UCSC Campus: Main Campus

DATE: 2019-07-15

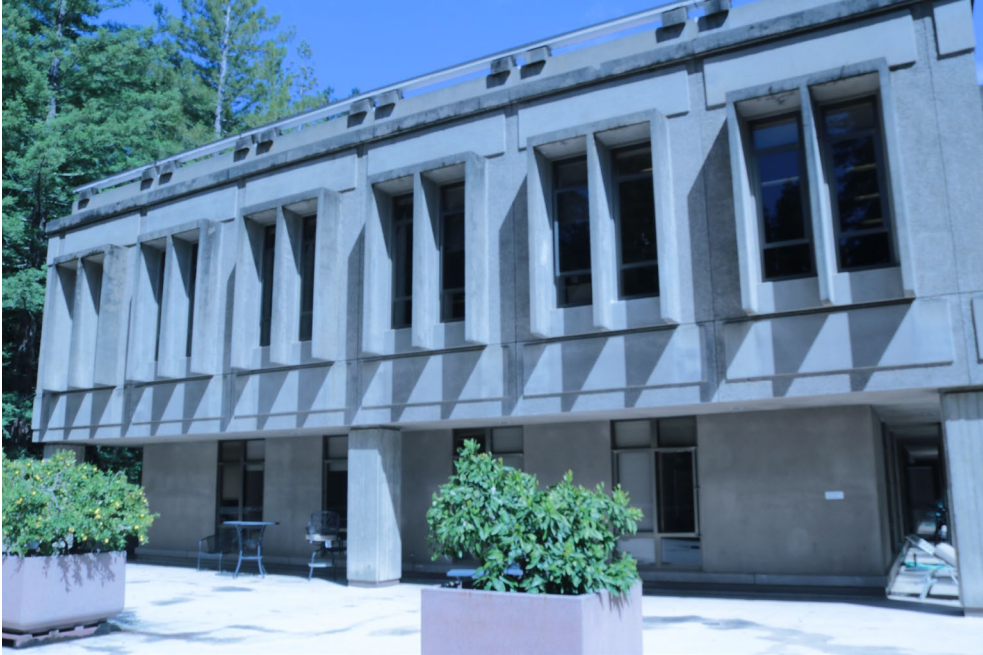
Typical precast panel elevation

| UCOP non-structural checklist item | Life safety hazard? | UCOP non-structural checklist item | Life safety hazard? |
|--|---|--|---|
| Heavy masonry or stone veneer above exit ways and public access areas | Precast panels at exterior | Masonry chimneys | None observed |

| Rating summary | Entry | Notes |
|--|---|---|
| Further evaluation recommended? | Tier 2 | Focused on a number of deficiencies including potential hazard of precast cladding |
