**UC Santa Cruz building seismic ratings**  
**Oakes College Residence A13-15**

CAAN #7408  
 220 Oakes Road, Santa Cruz, CA 95064  
 UCSC Campus: Main Campus

DATE: 2019-06-30

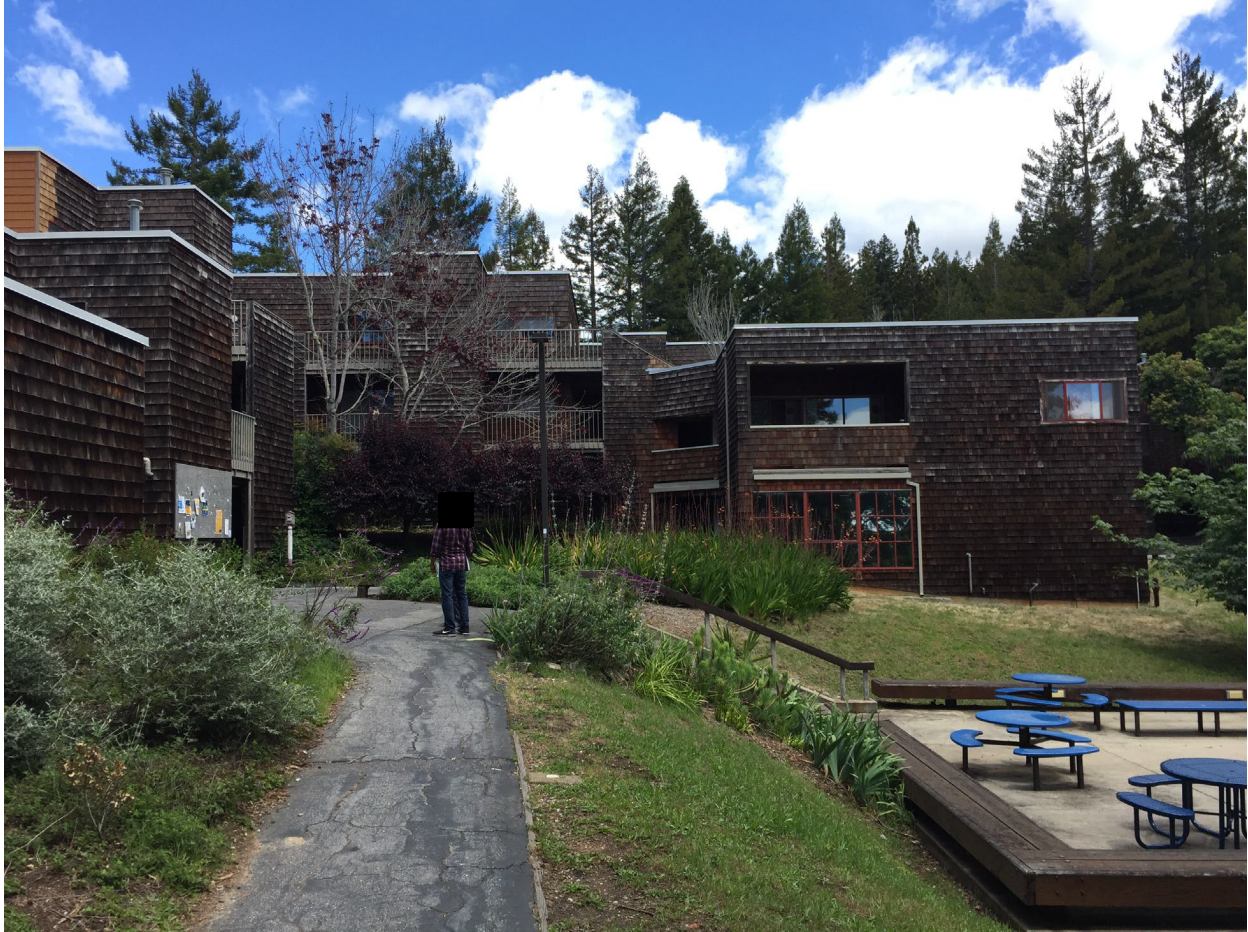
We observed no clear concerns. The stair connections at the exterior walkway is rigid at both ends and may present drift compatibility issues in a seismic event.

Photos of walkway and stairs
