UC Santa Cruz building seismic ratings
Visual Arts Facilities-Building E

CAAN #7497

Elena Baskin Visual Arts, Santa Cruz, CA 95064

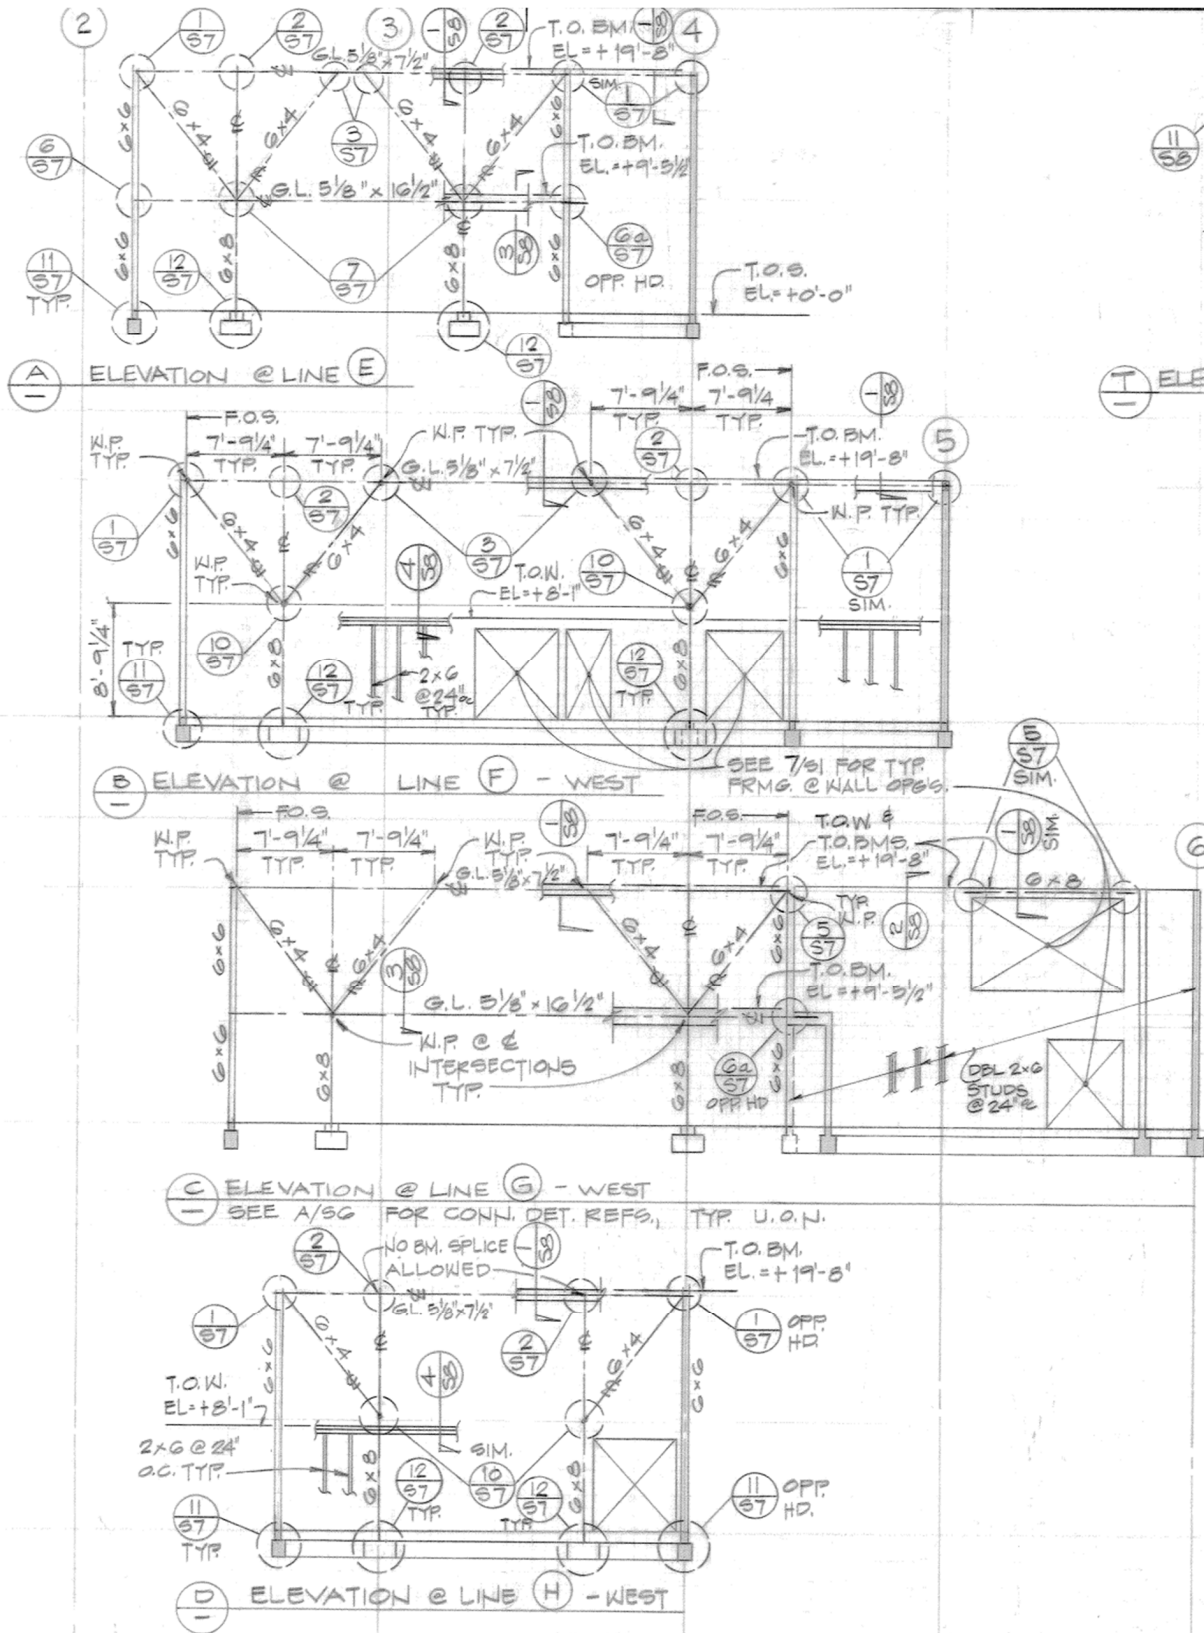
Example Braced Frame Elevations

- The braced frames rely on a complicated set of force transfer details that include bolts in shear in the wood. These details have reduced end distances (4D rather than 7D) and limited ductility compared to a plywood shear wall that dissipates energy through nails in bending, and they are ultimately likely to lead to longitudinal splitting of the wood. This is an unusual structural system not covered by the wood frame Tier 1 checklists of ASCE 41-17. A Tier 2 deficiency-based analysis of the frames, their internal connections, and their connections to the shear walls is needed to understand better the capacity and performance of this lateral force-resisting system.

We recommend that the campus perform a Tier 2 evaluation to review the lateral force-resisting capacity of the wood braced frame members, internal connections, and connections to the plywood shear wall. While ductility is low, it may be that there is sufficient capacity due to low demands. If the braced frames were found to be inadequate, connections could be strengthened or supplemental lateral resistance could be added, such as steel moment frames to help continue to preserve the clerestory light. Retrofits would also include positive anchorage at the canopy to perimeter stud walls to prevent cross-grain bending. We assign the building to Priority Category B, as the retrofit of the building should be done when there are any plans for renovation.
