Rating form
completed by:**RUTHERFORD + CHEKENE**
ruthchek.com

DATE: 2019-06-28

UC Santa Cruz Building Seismic Ratings
P.E. Fitness Center

CAAN #7726

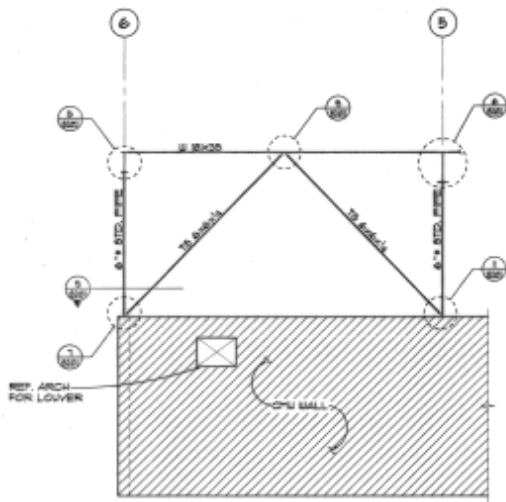
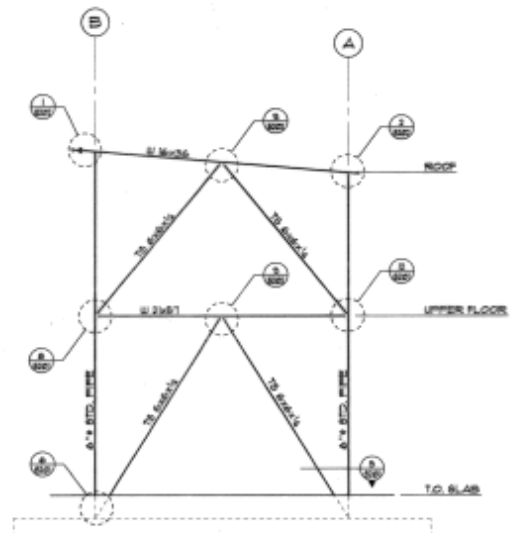
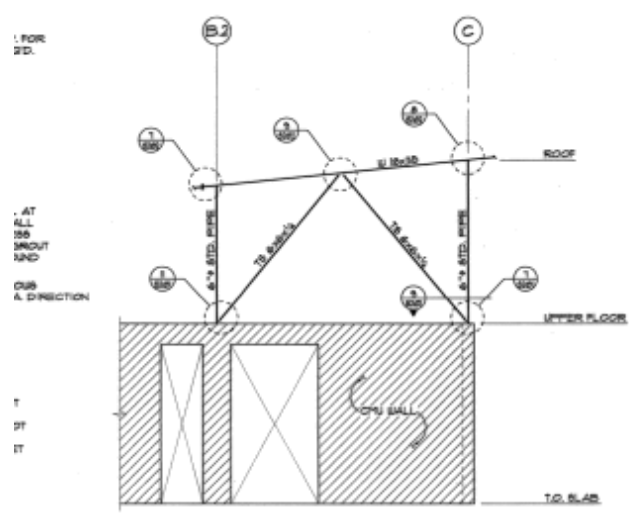
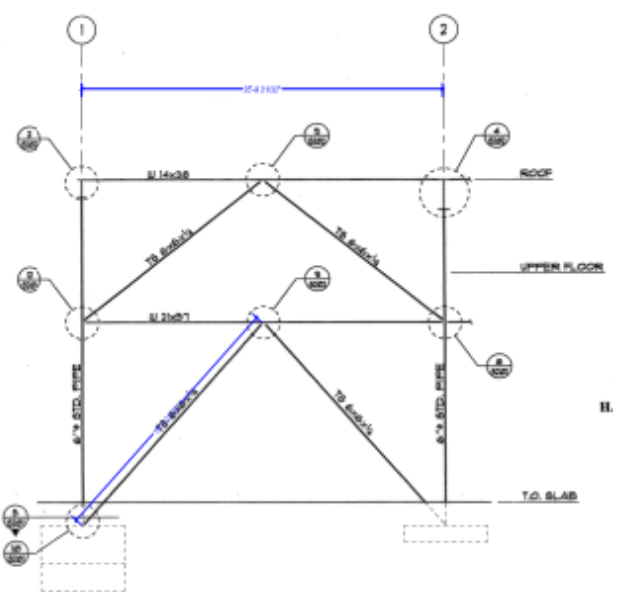
Elevations of Four Braced Frame/CMU Wall Sections (Details 1, 2, 3, 4/S201)

- The braced frame connections were not built as shown on the structural drawings. The 5/16 double fillet from the gusset to the top flange of the beam was missing on both sides of the corner column at one location we observed (see photo in Appendix A). This severely limits the capacity of the braced frames.
- At the second floor, in 5C-6C grid, the seismic force-resisting system changes from a one-bay braced frame to 10" x 71.5 ft CMU wall. This occurs at B.2-C also. Per ASCE 41-17, geometric irregularities can affect the dynamic

Braces are expected to experience overall buckling in compression and yielding in tension. The lack of welds from the gusset plates to the beam severely limits the connection capacities. Because of their width-thickness ratio, braces are not anticipated to sustain many inelastic cycles of axial deformation. Braces may fracture prematurely. If braces are able to resist many inelastic cycles, brace end connections may fracture at their net sections. If that does not occur, the gusset connection with a discontinuous load path may tear apart from the column. Assuming none of the preceding occurs and the braces develop large unbalanced vertical loads, then beams intersecting braces may yield in flexure and undergo very large deformations. If braces are able to develop their tension strength, there are two frame columns which resist loads from orthogonal directions which may need to resist compressive load in excess of their strength. If that occurs, loss of vertical load-carrying support over a limited area may be a possibility.

This building continuously serves students. We did verify that the posted occupant load is less than 300; as a result, the building need not be classified as Risk Category III. Given the continuous use of the building by students, we recommend that advanced Tier 2 or Tier 3 analyses be conducted to more carefully ascertain its seismic risk. More advanced analyses will also help identify the magnitude of retrofit required to bring into compliance the detailing and strength deficiencies identified.

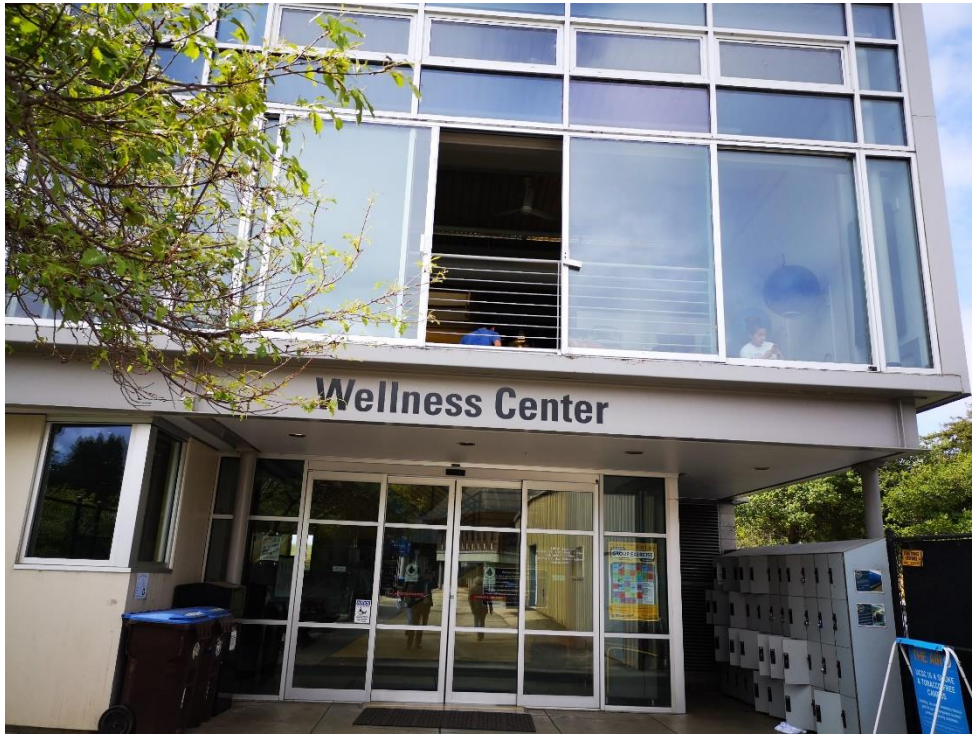
Entrance (North Elevation Looking South)

The building has full height glazing adjacent to and above the Wellness Center entrance. We recommend verifying that the glazing consists of tempered glass or the like.
