RUTHERFORD + CHEKENE
ruthchek.com

UC Santa Cruz building seismic ratings
Earth & Marine Sciences
(Lecture Hall B206 Steel Braced Frames)

CAAN #7775.2

552 Red Hill Road, Santa Cruz, CA 95064

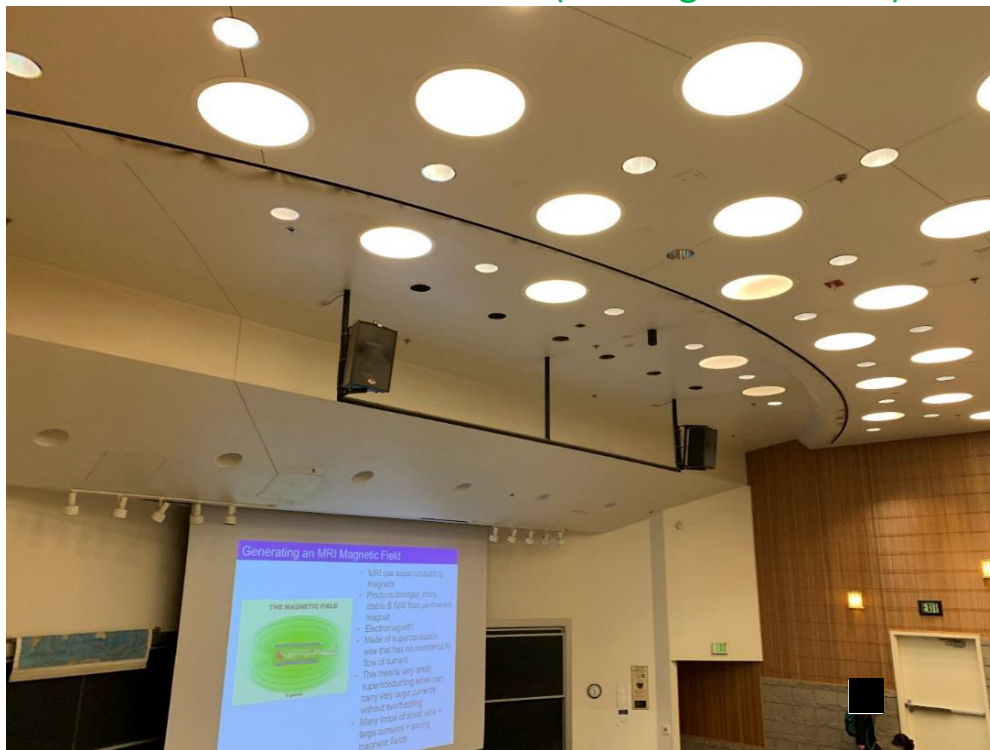
Interior View at Front of Lecture Hall B206

The Lecture Hall has heavy overhead ceilings and lights that could be a falling hazard. Additionally, the Lecture Hall depends in part on the Atrium for path of egress. That is an undesirable dependency because the Atrium has full height glazing supported by flexible moment frames and situated with inadequate seismic gaps to the adjacent wings. Pounding between the four adjacent moment frames may result in damage to the glazing leading to a life safety falling hazard.
